# COLORADO DIVISION OF RECLAMATION, MINING AND SAFETY COAL PROGRAM INSPECTION REPORT

<b>Permit Number:</b> C-1981-014 <b>Mine Name:</b> Southfield Mine <b>Operator:</b> Energy Fuels Coal, Inc. <b>Operator Address:</b> Mr. George Patterson P.O. Box 459 Florence, CO 81226	<b>County:</b> Fremont <b>Operation Type:</b> Underground <b>Permit Status:</b> Permanent Cessation <b>Ownership:</b> Private
<b>Operator Representative Present:</b>  George Patterson	
<b>Operator Representative Signature:</b> (Field Issuance Only)

<b>Inspection Start Date:</b> November 13, 2013 <b>Inspection Start Time:</b> 10:00 <b>Inspection End Date:</b> <b>Inspection End Time:</b>	<b>Inspection Type:</b> Coal Complete Inspection <b>Inspection Reason:</b> Normal I&E Program <b>Weather:</b> Clear	
<b>Joint Inspection Agency:</b>  None	<b>Joint Inspection Contacts:</b>	
<b>Post Inspection Agency:</b>  None	<b>Post Inspection Contacts:</b>	
<b>Inspector(s):</b>  Robert D. Zuber, P.E.	<b>Inspector's Signature:</b>

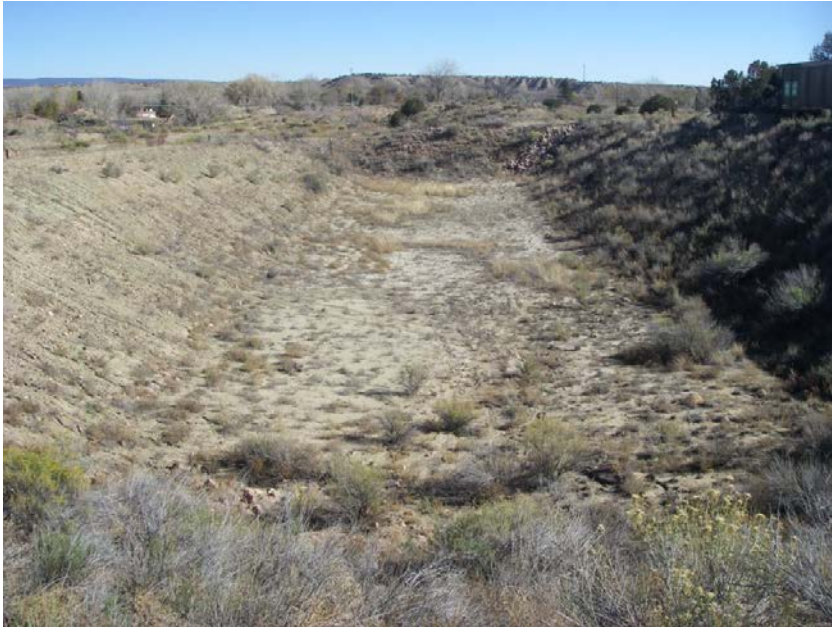
- Pond L-1 primary spillway contains some sediment at the downstream end. If this gets more than half full, it should be cleaned out.
- The sediment level in Pond 4, on average, appears to be at least two feet below the invert of the decant pipe. Thus the pond does not need to be cleaned at this time.
- The sediment level in Pond 5, on average, appears to be at least two feet below the invert of the decant pipe. Thus the pond does not need to be cleaned at this time. The upper end of this pond has recently been cleaned.
- The channel below the primary spillway of Pond 5 has been cleared of sediment. However, there is significant sediment in the pipe itself; if this condition worsens (reaches the half-way point) it will require

**Sediment Pond L-1**

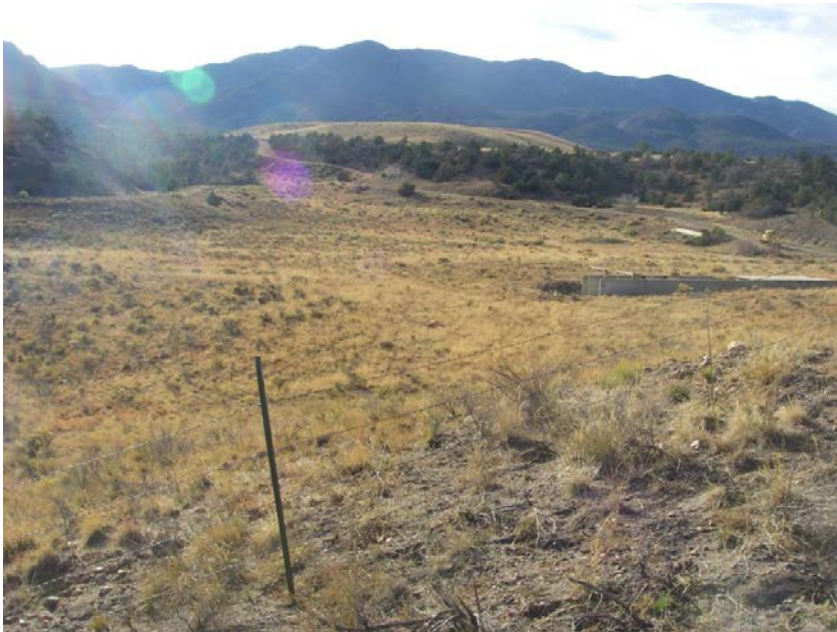
The portal area was in good shape; no erosion or large weed patches were observed.

**Portal area, looking northwest**

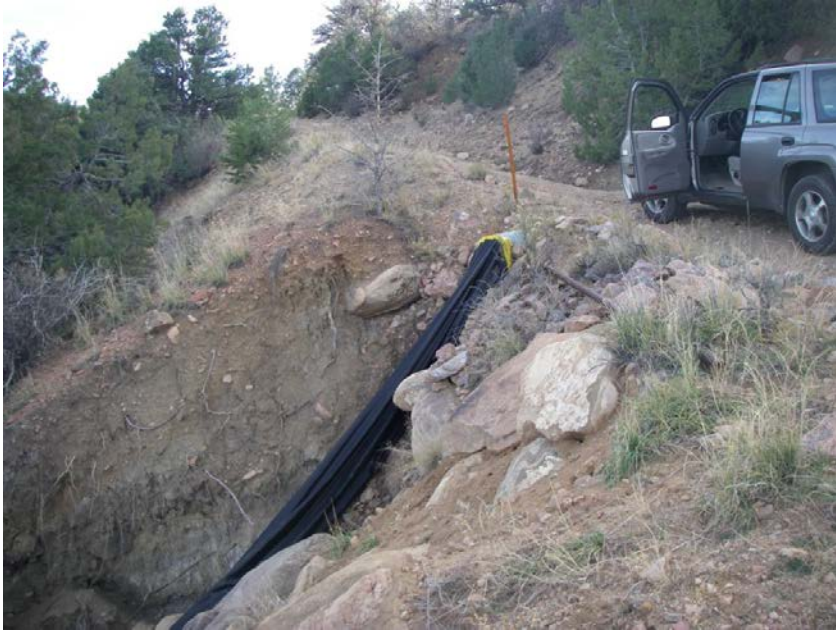
Roads to the facilities area and the RDA were in good shape, and water bars (aka ditch outs) have recently been cut. Along the road to the Monarch Mine, the downdrain structures (“socks”) were found to be in good shape, and no problems with culverts were seen.

**Drainage “sock” on road to Monarch fan**

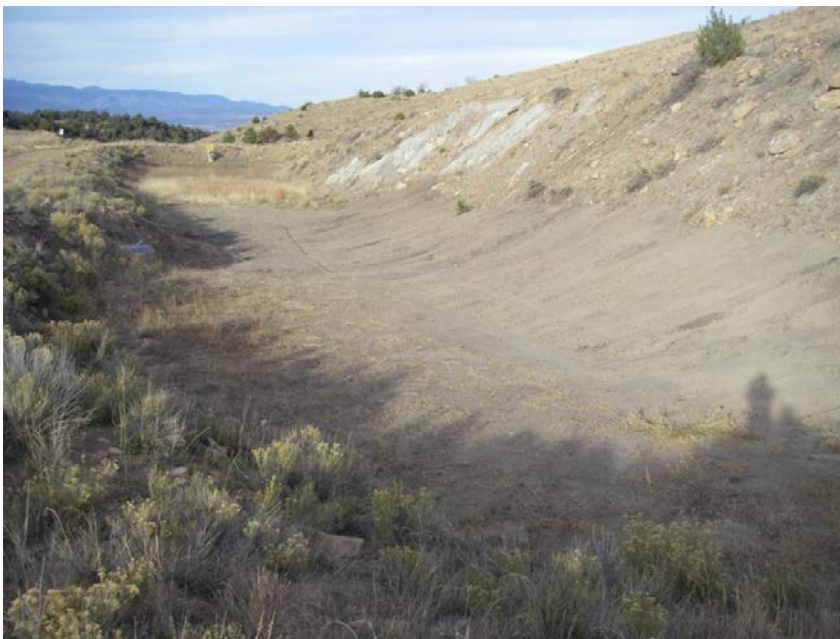
The two ponds at the mine site, Pond 4 and Pond 5, were holding water. Neither of these ponds was discharging. At the loadout, ponds L-1 and L-2 were dry at the time of the inspection.

**Sediment Pond 5 – upper part of pond has been cleaned**

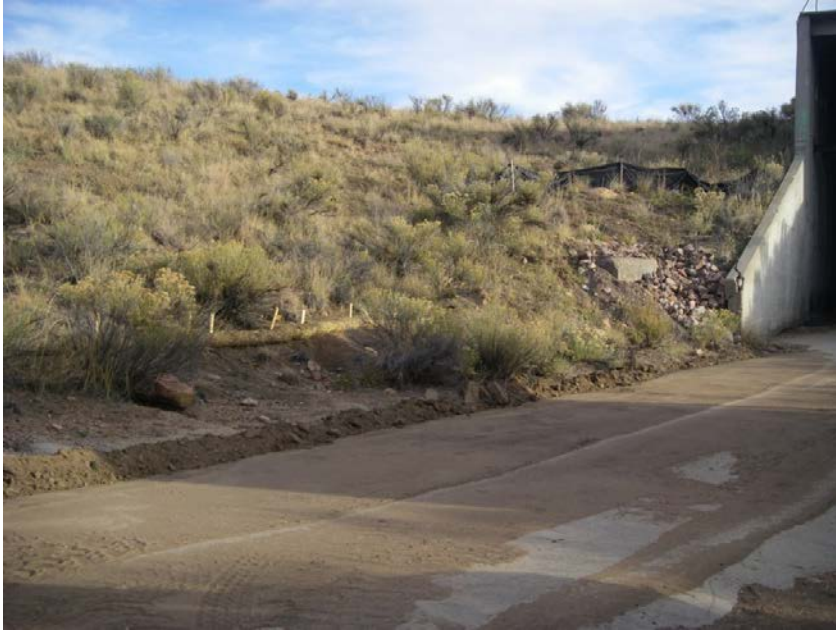
Near the truck tunnel, where erosion has been observed in recent inspections, the slope looks stable and BMPs were in order, including silt fence and a new wattle.

**BMPs near truck tunnel**

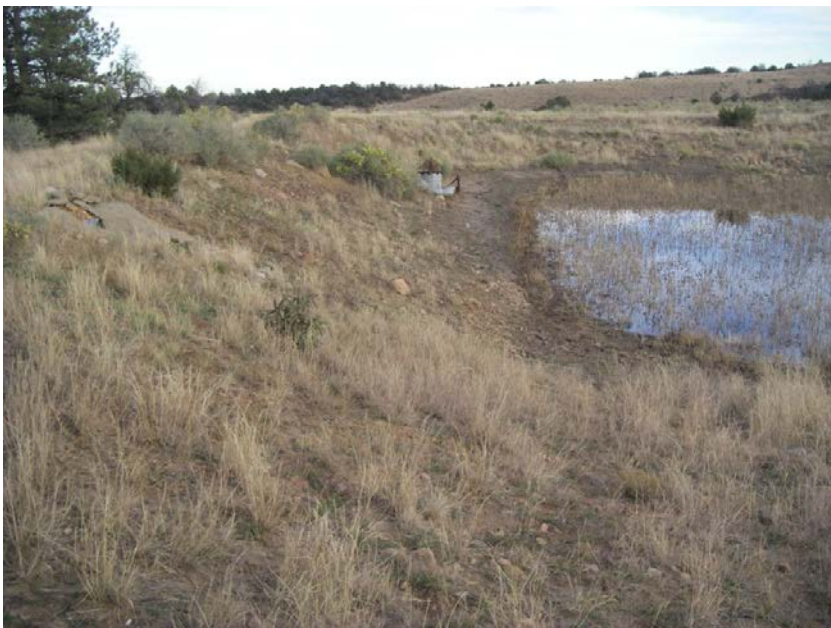
No major problems were found with embankments or spillways. Some additional observations regarding the ponds:

**Sediment Pond 4 embankment**

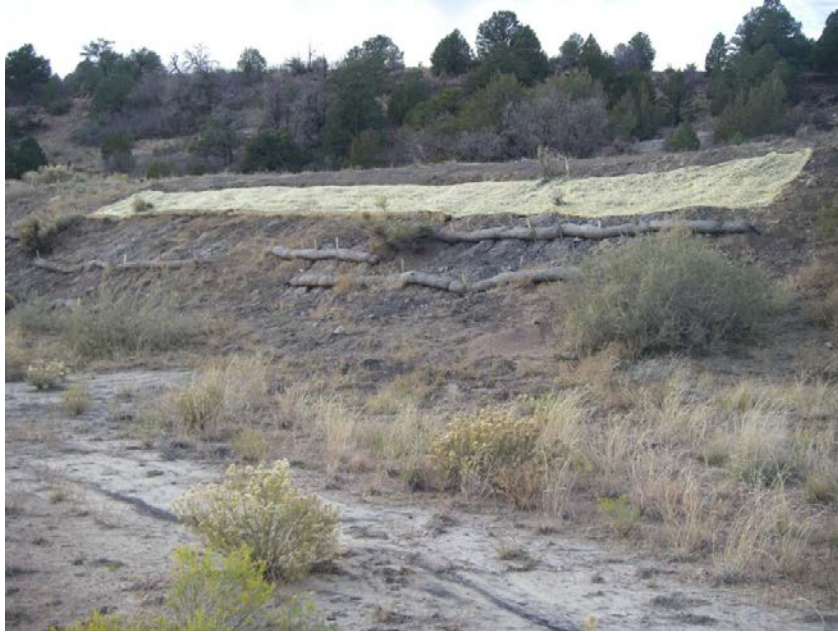
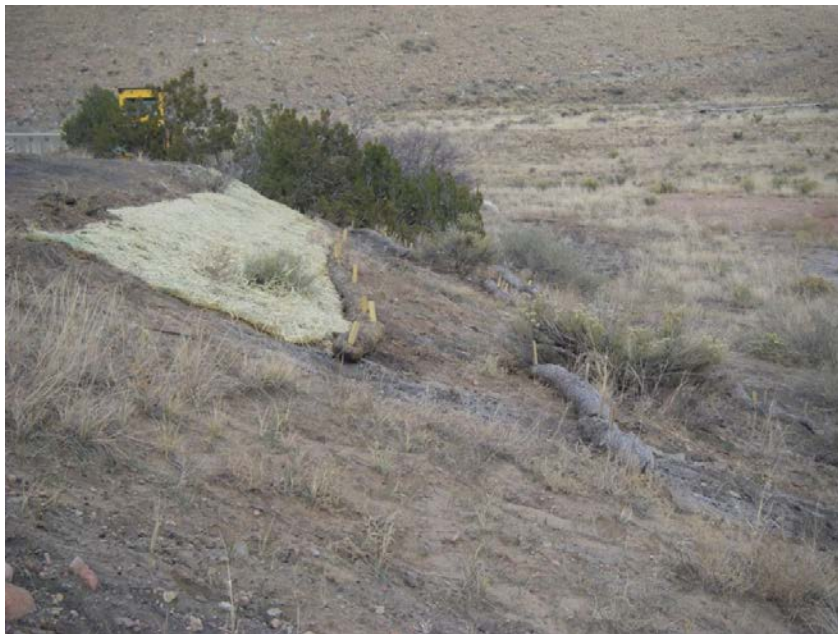
The wattles near the gravel parking lot in the portal area appear to be functioning and the hillside appears stable. An erosion mat has been added to the top of the slope.

**BMPs on slope above gravel lot**
