COLORADO DIVISION OF RECLAMATION, MINING AND SAFETY COAL PROGRAM INSPECTION REPORT

Permit Number: C-1981-017 Mine Name: Coal Basin Mines Operator: Mid-Continent Resources Operator Address:	County: Pitkin Operation Type: Underground Permit Status: Revoked Ownership: Federal
	Operator Representative Present: None
Operator Representative Signature: (Field Issuance Only)

Inspection Start Date: July 23, 2013 Inspection Start Time: 09:00 Inspection End Date: July 23, 2013 Inspection End Time: 16:00	Inspection Type: Coal Complete Inspection Inspection Reason: Normal I&E Program Weather: Clear	
Joint Inspection Agency: None	Joint Inspection Contacts:	
Post Inspection Agency: None	Post Inspection Contacts:	
Inspector(s): Brock F. Bowles	Inspector's Signature:

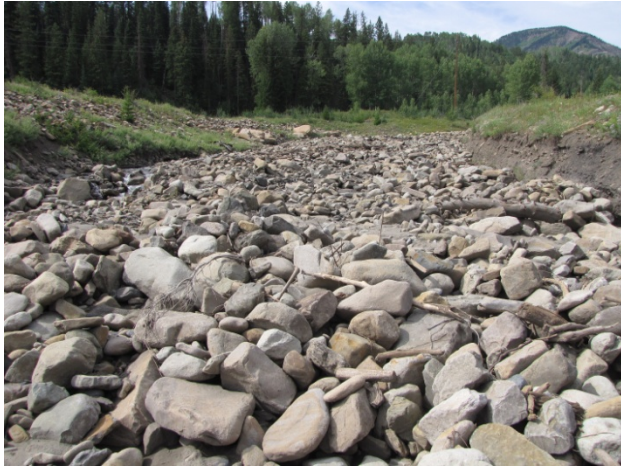
Photo 1 – Dutch Creek Reconstructed Channel

Steve Renner explained the concept behind the design of the Dutch Creek channel. Dutch Creek is prone to frequent flash flooding containing large amounts of sediment, rocks and trees. The channel was built to be an active, migrating channel, mimicking the natural stream tendencies and is expected to migrate over time. The channel bottom consisted of large rocks/boulders and fallen trees (photo 1).

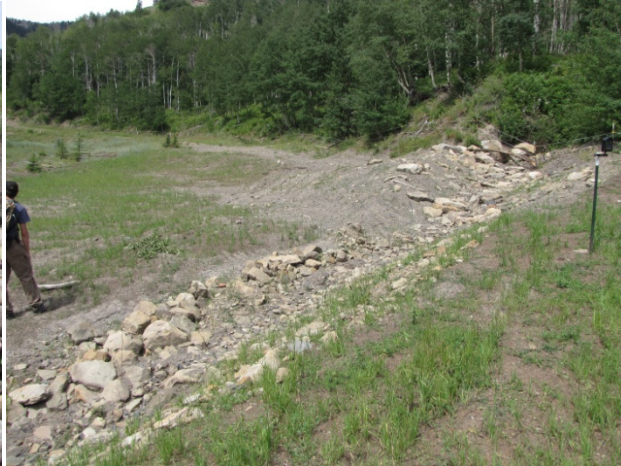
Photo 2 – Alluvial Fan in Road B

The USFS has constructed an alluvial fan in Road B, west of the lamphouse, to mitigate a slide area. A rock lined water channel was constructed with willows stems in the bottom. A several acre fan area west of the channel was constructed to catch excess water and sediment. All areas of the alluvial fan had 3 inches of biochar applied and was then ripped and seeded. Tree seedlings were planted and some large logs were laid across the fan area as energy dissipaters. The entire area was enclosed by an electric fence (photo 2).
