**COLORADO DIVISION OF RECLAMATION, MINING AND SAFETY**  
**MINERALS PROGRAM INSPECTION REPORT**  
**PHONE: (303) 866-3567**

<b>MINE NAME:</b> Thomeczek Pit	<b>MINE/PROSPECTING ID#:</b> M-1995-007	<b>MINERAL:</b> Sand and gravel	<b>COUNTY:</b> Bent
<b>INSPECTION TYPE:</b> Monitoring	<b>INSPECTOR(S):</b> Tyler V. O'Donnell	<b>INSP. DATE:</b> October 4, 2013	<b>INSP. TIME:</b> 10:30
<b>OPERATOR:</b> Bent County Ready Mix	<b>OPERATOR REPRESENTATIVE:</b>	<b>TYPE OF OPERATION:</b> 110c - Construction Limited Impact

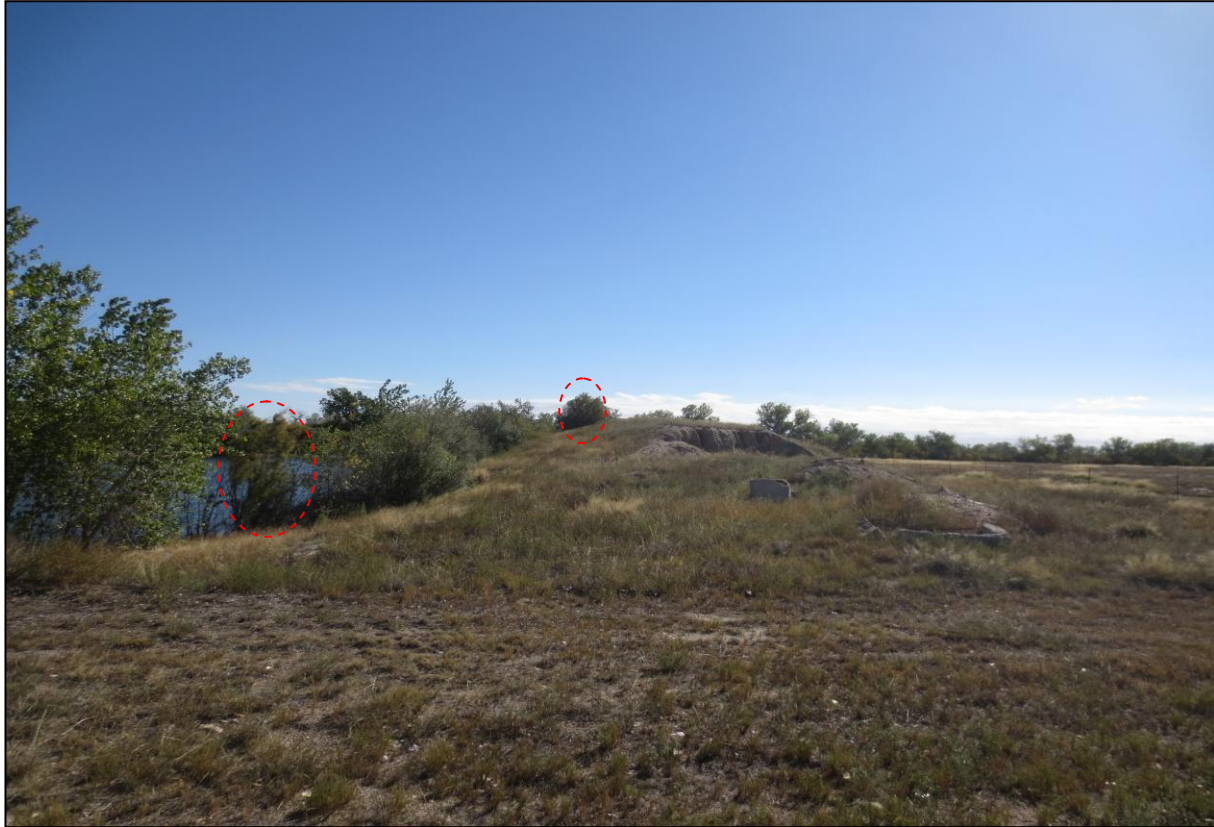
**PROBLEM/POSSIBLE VIOLATION:** Problem: Tamarisk (salt cedar) trees are present within or have volunteered into the eastern portion of the permit area and are becoming established. This is a problem for failure to employ weed control methods for a state listed noxious weed species within the permitted area, and to reduce the spread of weeds to nearby areas as required by Section 3.1.10 (6) of the rule.

Approximately 1 acres of the permit area was covered with Tamarisk trees and Russian olive trees. This is cited as a problem in the inspection report.

There was a small amount of construction waste located within the permit boundary see photo 1. This material needs to be removed.

**Photo 1:** View looking east. Construction waste in the foreground, the stockpile of topsoil and overburden is in the background. The Tamarisk trees are circled in red.

**CORRECTIVE ACTIONS:** The Operator shall either implement the existing weed control plan, or develop a weed control and management plan in accordance with Section 3.1.10 (6) of the Rule. This plan should be developed in consultation with the county extension agency, or weed control district office and should include specific control measures to be applied, a schedule for when control measures will be applied and a post-treatment monitoring plan. This weed control plan shall be submitted to the Division as a Technical Revision to the approved plan with the appropriate Technical Revision fee of \$216.00 by the corrective action date.

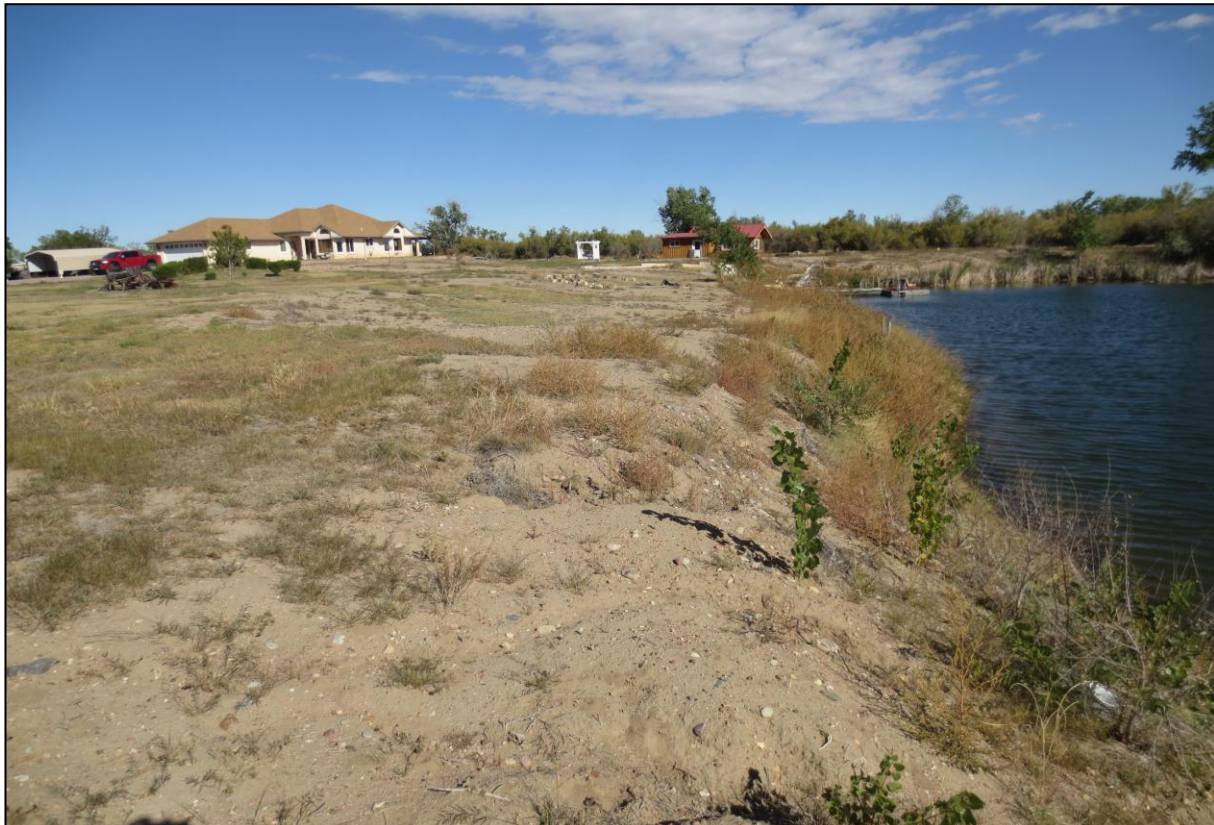
The excavated pit is now an approximate 3.5-acre pond that has shorelines with slopes of approximately 1.5H:1V to 2.5H:1V. The west side of the pond is a beach having a slope of approximately 4.5H:1V. A stockpile of excavated material extends along the southern permit boundary and is estimated to contain approximately 13,500 cubic yards of topsoil and overburden.

The Operator has not completed the approved reclamation plan. This is a problem for failure to reclaim the site in a diligent, timely manner, as required by the C.R.S. 34-32.5-116(4)(q)(I). This will be cited as a problem in the inspection report. The Operator will need to complete the approved Reclamation Plan.

**Photo 2:** View looking north at the un-reclaimed pond slopes at approximately 1.5H:1V to 2.5H:1V. The beach area is in the background near the boat dock.

**CORRECTIVE ACTIONS:** The Operator must demonstrate that reclamation has been completed by the corrective action date. 12/31/2013

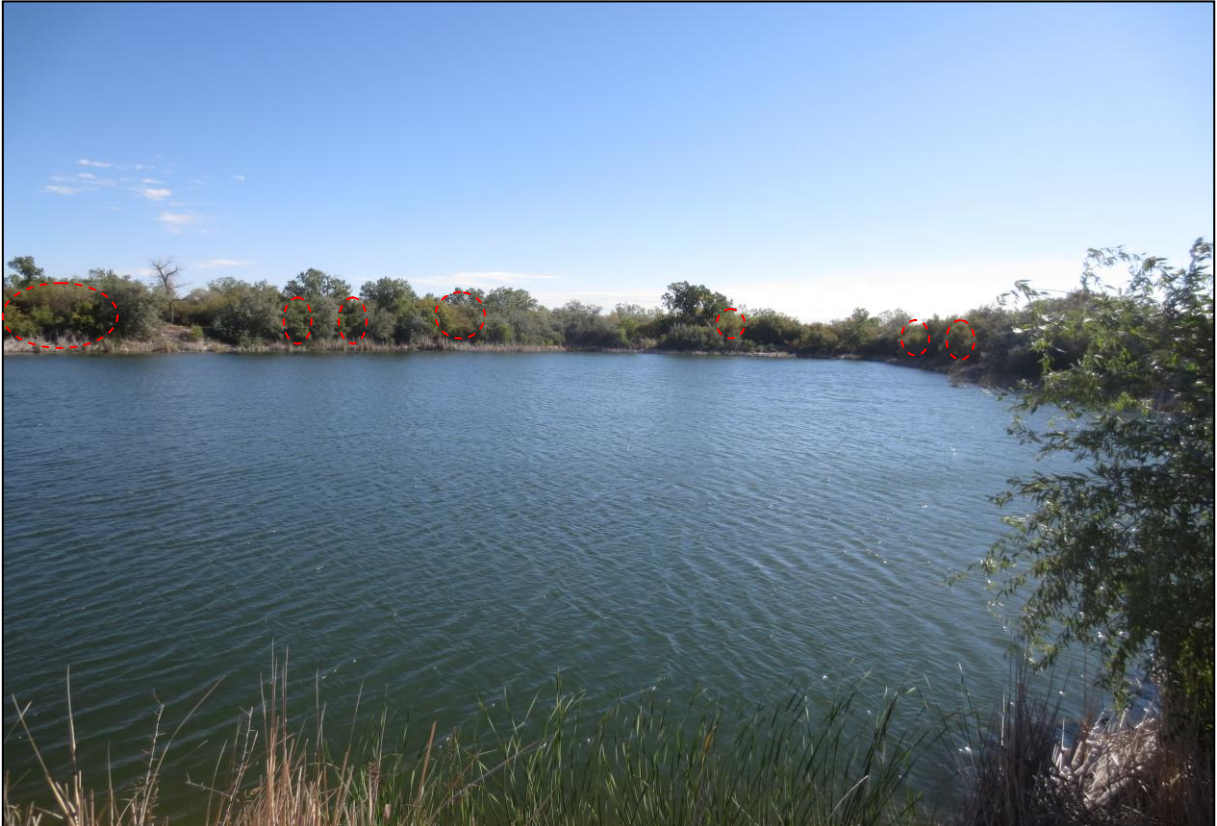
**Photo 3:** View looking across the pond, patches of tamarisk trees circled in red.

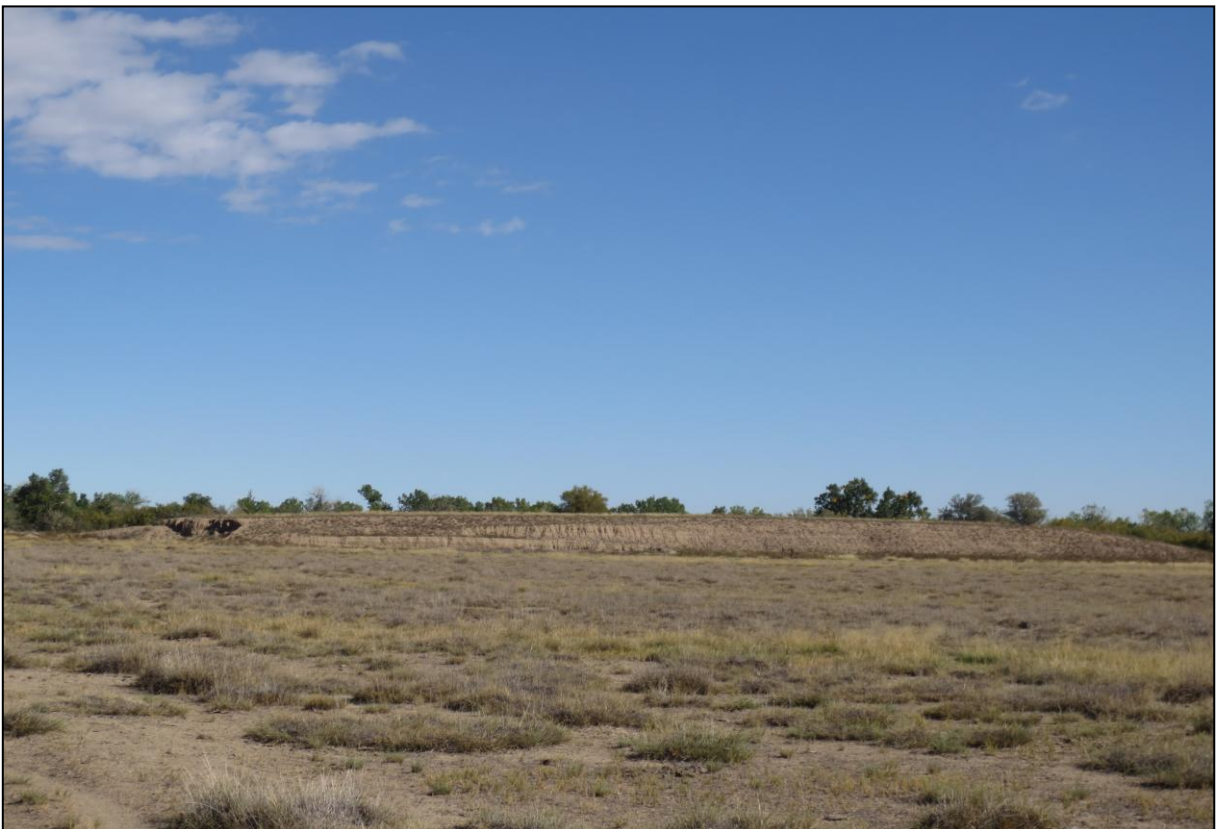
**Photo 4:** View looking northeast at the overburden and topsoil stockpile.
