## COLORADO DIVISION OF RECLAMATION, MINING AND SAFETY COAL PROGRAM INSPECTION REPORT

<b>Permit Number:</b> C-1981-019 <b>Mine Name:</b> Colowyo Coal Mine <b>Operator:</b> Colowyo Coal Company L.P. <b>Operator Address:</b> Mr. Tony Tennyson 5731 State Highway 13 Meeker, CO 81641	<b>County:</b> Moffat, Rio Blanco <b>Operation Type:</b> Surface <b>Permit Status:</b> Active <b>Ownership:</b> Federal
<b>Operator Representative Present:</b>	
<b>Operator Representative Signature: (Field Issuance Only)</b>

<b>Inspection Start Date:</b> November 19, 2013 <b>Inspection Start Time:</b> 14:00 <b>Inspection End Date:</b> November 20, 2013 <b>Inspection End Time:</b> 11:30	<b>Inspection Type:</b> Coal Partial Inspection <b>Inspection Reason:</b> Normal I&E Program <b>Weather:</b> Cloudy
<b>Joint Inspection Agency:</b>  None	<b>Joint Inspection Contacts:</b>
<b>Post Inspection Agency:</b>  None	<b>Post Inspection Contacts:</b>
<b>Inspector(s):</b>  Robert D. Zuber, P.E.	<b>Inspector's Signature:</b>  <i>Robert D. Zuber</i>  <b>Signature Date:</b>  11/19/2013

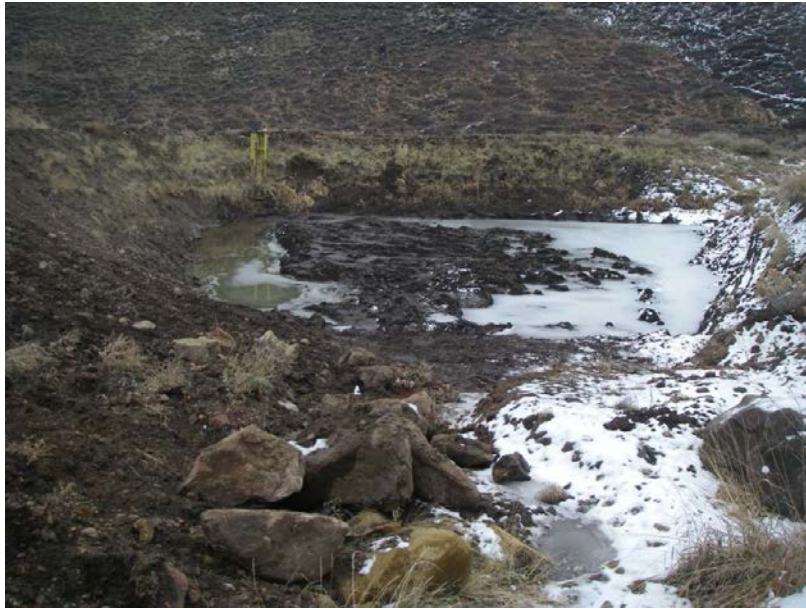
**Prospect Pond, from inlet**

Snowmelt runoff was seen flowing in some areas of the mine site, including the inlet to Prospect Pond.

- Prospect Pond was no longer being cleaned; this has been completed for 2013. The average sediment level appeared to be approximately 5 feet below the lowest weep hole on the spillway.
- The sump for Gossard Pond was holding water, but it appeared that there was very little sediment in this structure.
- The flume below the Rail Loop Pond requires cleaning.
- At Stoker Siding Pond, muskrats continue to plug the lower holes of the primary spillway. The pond remains functional.

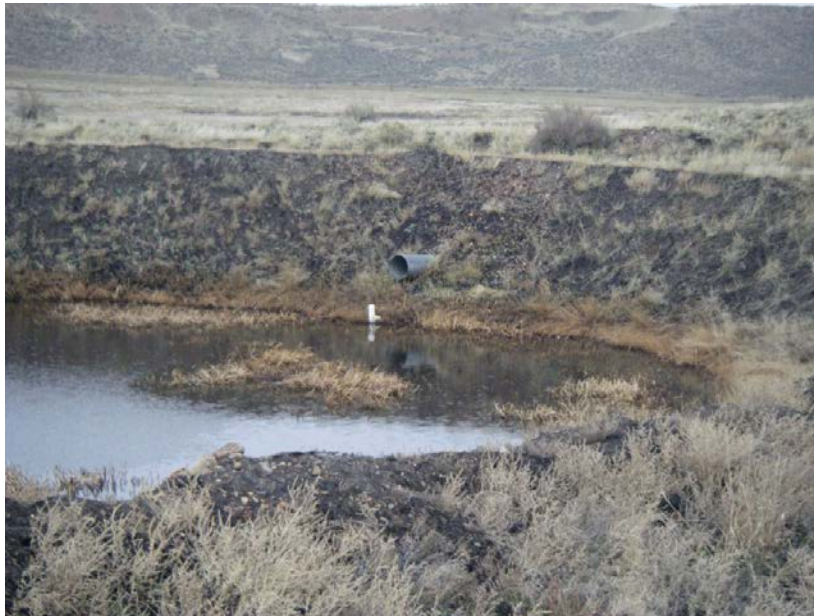
**Gossard Pond spillways**

Prospect and Rail Loop Ponds were holding water but not discharging. The following ponds were discharging: Gossard, Stoker Siding, and Work Area (all very small discharges). The Gulch A Pond was dry. For all discharging ponds, no sign of pollutants was observed. No major problems were found with embankments or other structures.

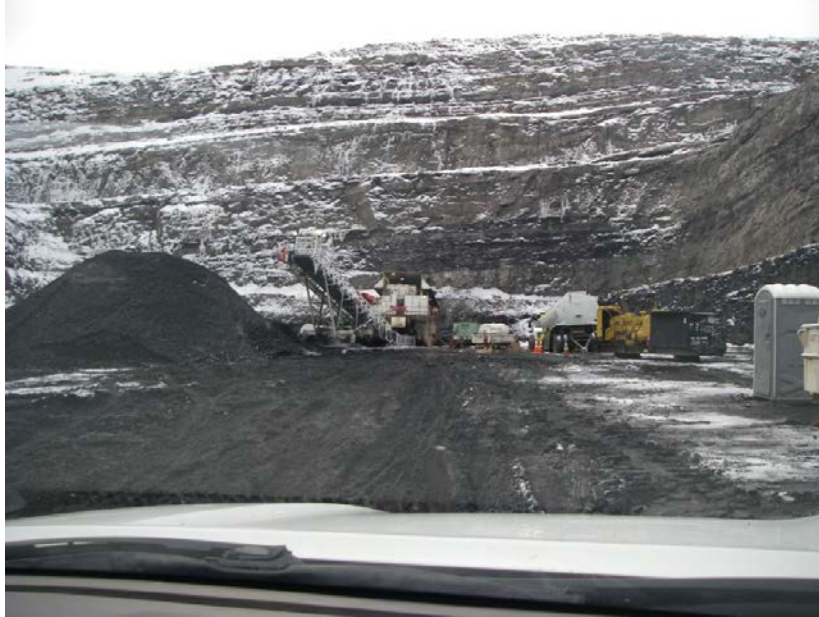
**Highwall mining operation in South Taylor Pit**

- In the South Taylor Pit, highwall mining is underway at the south end of the pit. A small quantity of coal was coming off the conveyor and forming a pile.
- In the upper part of South Taylor Pit (western portion) the 115 excavator was removing F1 overburden.
- In the upper part of South Taylor Pit a dozer was cleaning coal and a coal drill rig was moving into the pit.

Regarding the highwall mining, Lee Sampson (Colowyo engineer) indicated in the office that the first entry has progressed approximately 400 feet into the wall. Kurtis Blunt indicated that Colowyo reports progress to the BLM.

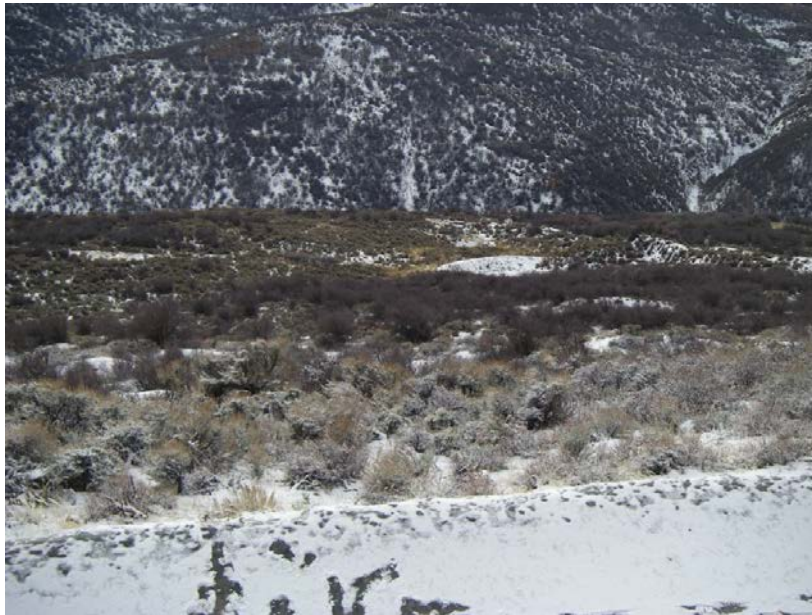
**Slide area below Section 28 Ditch**

The slide below the Section 28 Ditch was viewed from the hillside above. No evidence of new movement

was detected, but this area should be observed in the future using aerial photographs.
