**COLORADO DIVISION OF RECLAMATION, MINING AND SAFETY  
COAL PROGRAM INSPECTION REPORT**

<b>Permit Number:</b> C-1981-041 <b>Mine Name:</b> Roadside Portals <b>Operator:</b> Snowcap Coal Company, Inc <b>Operator Address:</b> Ms. Tonya Hammond P.O. Box 1430 Palisade, CO 81526	<b>County:</b> Mesa <b>Operation Type:</b> Underground <b>Permit Status:</b> Permanent Cessation <b>Ownership:</b> Federal
<b>Operator Representative Present:</b>  Tonya Hammond	
<b>Operator Representative Signature: (Field Issuance Only)</b>  Issued from Grand Junction Field Office

<b>Inspection Start Date:</b> November 19, 2013 <b>Inspection Start Time:</b> 08:30 <b>Inspection End Date:</b> November 19, 2013 <b>Inspection End Time:</b> 12:00	<b>Inspection Type:</b> Coal Partial Inspection <b>Inspection Reason:</b> Normal I&E Program <b>Weather:</b> Cloudy
<b>Joint Inspection Agency:</b>  None	<b>Joint Inspection Contacts:</b>
<b>Post Inspection Agency:</b>  None	<b>Post Inspection Contacts:</b>
<b>Inspector(s):</b>  Michael P. Boulay	<b>Inspector's Signature:</b>  <i>Michael P. Boulay</i> <b>Signature Date:</b>  11/21/13

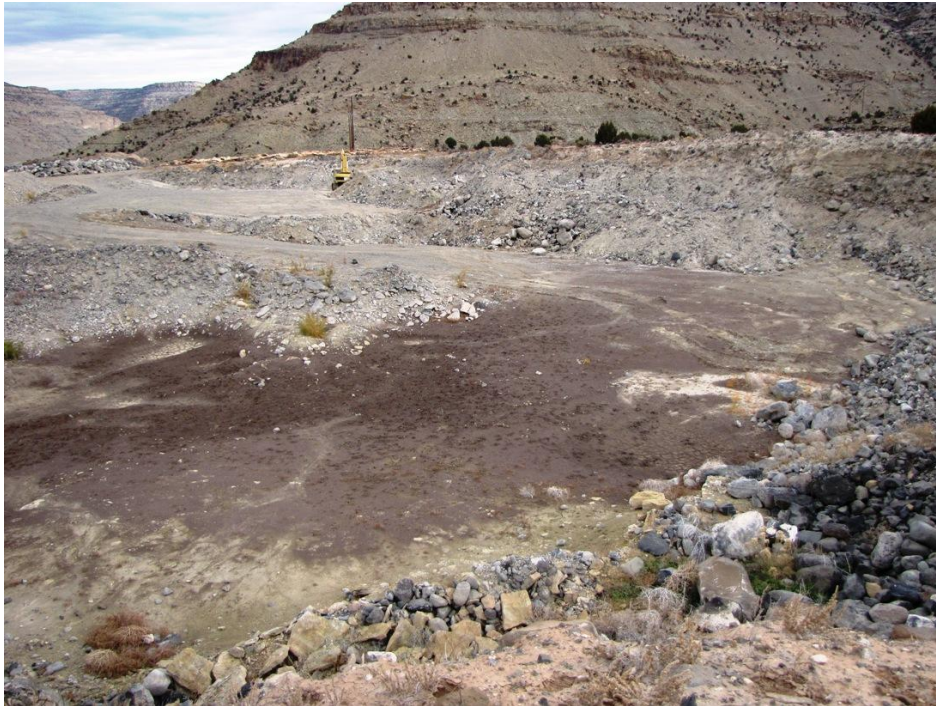
Photograph No. 1 - Fontanari active gravel mining operation

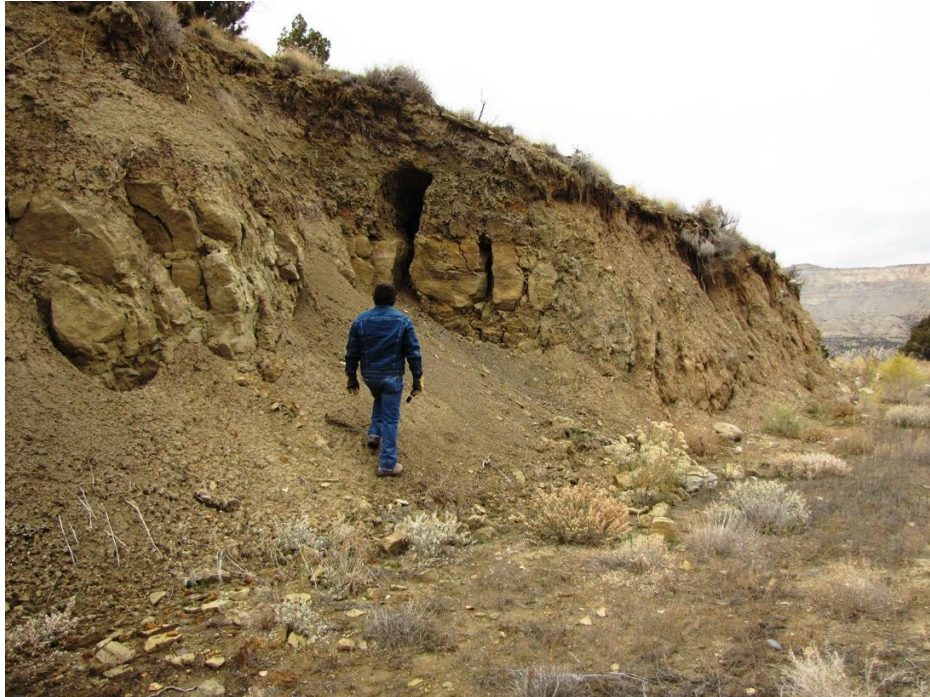
Photograph No. 2 - Cut slope and bench where upper irrigation pipeline is buried.

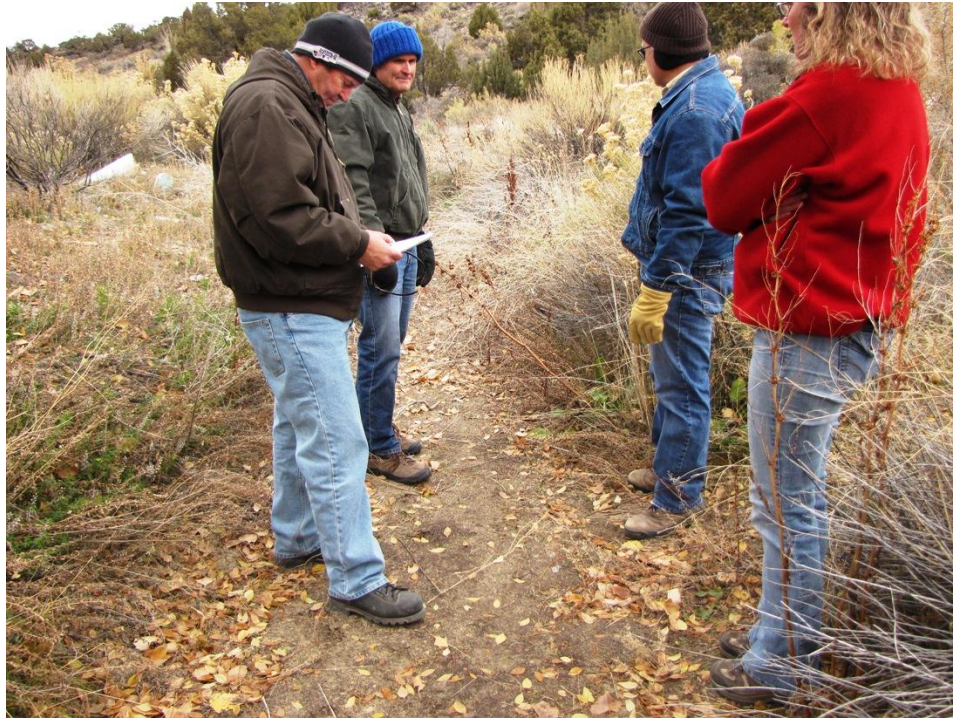
Photograph No. 3 – Lower irrigation ditch

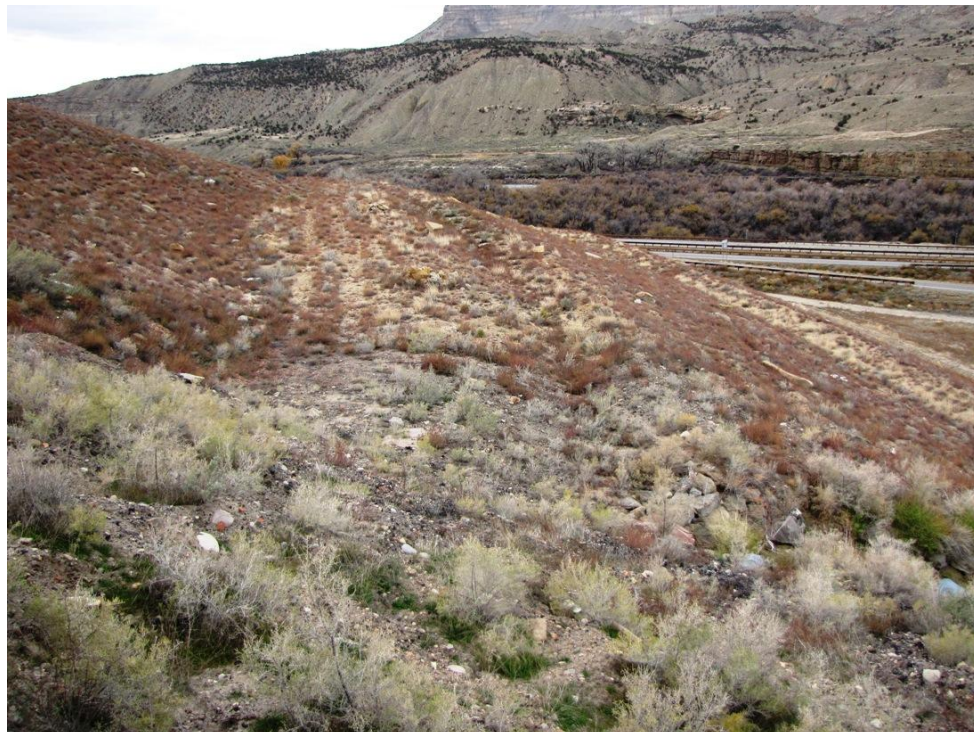
The CRDA-1 and CRDA-2 waste piles were viewed and appeared to be stable. Terrace drains and perimeter ditches are maintained and functional. The RSRDA at the South Portal area was in very good condition with no erosion or instability noted (see Photograph No. 4). No problems were identified at any of the refuse disposal sites during this inspection.

Photograph No. 4 – Roadside South Refuse Disposal Area
