## COLORADO DIVISION OF RECLAMATION, MINING AND SAFETY COAL PROGRAM INSPECTION REPORT

<b>Permit Number:</b> C-1982-057 <b>Mine Name:</b> Seneca II-W Mine <b>Operator:</b> Seneca Coal Company, LLC <b>Operator Address:</b> Mr Roy Karo 37796 Routt County Road 53 P.O. Box 670 Hayden, CO 81639	<b>County:</b> Routt <b>Operation Type:</b> Surface <b>Permit Status:</b> Permanent Cessation <b>Ownership:</b> Federal
	<b>Operator Representative Present:</b>  Dennis Bugai
<b>Operator Representative Signature:</b> (Field Issuance Only)

<b>Inspection Start Date:</b> November 20, 2013 <b>Inspection Start Time:</b> 09:15 <b>Inspection End Date:</b> November 20, 2013 <b>Inspection End Time:</b> 12:30	<b>Inspection Type:</b> Coal Partial Inspection <b>Inspection Reason:</b> Normal I&E Program <b>Weather:</b> Cloudy
<b>Joint Inspection Agency:</b>  None	<b>Joint Inspection Contacts:</b>
<b>Post Inspection Agency:</b>  None	<b>Post Inspection Contacts:</b>
<b>Inspector(s):</b>  Janet H. Binns	<b>Inspector's Signature:</b>

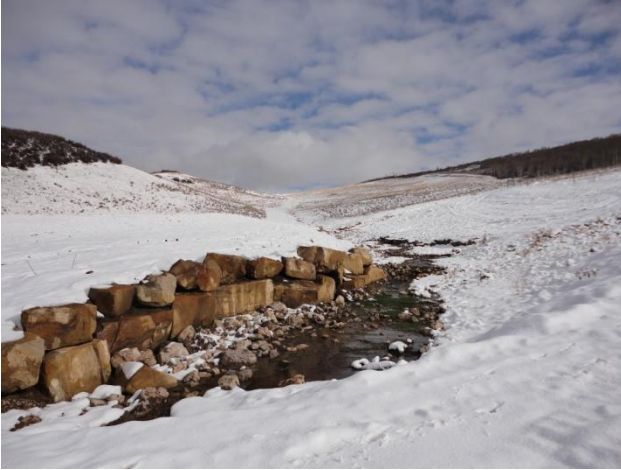
Drainages that were visible appeared stable. Drainage 006-SE, 006-Gulch, and drainage 006-NE1 appeared stable. PM-2 had a good flow of water west of the spring. The rock bank of PM-2 was in good shape. PM-3 and PM-2A looked stable.

Photo 1: rock bank at PM-2, looking up PM-3

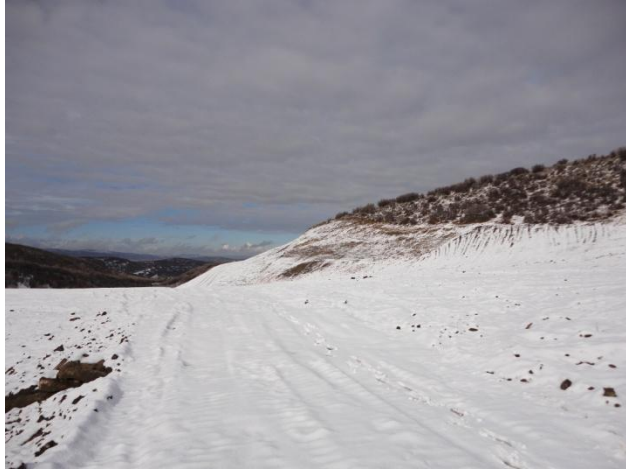
Photo 2: slope above J road north of Pond 016, appears stable

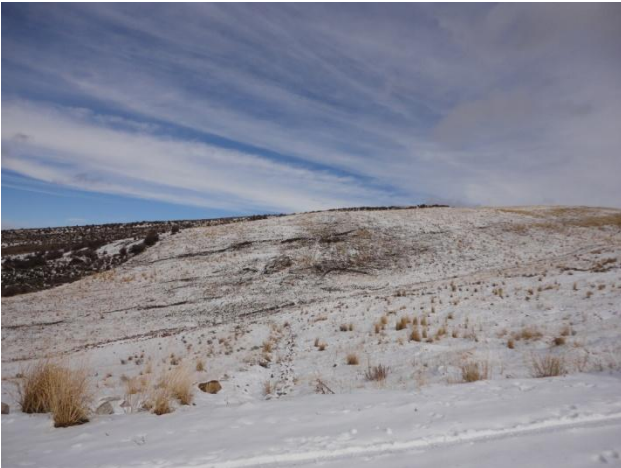
Regraded slopes were snow covered with several inches of fresh snow. No evidence of new slides were apparent. Some slope instability could be noted north and northwest of stock tank T-20. Some of the slump scars are located in areas undisturbed by mining activities.

Photo 3: old slump scars north of stock tank T-20
