COLORADO DIVISION OF RECLAMATION, MINING AND SAFETY COAL PROGRAM INSPECTION REPORT

Permit Number: C-1992-081 Mine Name: Hayden Gulch Loadout Operator: Hayden Gulch Terminal, LLC Operator Address: Mr Roy Karo 37796 Routt County Road 53 P.O. Box 670 Hayden, CO 81639	County: Routt Operation Type: Loadout Permit Status: Permanent Cessation Ownership: Private
	Operator Representative Present: None
Operator Representative Signature: (Field Issuance Only)

Inspection Start Date: November 19, 2013 Inspection Start Time: 12:35 Inspection End Date: November 19, 2013 Inspection End Time: 14:30	Inspection Type: Coal Partial Inspection Inspection Reason: Normal I&E Program Weather: Cloudy
Joint Inspection Agency: None	Joint Inspection Contacts:
Post Inspection Agency: None	Post Inspection Contacts:
Inspector(s): Janet H. Binns	Inspector's Signature:

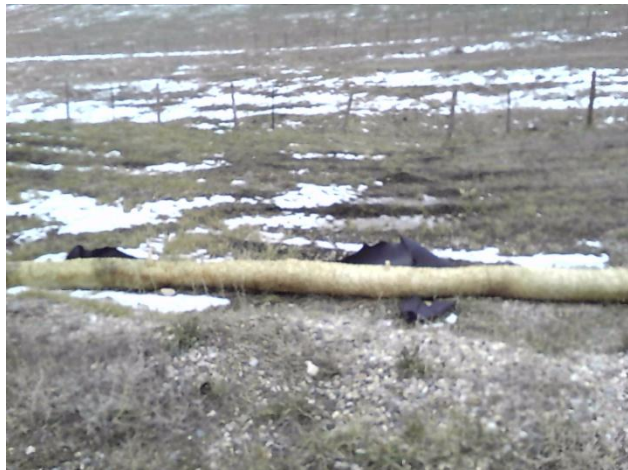
Ditches at the reclaimed load out were in good condition. The weathered silt fence at the substation SAE has been removed and new straw wattles anchored in place. (Photo 1)

Photo 1: Straw wattles anchored in place at Substation SAE

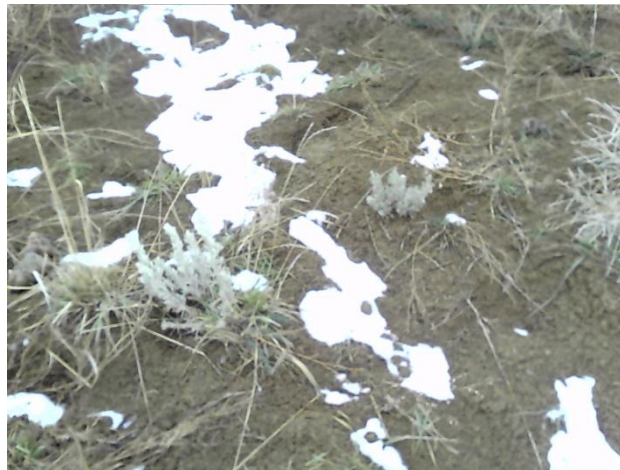
The vegetative cover on the reclaimed facilities area is still thin and still exhibits signs of considerable biennial species (yellow sweetclover). The site was last seeded in 2011. It is not unexpected to see a dominance of annual and biennial species the first several growing seasons after seeding. Perennial species are present, specifically, Orchardgrass, Flax, wheatgrasses and numerous Sagebrush seedlings. No noxious weed species were observed throughout the reclamation during this inspection.

Photo 2: This cover with perennial grasses & sagebrush seedlings

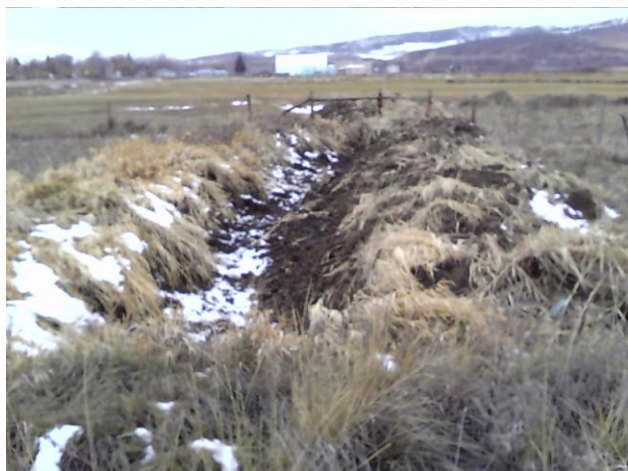
Photo 3: Irrigation ditch and RRC-3 cleared

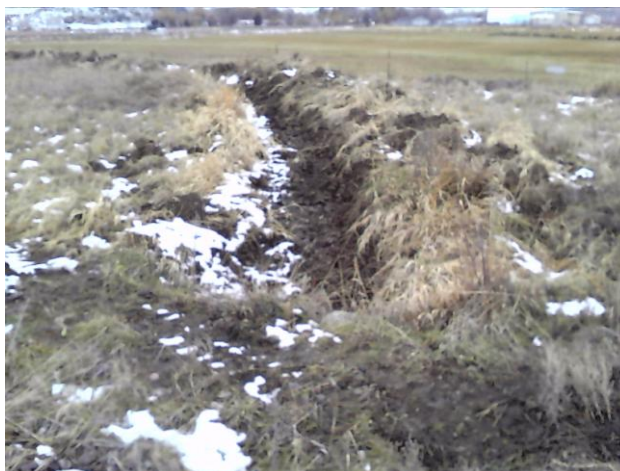
Photo 4: Irrigation ditch and RRC-2 cleared

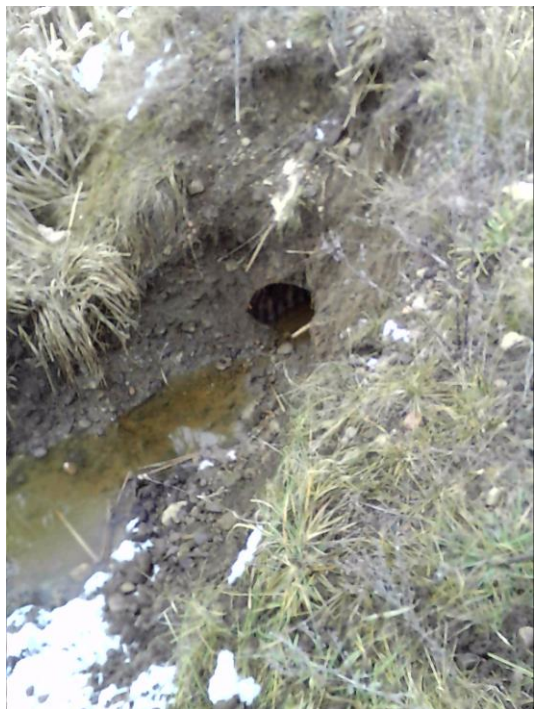
Photo 5: West side of RRC-1 cleared

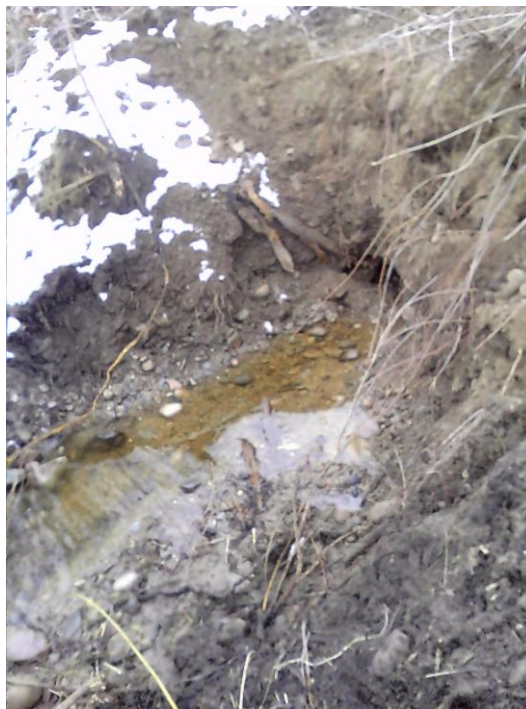
The previously culverts identified north of Highway 40 were checked. Irrigation ditches at all 4 culverts have been cleared. The east side of RRC-1 is below the general grade of the ditch. Water was flowing through RRC-1 unimpeded at the time of the inspection. RRC-2, RRC-3 and RRC-4 are all clear and in good condition. (Figure 12-1 Facilities Map)

Photo 6: East side of RRC-1 cleared and flowing

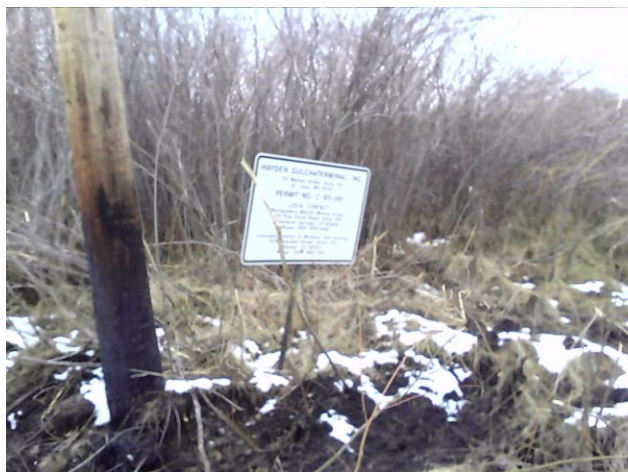
Mine ID signs will need to be updated to reflect the new location of the HGT office. The Northern Identification sign previously identified has been cleared of willows, but the information on the sign is out of date and requires updating.

Photo 7: North Mine ID sign near main rail line.
Willows cleared form sign, but info. needs updating.
