**COLORADO DIVISION OF RECLAMATION, MINING AND SAFETY  
COAL PROGRAM INSPECTION REPORT**

<b>Permit Number:</b> C-1982-056 <b>Mine Name:</b> Foidel Creek Mine <b>Operator:</b> Twentymile Coal, LLC <b>Operator Address:</b> Mr Jerry Nettleton 29515 Routt County Road No. 27 Oak Creek, CO 80467	<b>County:</b> Routt <b>Operation Type:</b> Underground <b>Permit Status:</b> Active <b>Ownership:</b> Federal
	<b>Operator Representative Present:</b>  Brian Watterson
<b>Operator Representative Signature: (Field Issuance Only)</b>

<b>Inspection Start Date:</b> November 20, 2013 <b>Inspection Start Time:</b> 08:00 <b>Inspection End Date:</b> November 20, 2013 <b>Inspection End Time:</b> 12:00		<b>Inspection Type:</b> Coal Partial Inspection <b>Inspection Reason:</b> Normal I&E Program <b>Weather:</b> Foggy	
<b>Joint Inspection Agency:</b>  None		<b>Joint Inspection Contacts:</b>	
<b>Post Inspection Agency:</b>  None		<b>Post Inspection Contacts:</b>	
<b>Inspector(s):</b>  Jason D. Musick  Zach T. Trujillo	<b>Inspector's Signature:</b>

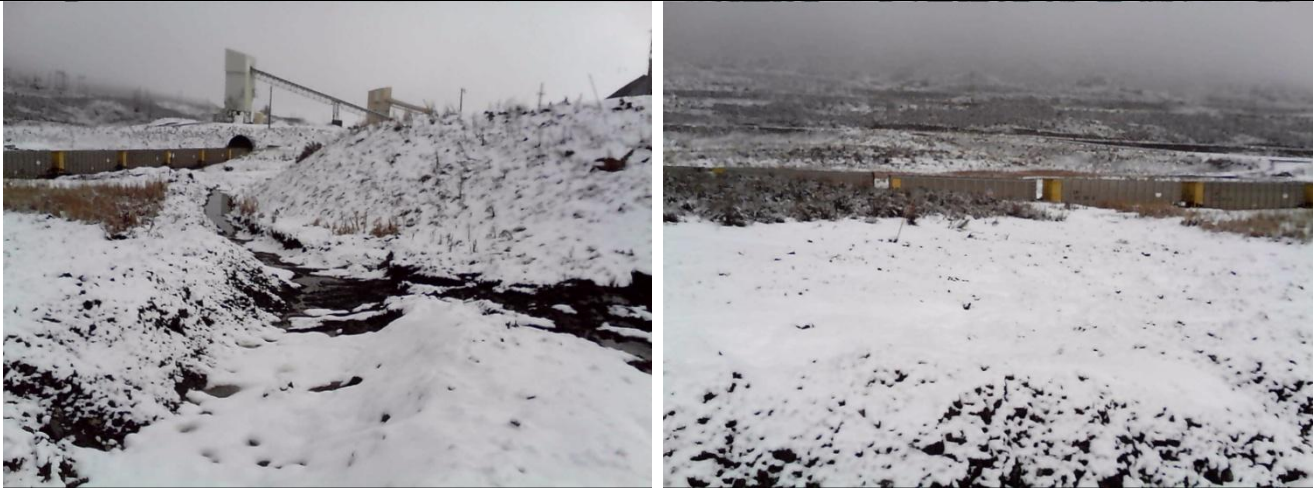
- The lower end of the ditch and associated rock check dams (B-1) west of the BOB Pile had failed. The coal fines were contained in the area by the Southeast sediment basin and the ditch along the railway; however this area required maintenance to clear coal fines that have built up and to re-establish the ditch. Evidence of maintenance was identified; however additional material has breached the ditch and continues towards the north west. This area has been adequately addressed and the ditch re-established.

BOB Pile Clean up and Ditch Repair

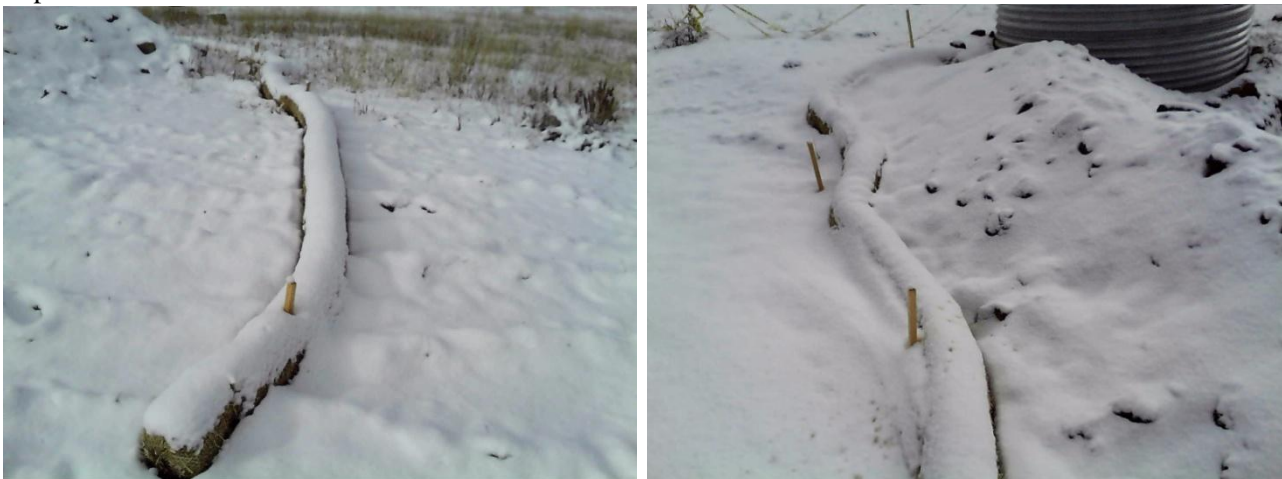
Due to the dredging operations at the Fish Creek Borehole ponds water is being diverted and new valves are being installed on the pipeline along the Fish Creek Borehole access road. These areas are approved to be disturbed and have yet to achieve bond release; however backfilling and grading, topsoil replacement and reseeding has been done in these two valve installation areas. Any disturbance will require segregation of topsoil, erosion control installation, and required markers. These areas have been identified and BMP's were in place at the time of the inspection.

Erosion Control at Fish Creek Borehole Access Road

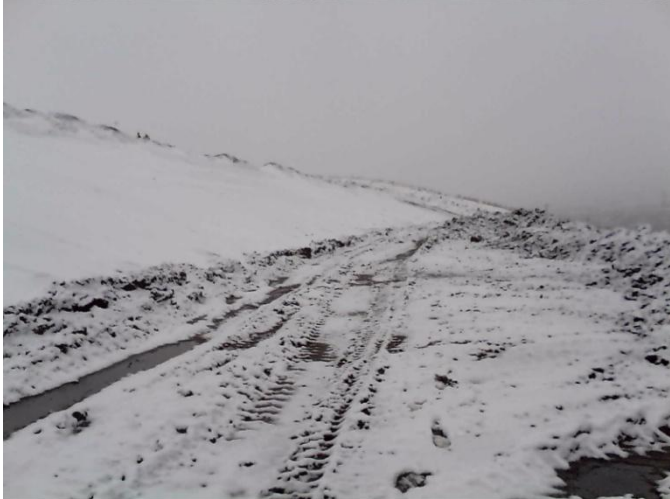
The first bench has been completed and the second bench is near elevation. The out slope of the first bench is stable and the outslope of the second bench is stable.

RDA Bench

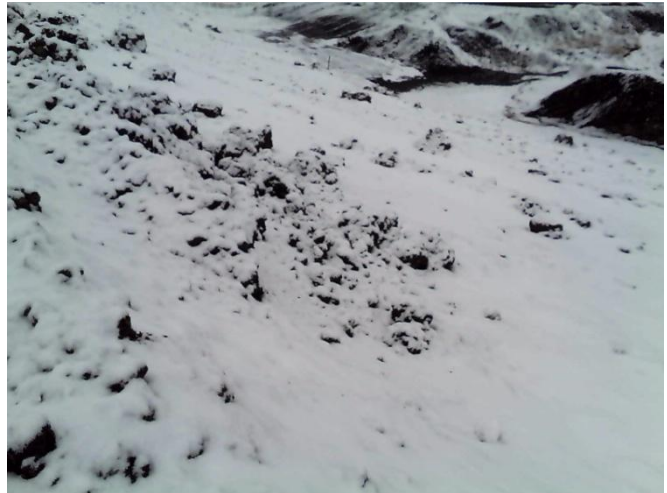
Cover material on RDA toe

Due to the initiation of the RDA-4 ditch, topsoil is being windrowed along the ditch construction area. This material will be direct hauled to the toe of the RDA expansion area. Based on the approved Exhibit 26C 2.5 feet of cover material will be placed on the toe of the RDA and 1.5 feet of topsoil will be placed on cover material for a total of 4 feet of cover. Cover material was placed on the toe slope to the first bench of the RDA. Four cover material depths were inspected and found to be +2 feet of cover material.
