COLORADO DIVISION OF RECLAMATION, MINING AND SAFETY
MINERALS PROGRAM INSPECTION REPORT
PHONE: (303) 866-3567

MINE NAME: White Banks Mine	MINE/PROSPECTING ID#: M-1999-042	MINERAL: Alabaster, marble, quartz	COUNTY: Pitkin
INSPECTION TYPE: Monitoring	INSPECTOR(S): Dustin M. Czapla	INSP. DATE: November 12, 2013	INSP. TIME: 11:00
OPERATOR: Avalanche Creek Marble & Alabaster LLC	OPERATOR REPRESENTATIVE: Robert Congdon, Walter Brown	TYPE OF OPERATION: 110c - Construction Limited Impact

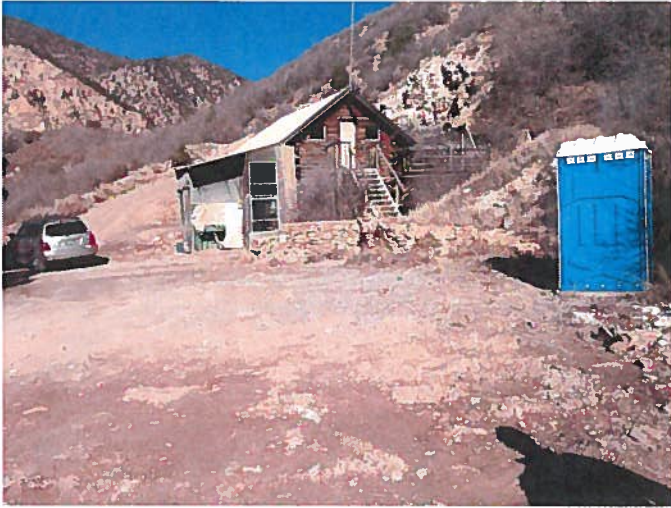
Figure 1: Cabin area on north side of FR 310.

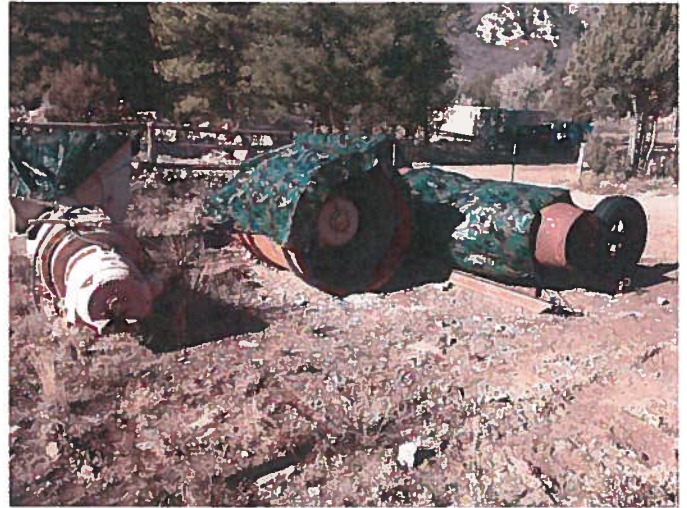
Equipment that is not considered necessary to the operation has been removed from this area.

Figure 2: Equipment considered necessary for the mining operation stored on north side of FR 310.

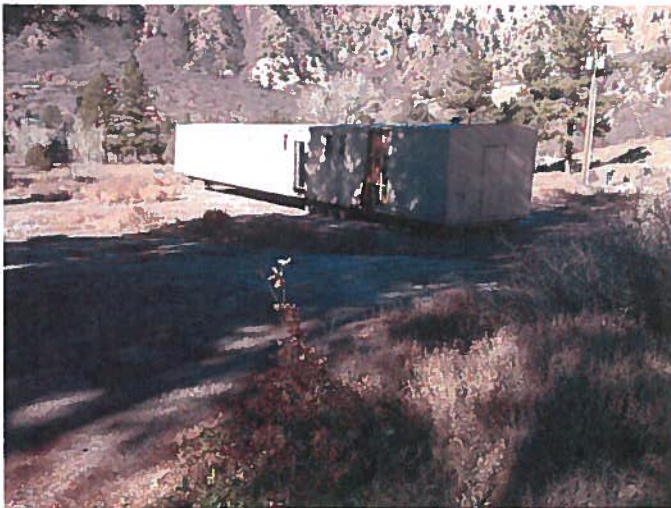
The bath house has been disconnected from power and staged for removal. The various refuse and debris, that was located outside the bath house, and the flat-bed gooseneck trailer has been removed from the area. The "temporary" stockpile of material, which was addressed through TR-2 in 2004, was still located in the southeast part of the conifer grove.

Figure 3: Bathhouse staged for removal in parking/staging area on south side of FR 310.

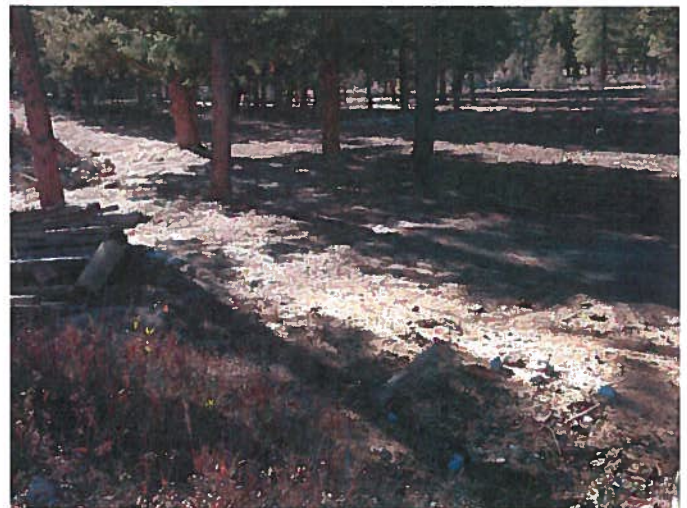
Figure 4: Prior location of bathhouse cleaned up.
