COLORADO DIVISION OF RECLAMATION, MINING AND SAFETY
MINERALS PROGRAM INSPECTION REPORT
PHONE: (303) 866-3567

MINE NAME: Gentz Gravel Pit	MINE/PROSPECTING ID#: M-1983-116	MINERAL: Sand and gravel	COUNTY: Prowers
INSPECTION TYPE: Monitoring	INSPECTOR(S): Tyler V. O'Donnell	INSP. DATE: October 3, 2013	INSP. TIME: 16:00
OPERATOR: Kiowa County	OPERATOR REPRESENTATIVE: Jack Howard	TYPE OF OPERATION: 110c - Construction Limited Impact

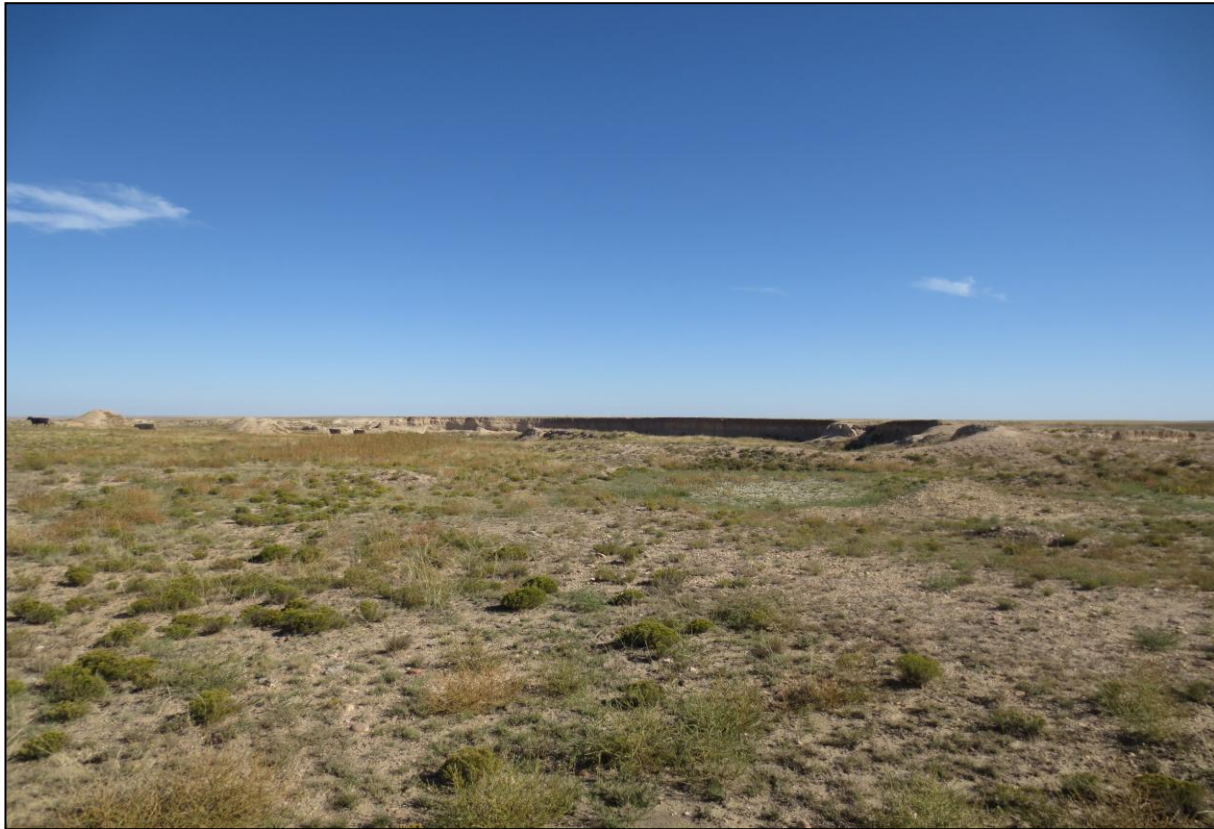
The pit has a highwall that is estimated to be 550 ft long, with an average estimated height of 15 ft.

Photo 1: View looking southeast, highwall in the background.

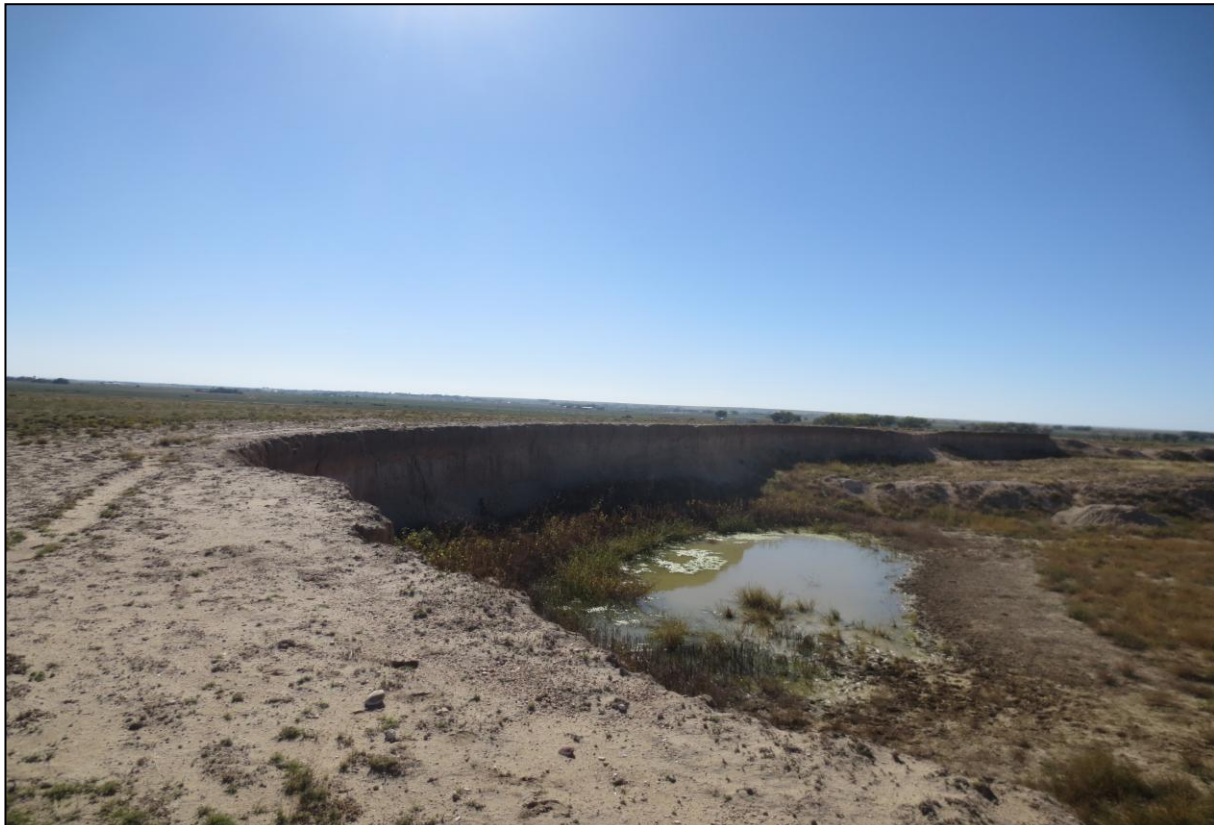
Please be advised that the Division of Water Resources requires all storm water to either infiltrate or be released within 72 hours of a rainfall event.

Photo 2: The pit highwall, storm water was from a recent storm event.

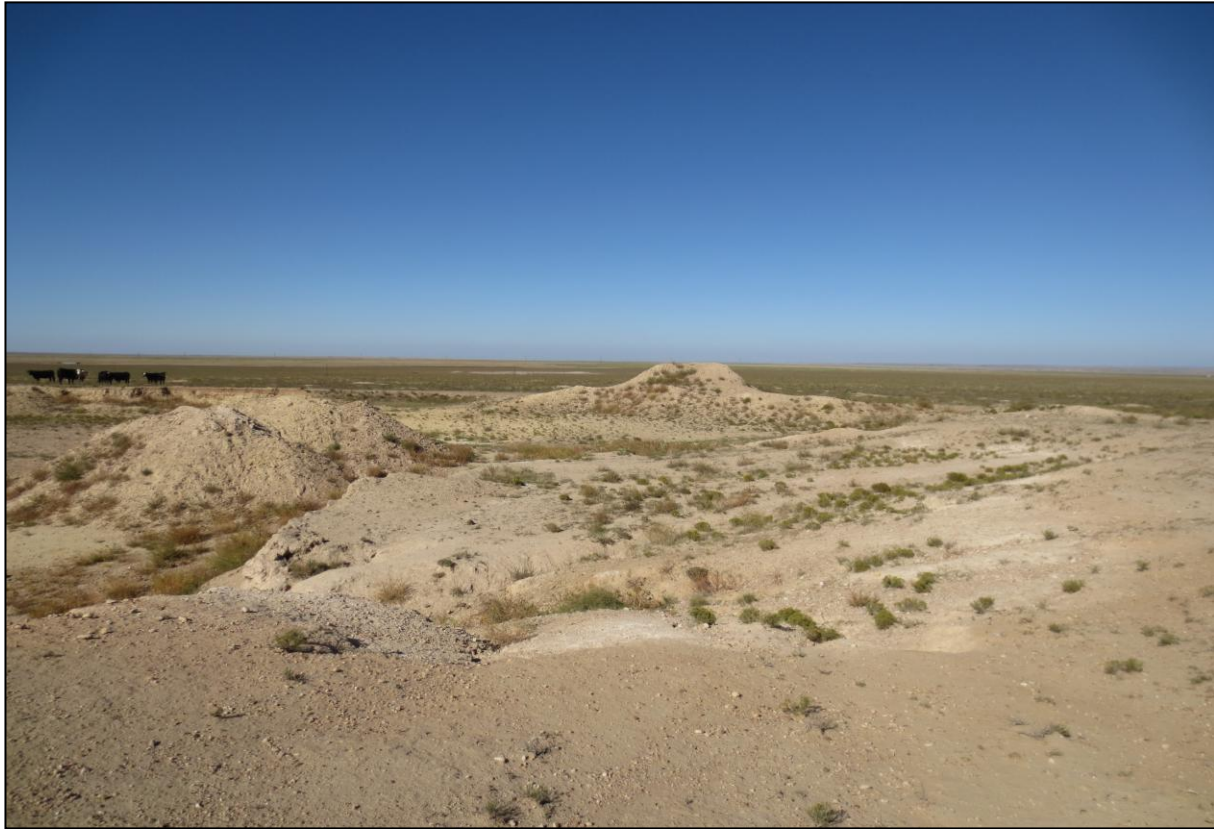
Topsoil stockpiles are located along the eastern side of the pit.

Photo 3: Product stockpile in the foreground and topsoil stockpile in the background.

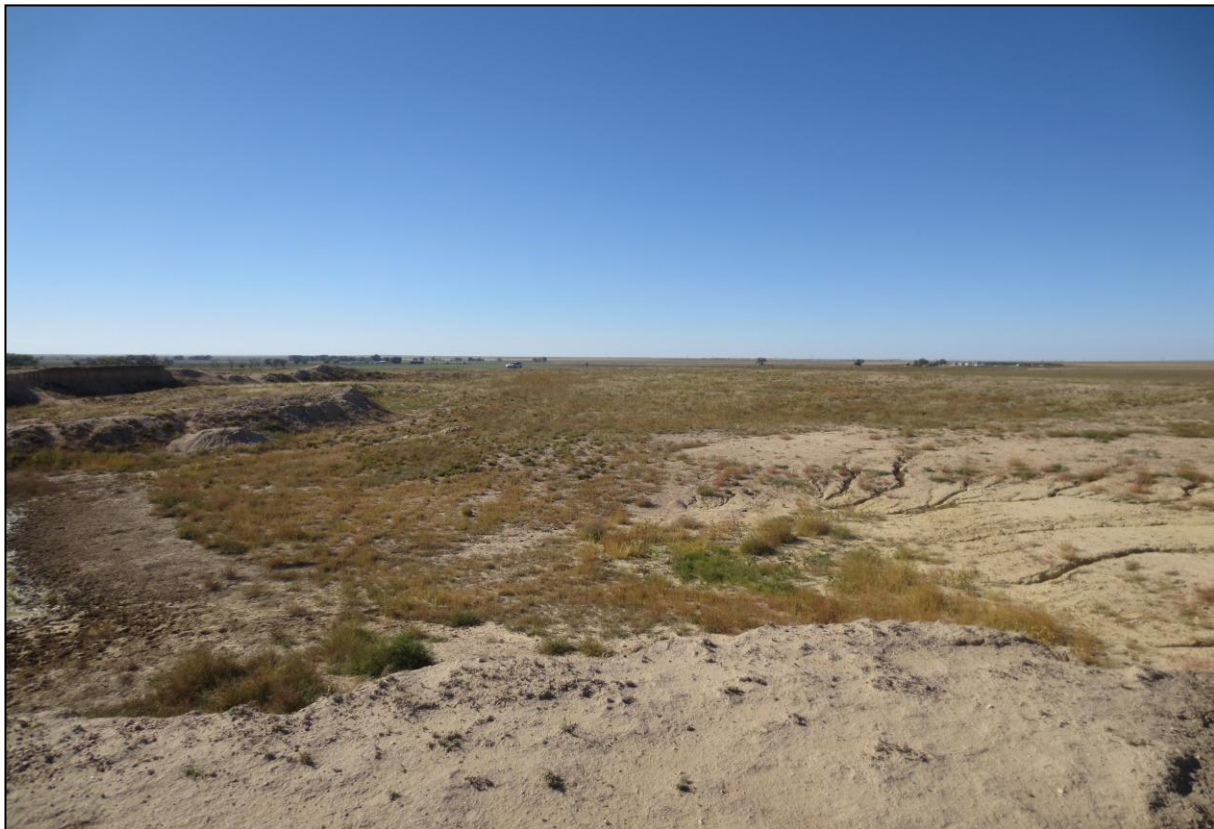
There was evidence of erosion (rills and gullies), leading into the pit however there was no off site damage caused by erosion.

Photo 4: Rills and gullies leading into the pit.
