COLORADO DIVISION OF RECLAMATION, MINING AND SAFETY
MINERALS PROGRAM INSPECTION REPORT
PHONE: (303) 866-3567

MINE NAME: JD-7 Pit	MINE/PROSPECTING ID#: M-1979-094-HR	MINERAL: Uranium and vanadium	COUNTY: Montrose
INSPECTION TYPE: Monitoring	INSPECTOR(S): Dustin Czapla	INSP. DATE: November 20, 2013	INSP. TIME: 1230
OPERATOR: Cotter Corporation	OPERATOR REPRESENTATIVE: Glen Williams	TYPE OF OPERATION: 112d-3 - Designated Mining Operation

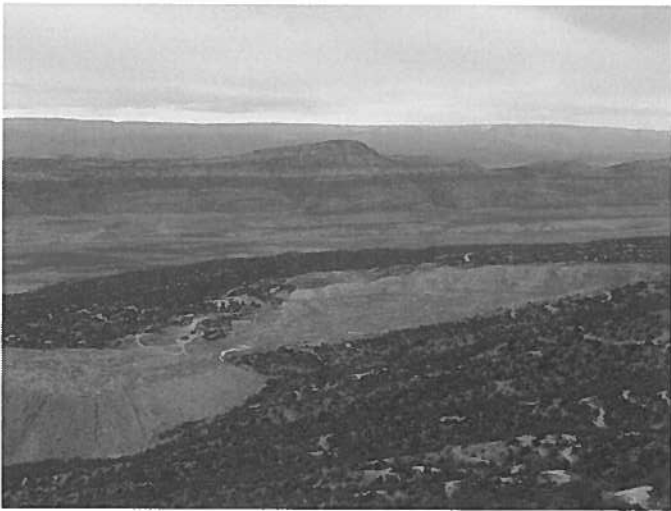
The pit floor and dump area to the west appeared to be well vegetated and stable. A benched highwall, with overall slopes approximately 1H:1V, was located on the east side of the pit. No major stability issues were noted during this inspection. Slopes at the west end of the dump area have been reclamation graded and vegetated.

Figure 1: View facing north toward the site, from DD19 Road. Waste dump is shown in the left, and the pit area in the right.

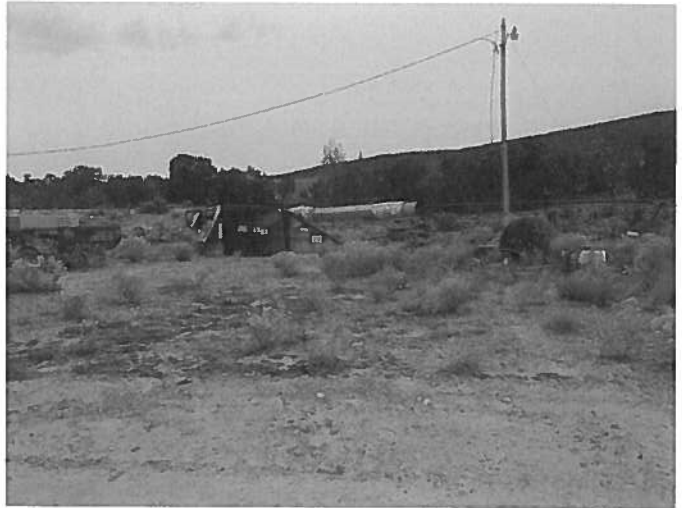
Various mine equipment and debris was noted around the area of the mine office/shop located near the JD-7 Underground portal. Settling ponds are located just west of the office area.

Figure 2: JD-7 underground portal area.

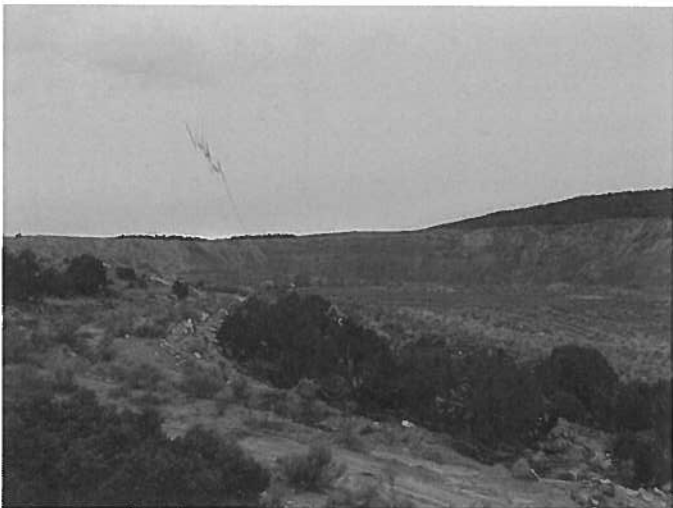
Figure 3: View towards the highwall from the northwest end of the pit.

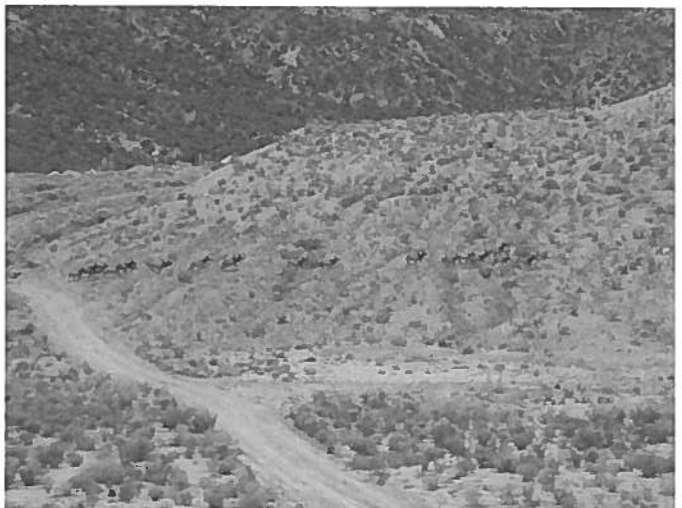
Figure 4: View toward the waste dump. Approximately twenty elk were seen crossing the pile during the inspection.

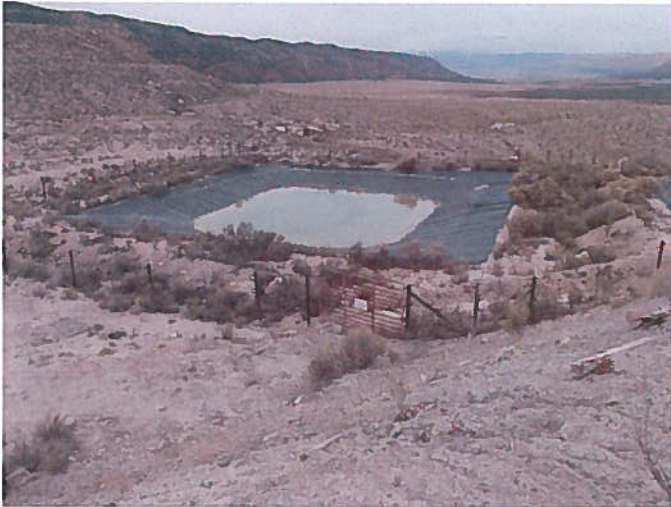
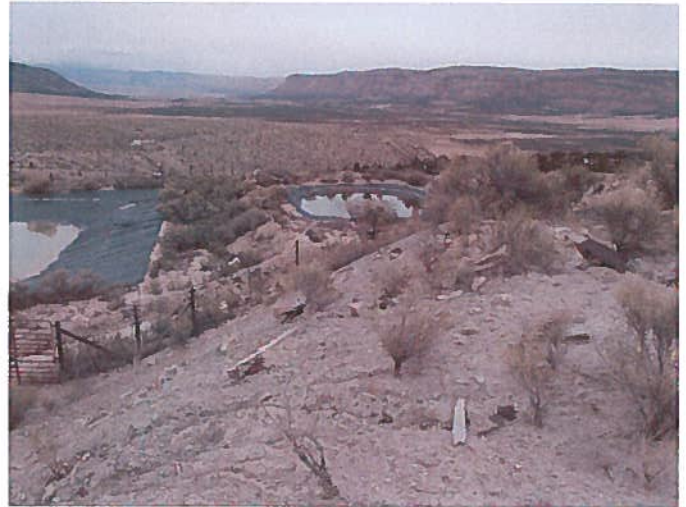
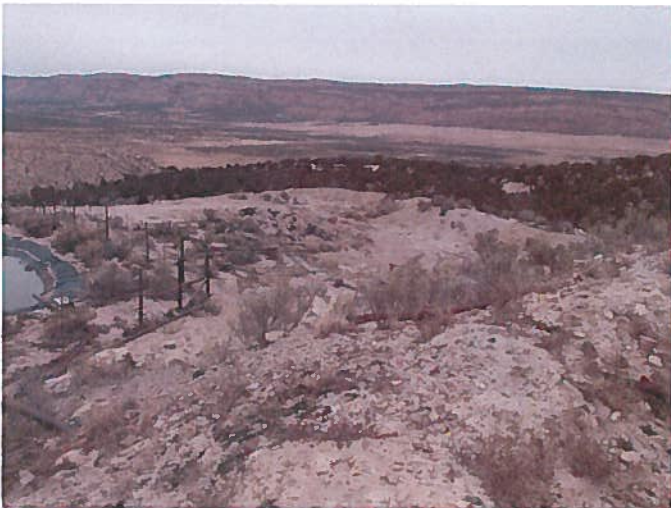
Figure 5: Retention ponds.

Figure 6: Retention ponds.

Figure 7: Retention ponds.

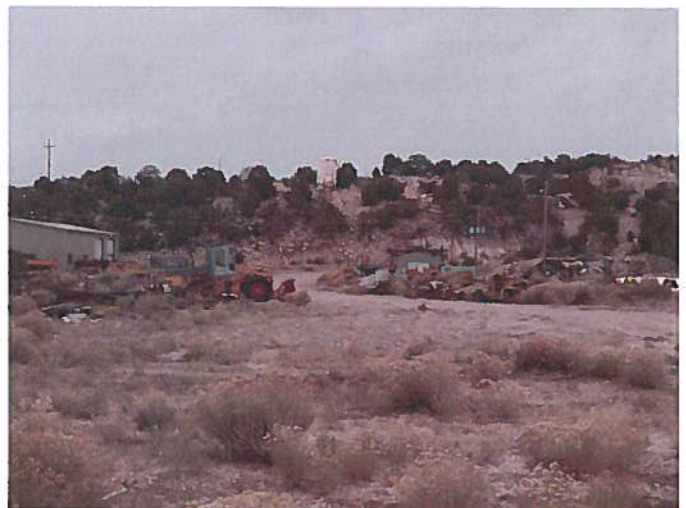
Figure 8: Shop area.
