**COLORADO DIVISION OF RECLAMATION, MINING AND SAFETY
MINERALS PROGRAM INSPECTION REPORT
PHONE: (303) 866-3567**

MINE NAME: C-JD-8	MINE/PROSPECTING ID#: M-1984-014	MINERAL: Uranium and vanadium	COUNTY: Montrose
INSPECTION TYPE: Monitoring	INSPECTOR(S): Dustin Czapla	INSP. DATE: November 20, 2013	INSP. TIME: 1200
OPERATOR: Cotter Corporation	OPERATOR REPRESENTATIVE: Glen Williams	TYPE OF OPERATION: 112d-1 - Designated Mining Operation

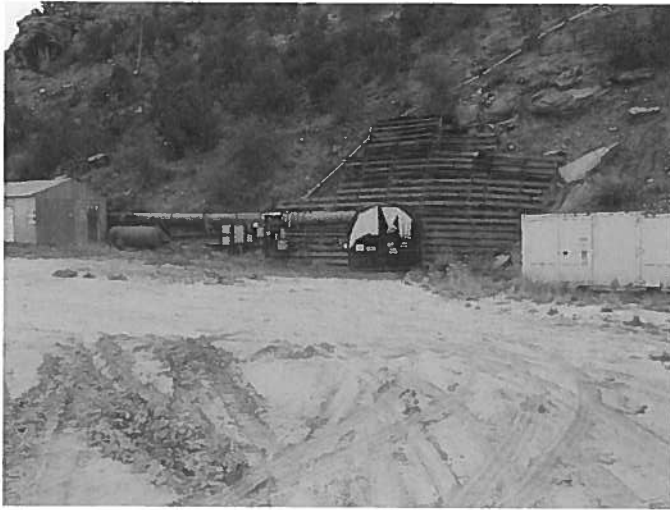
Figure 1: JD-8 portal

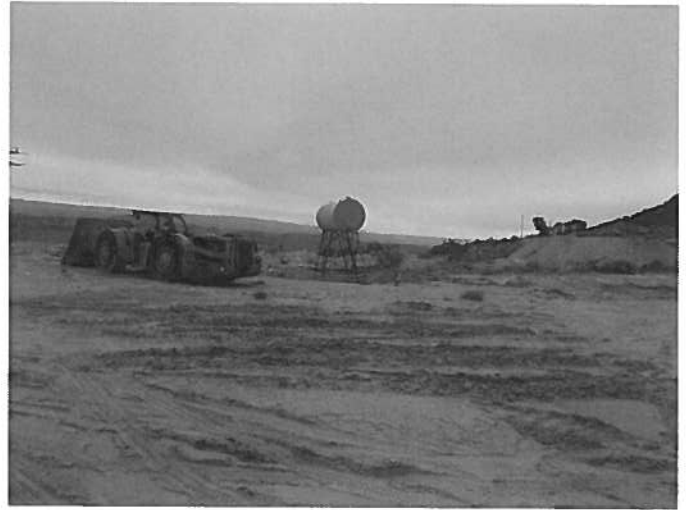
An office building, compressor building and ventilation system was in place on the main mine bench. Mining equipment was located at the site. An empty fuel tank was observed on the mine bench.

Figure 2: Operations area on mine bench.

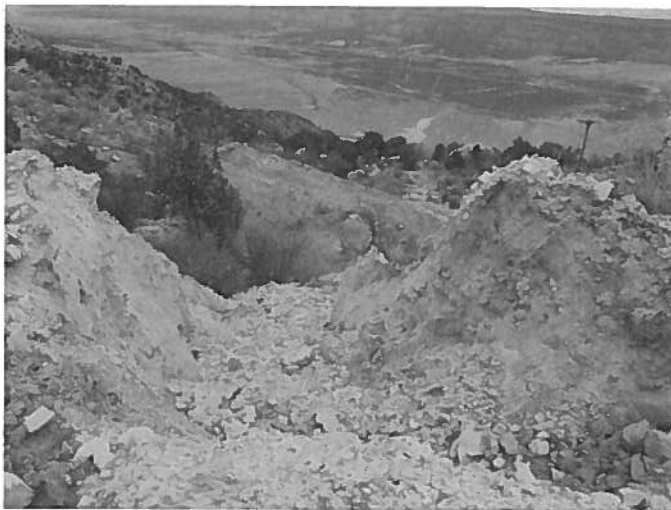
The sites storm water control system appeared to be effective. Some erosion was noted above the west retention pond, which occurred during the heavy rain events this fall.

Figure 3: Erosion occurred during fall precipitation event above west retention pond.

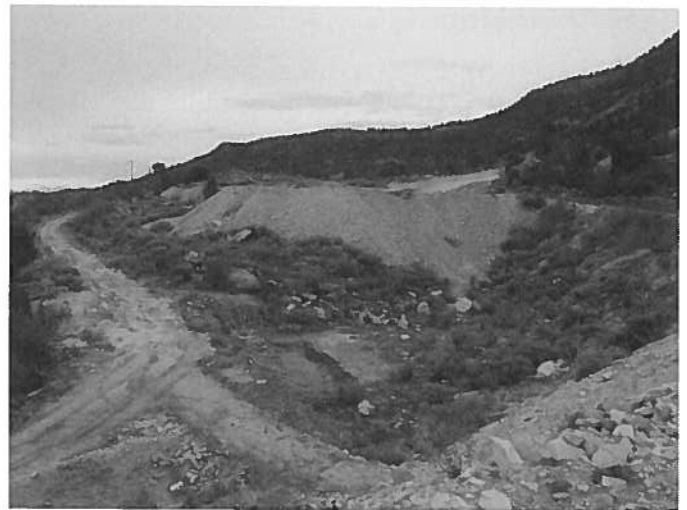
Figure 4: Sediment retention pond on east side of mine bench.
