COLORADO DIVISION OF RECLAMATION, MINING AND SAFETY
MINERALS PROGRAM INSPECTION REPORT
PHONE: (303) 866-3567

MINE NAME: C-LP-21 Mine	MINE/PROSPECTING ID#: M-1977-305	MINERAL: Uranium and vanadium	COUNTY: Montrose
INSPECTION TYPE: Monitoring	INSPECTOR(S): Dustin Czapla	INSP. DATE: November 20, 2013	INSP. TIME: 1400
OPERATOR: Cotter Corporation	OPERATOR REPRESENTATIVE: Glen Williams	TYPE OF OPERATION: 112d-1 - Designated Mining Operation

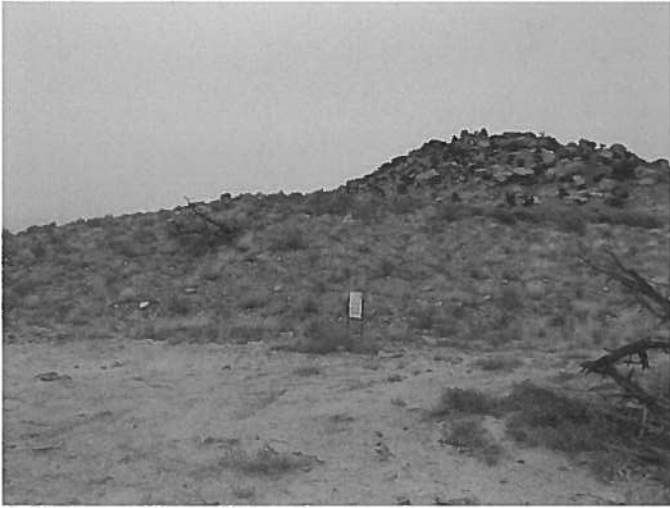
All reclaimed slopes at the site appeared stable. Vegetation was well established over the reclaimed areas.

Figure 1: View toward the reclaimed waste pile.

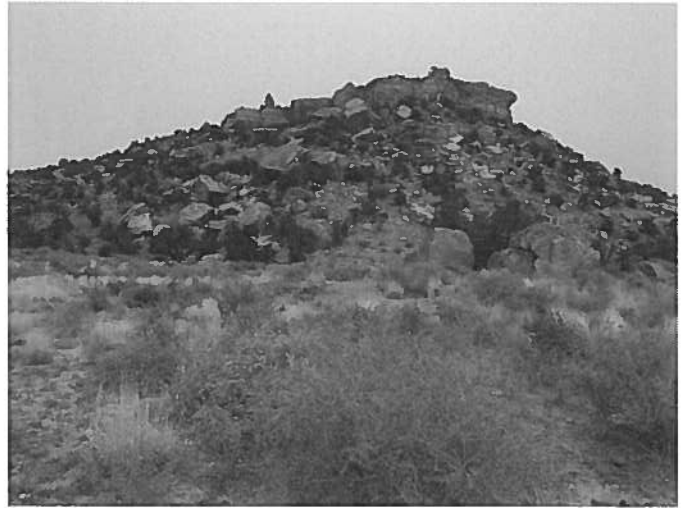
Figure 2: View toward the reclaimed portal.
