COLORADO DIVISION OF RECLAMATION, MINING AND SAFETY
MINERALS PROGRAM INSPECTION REPORT
PHONE: (303) 866-3567

MINE NAME: SR-11 Mine	MINE/PROSPECTING ID#: M-1977-451	MINERAL: Uranium and vanadium	COUNTY: San Miguel
INSPECTION TYPE: Monitoring	INSPECTOR(S): Dustin Czapla	INSP. DATE: November 19, 2013	INSP. TIME: 1200
OPERATOR: Cotter Corporation	OPERATOR REPRESENTATIVE: Glen Williams	TYPE OF OPERATION: 112d-1 - Designated Mining Operation

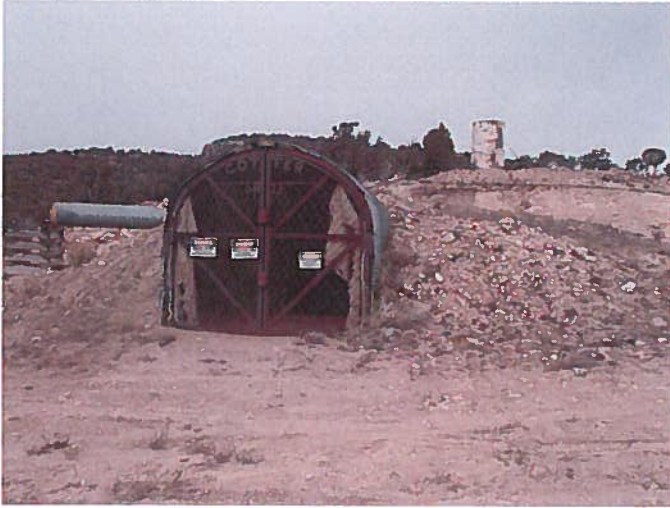
The portal was secured by a locked steel gate. A mine office building and water tank were located on site. No other structures or equipment were observed. Conditions appeared unchanged from the Division's previous inspection. Stormwater runoff is directed to and retained by a sediment pond located in the southeast corner of the site. The system appeared to be effective. No erosional issues were noted.

Figure 1: SR-11 Portal

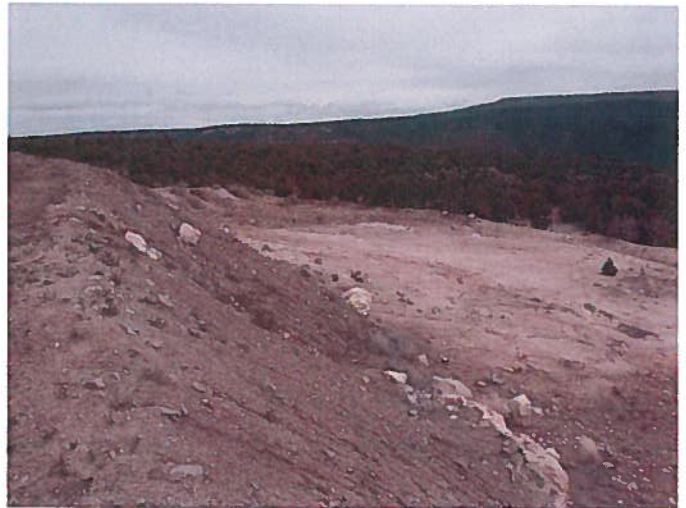
Figure 2: Sediment retention pond on south side of waste dump/mine bench.

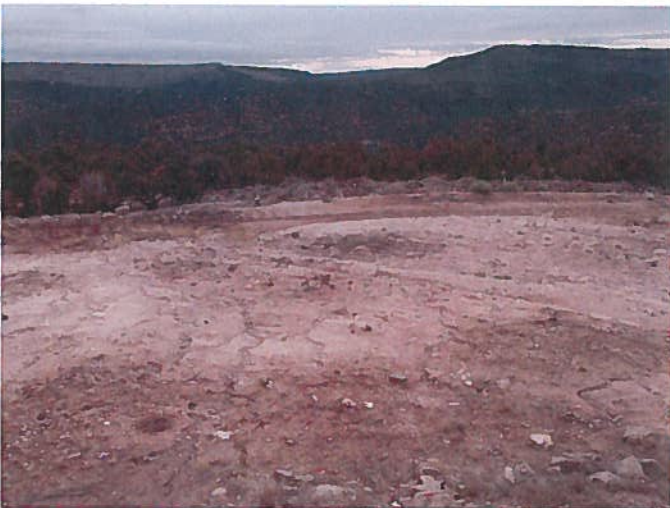
Figure 3: Sediment retention pond on south side of waste dump/mine bench.

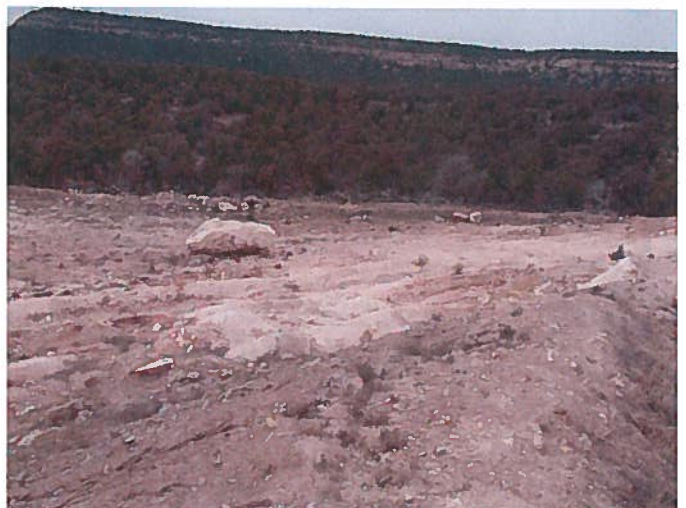
Figure 4: Sediment retention pond on south side of waste dump/mine bench.
