COLORADO DIVISION OF RECLAMATION, MINING AND SAFETY
MINERALS PROGRAM INSPECTION REPORT
PHONE: (303) 866-3567

MINE NAME: JD-9 Mine	MINE/PROSPECTING ID#: M-1977-306	MINERAL: Uranium and vanadium	COUNTY: Montrose
INSPECTION TYPE: Monitoring	INSPECTOR(S): Dustin M. Czapla	INSP. DATE: November 19, 2013	INSP. TIME: 1500
OPERATOR: Cotter Corporation	OPERATOR REPRESENTATIVE: Glen Williams	TYPE OF OPERATION: 112d-1 - Designated Mining Operation

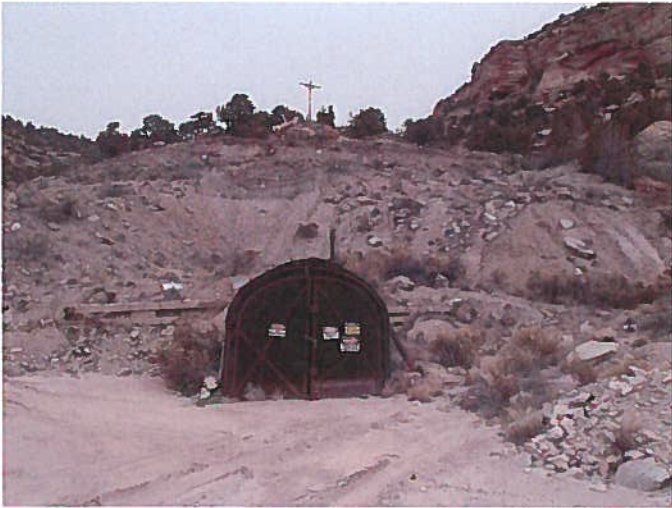
The portal in this area collapsed years ago and has not yet been reopened.

Figure 1: Collapsed portal in Bull Canyon area.

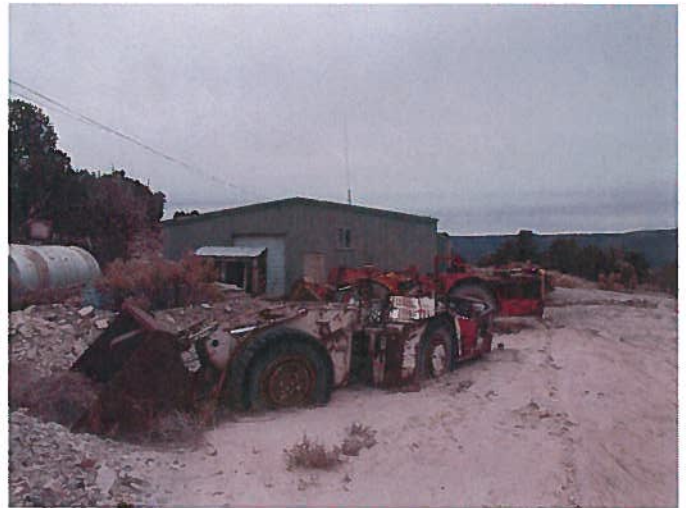
The Bull Canyon area conditions appeared unchanged from the Division's previous inspection. There is a mine building located on the main mine bench area. Several pieces of dilapidated equipment and refuse were observed around the building.

Figure 2: Bull Canyon area mine bench/operations area.

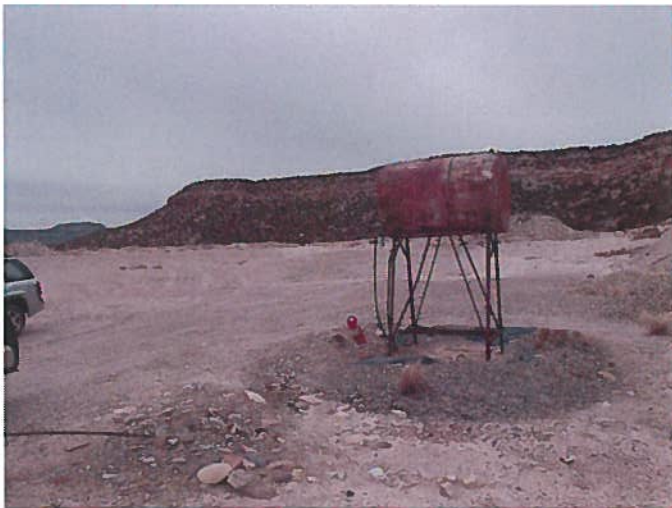
Figure 3: Bull Canyon area mine bench/operations area.

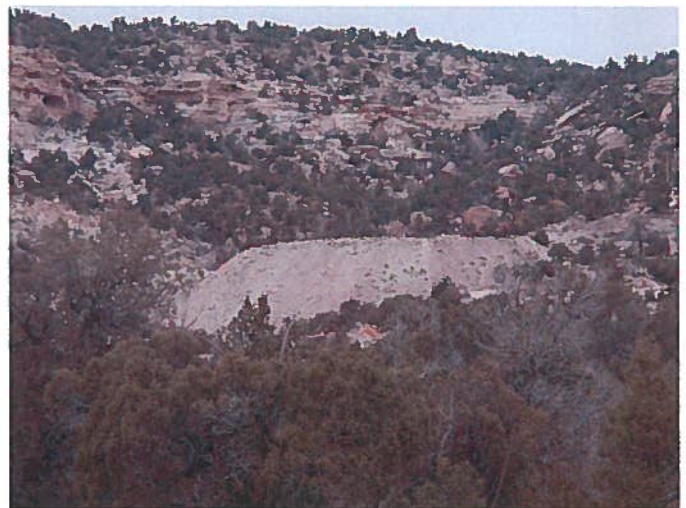
Figure 4: Bull Canyon area waste rock pile.

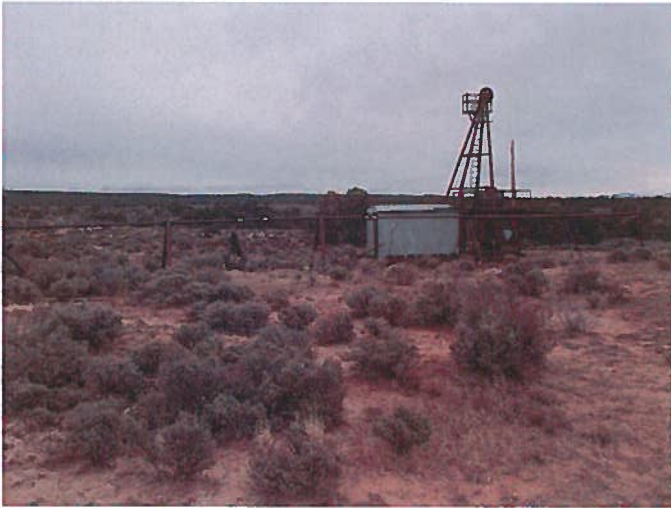
On the upper Monogram area, the vent fans were running. The water treatment plant is not currently in use. Water was noted in the two ponds on the side of the area. Facilities in this area appeared secure.

Figure 5: Upper Monogram area.

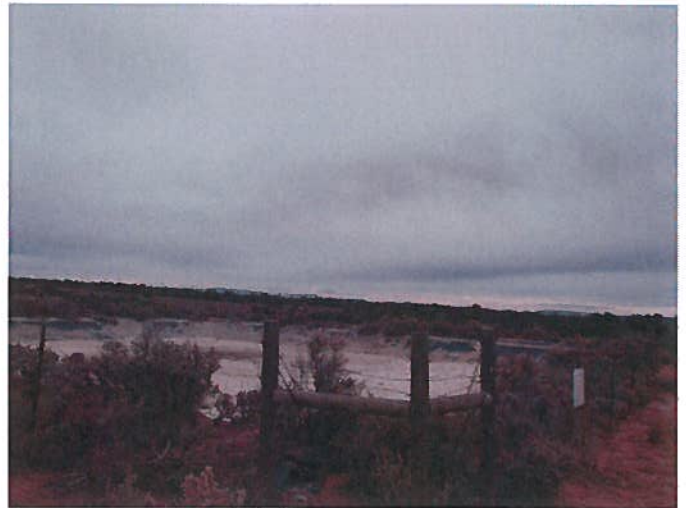
Figure 6: Upper Monogram treatment pond (easternmost).

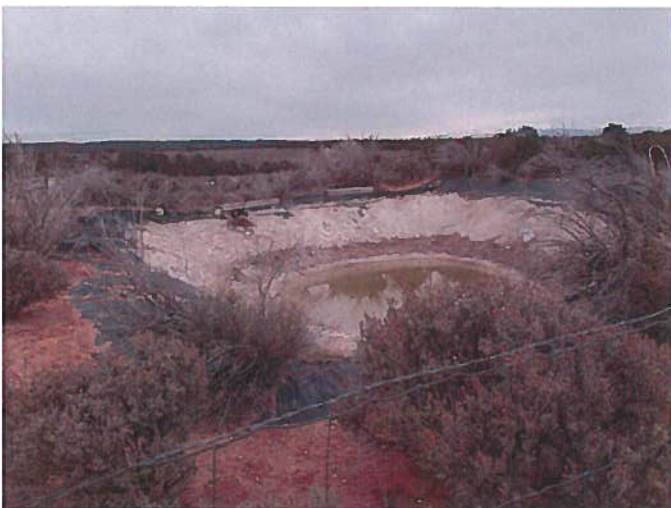
Figure 7: Upper Monogram treatment pond (central).

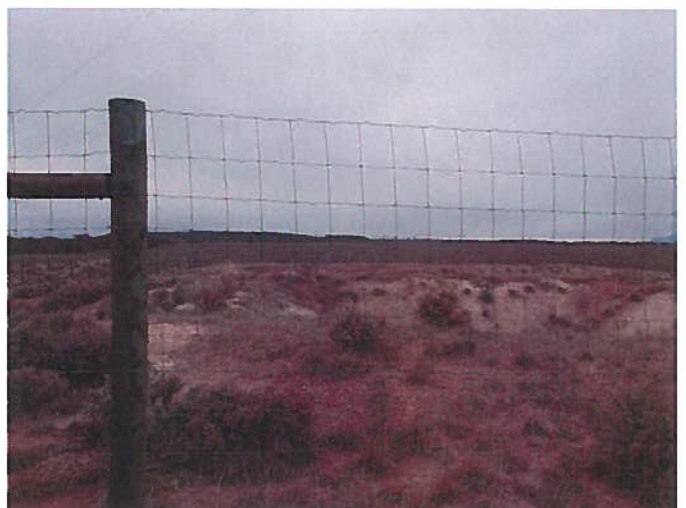
Figure 8: Upper Monogram treatment pond (westernmost).
