COLORADO DIVISION OF RECLAMATION, MINING AND SAFETY
MINERALS PROGRAM INSPECTION REPORT
PHONE: (303) 866-3567

| MINE NAME: SM-18 Mine | MINE/PROSPECTING ID#: M-1978-116 | MINERAL: Uranium and vanadium | COUNTY: Montrose |
| INSPECTION TYPE: Monitoring | INSPECTOR(S): Dustin Czaplá | INSP. DATE: November 19, 2013 | INSP. TIME: 0930 |

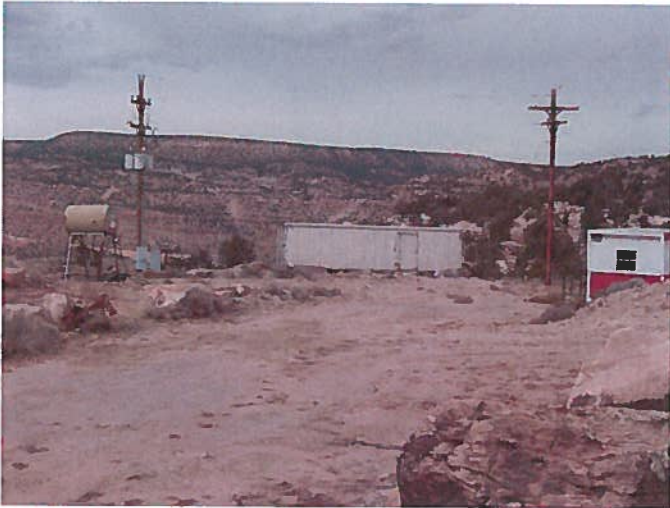
Figure 1: Operations area above Wright Portal.

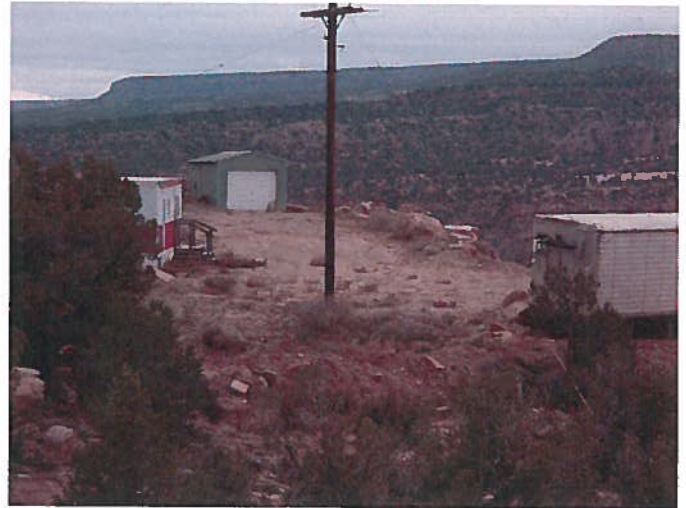
Figure 2: Operations area above Wright Portal.

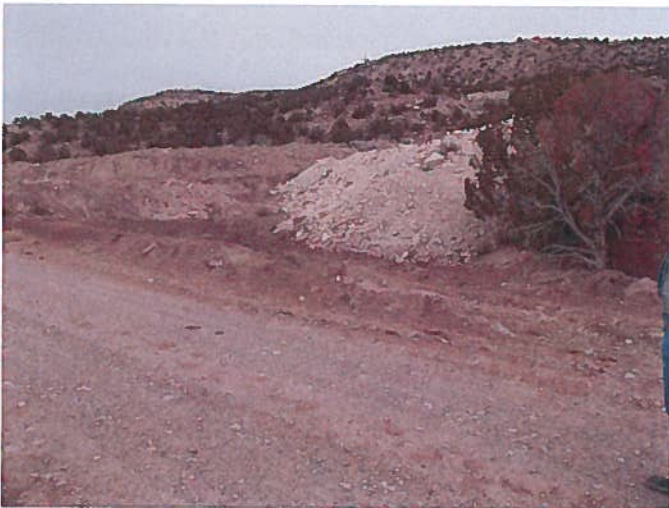
Figure 3: Waste dump area.

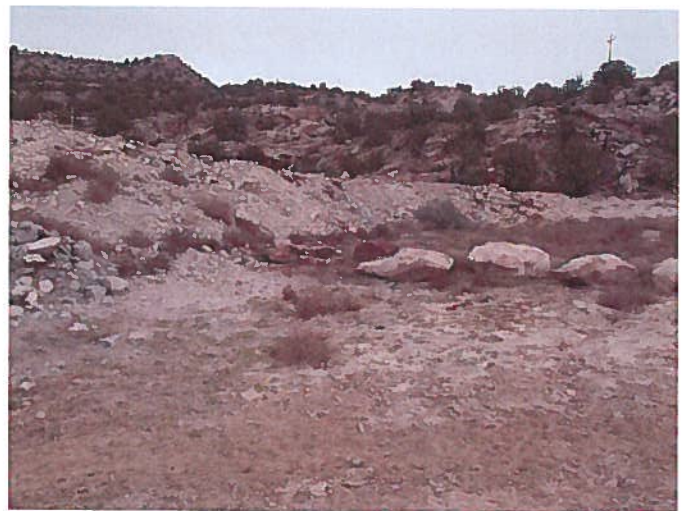
Figure 4: Waste dump area.
