**COLORADO DIVISION OF RECLAMATION, MINING AND SAFETY
COAL PROGRAM INSPECTION REPORT**

Permit Number: C-1981-010 Mine Name: Trapper Mine Operator: Trapper Mining, Inc. Operator Address: Mr. Forrest Luke P.O. Box 187 Craig, CO 81626	County: Moffat Operation Type: Surface Permit Status: Active Ownership: Federal
	Operator Representative Present: Graham Roberts
Operator Representative Signature: (Field Issuance Only)

Inspection Start Date: November 20, 2013 Inspection Start Time: 07:45 Inspection End Date: November 21, 2013 Inspection End Time: 12:45		Inspection Type: Coal Complete Inspection Inspection Reason: Surety Related Weather: Cloudy	
Joint Inspection Agency: OSM Colorado State Land Board		Joint Inspection Contacts: Christine Belka and Spencer Shumate with OSM. Jerod Smith, Colorado State Land Board.	
Post Inspection Agency: OSM Colorado State Land Board		Post Inspection Contacts: Christine Belka and Spencer Shumate with OSM. Jerod Smith, Colorado State Land Board.	
Inspector(s): Jared L. Ebert	Inspector's Signature:

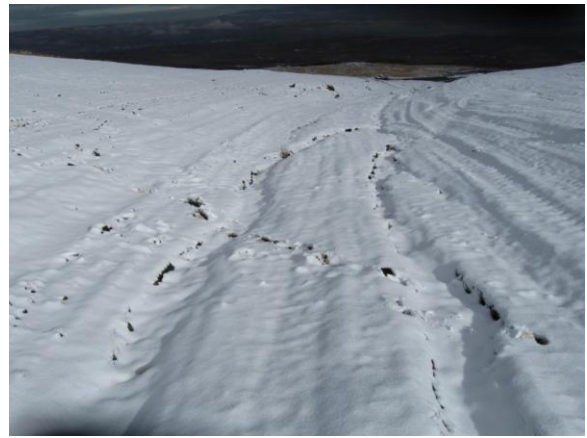
Small tributary to Oak Gulch

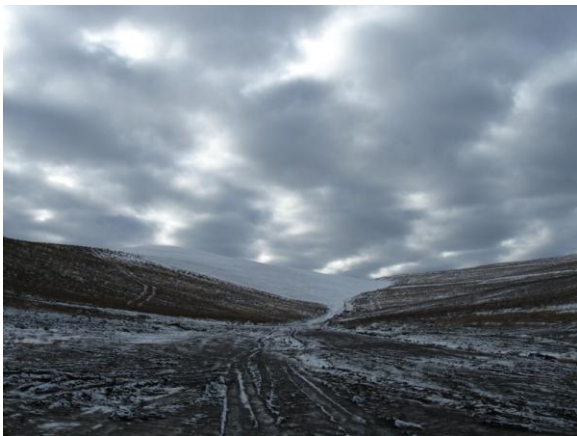
Parcel Z-A-13; top right snow covered land.
