COLORADO DIVISION OF RECLAMATION, MINING AND SAFETY COAL PROGRAM INSPECTION REPORT

Permit Number: C-1981-035 Mine Name: King Coal Mine Operator: GCC Energy, LLC Operator Address: Mr Tom Bird 6473 County Road 120 Hesperus, CO 81326	County: La Plata Operation Type: Underground Permit Status: Active Ownership: Federal
	Operator Representative Present: None
Operator Representative Signature: (Field Issuance Only) This report was issued electronically from the Division's Durango Field Office.

Inspection Start Date: November 29, 2013 Inspection Start Time: 10:20 Inspection End Date: November 29, 2013 Inspection End Time: 10:55		Inspection Type: Coal Partial Inspection Inspection Reason: Normal I&E Program Weather: Clear	
Joint Inspection Agency: None		Joint Inspection Contacts:	
Post Inspection Agency: None		Post Inspection Contacts:	
Inspector(s): Marcia L. Talvitie, P.E.	Inspector's Signature:

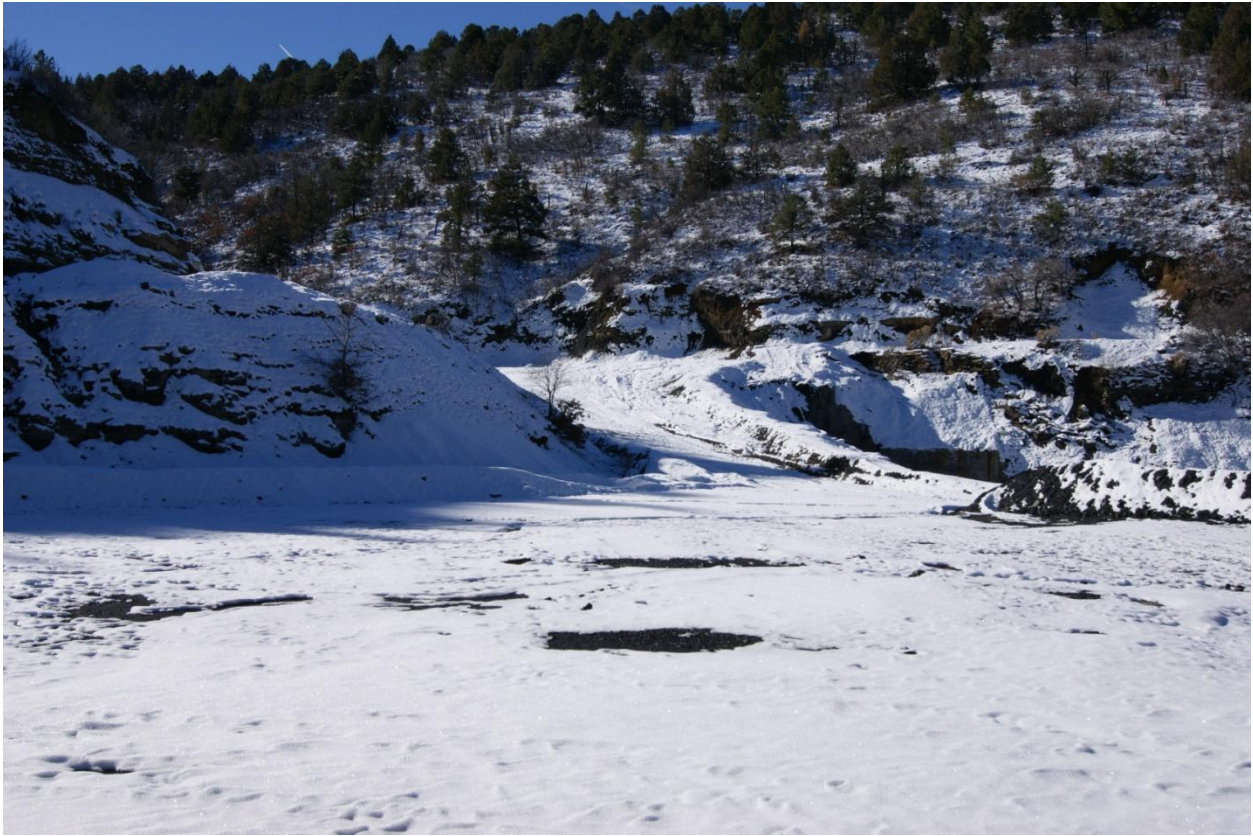
- At the King I area, the areas proposed for the West Waste Bank and coal storage were graded smooth, and were clear of coal mine waste, A think blanket of snow covered the ground.
- Access to the Valley-Fill refuse pile at King I was not attempted.

Looking SW across proposed Coal Storage Area; shop bench in upper left

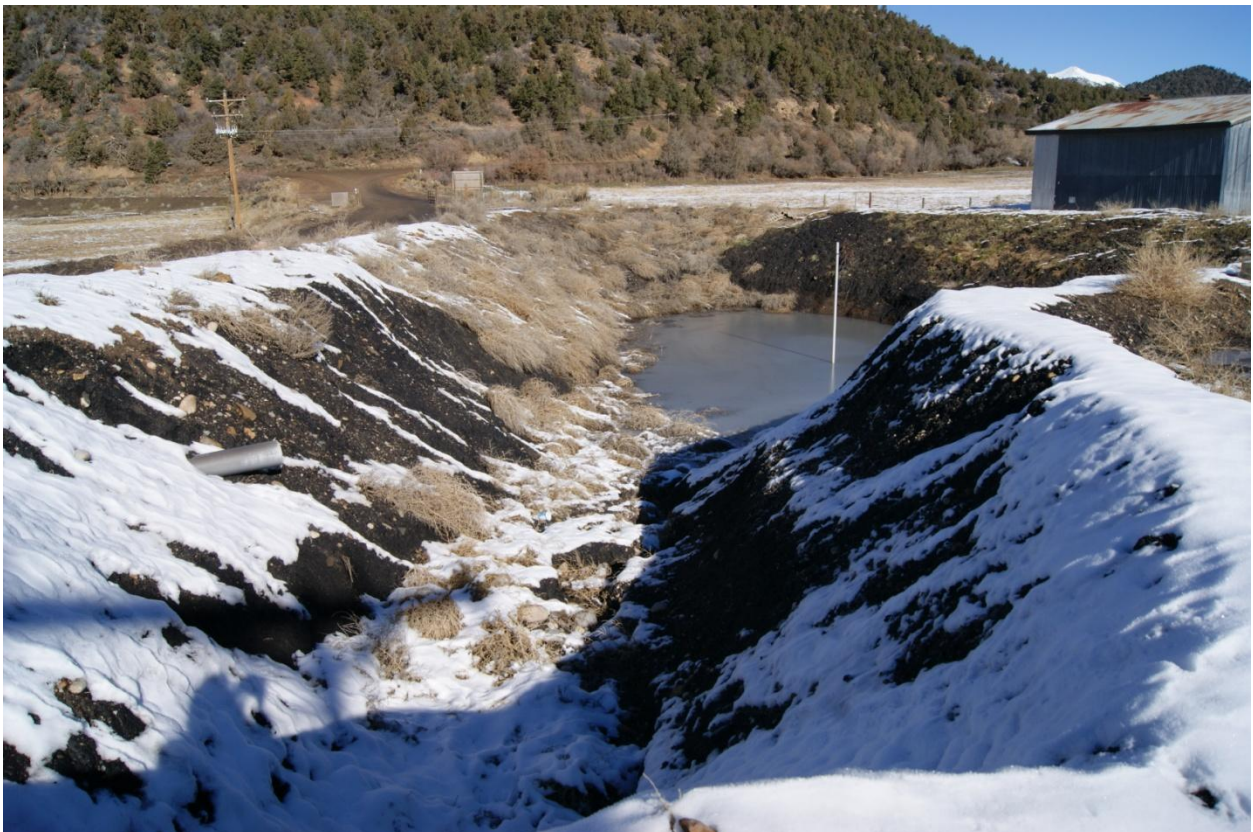
- The East and West Ponds at King I both held some water. The pond surfaces were frozen.
- At King II, the sediment pond held a shallow pool of water (also frozen) in its southern half, near the spillway structure.

King I East Sedimentation Pond, looking NE

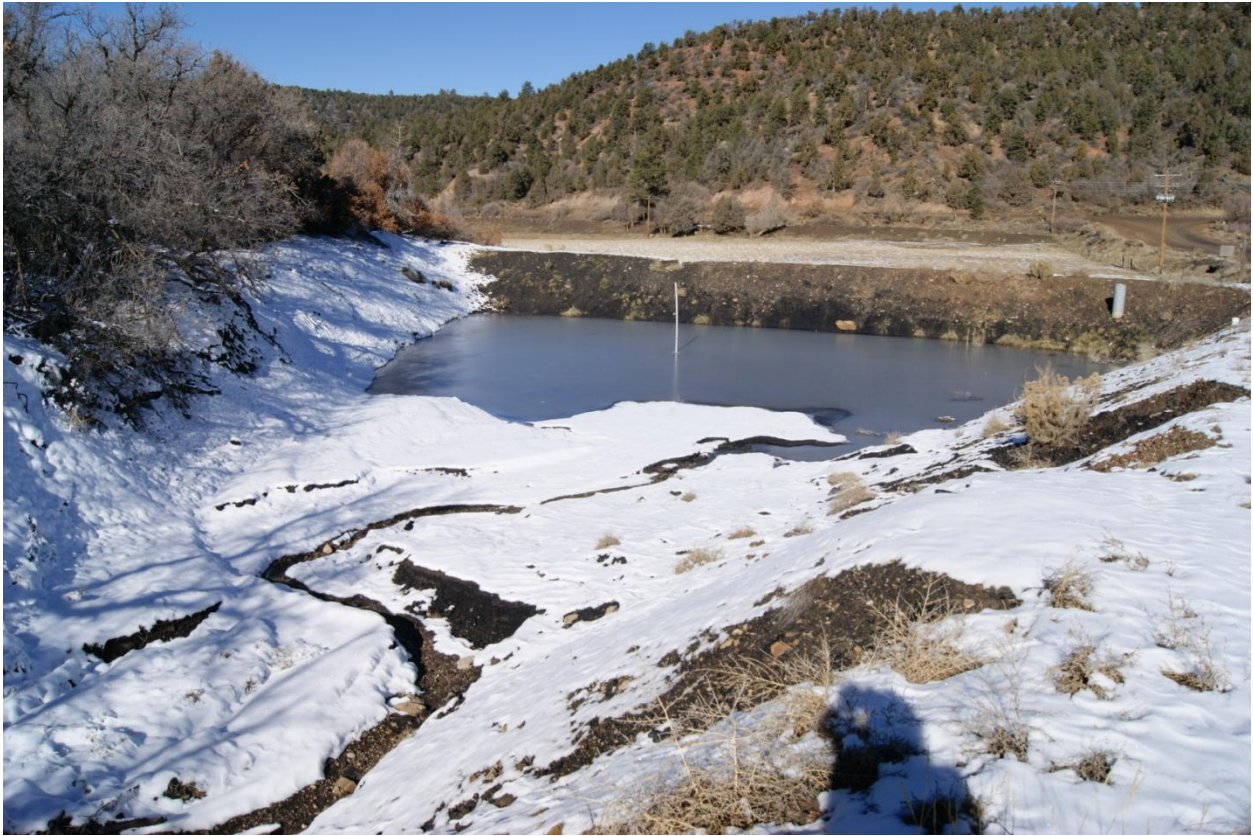
King I West Sedimentation Pond, looking N

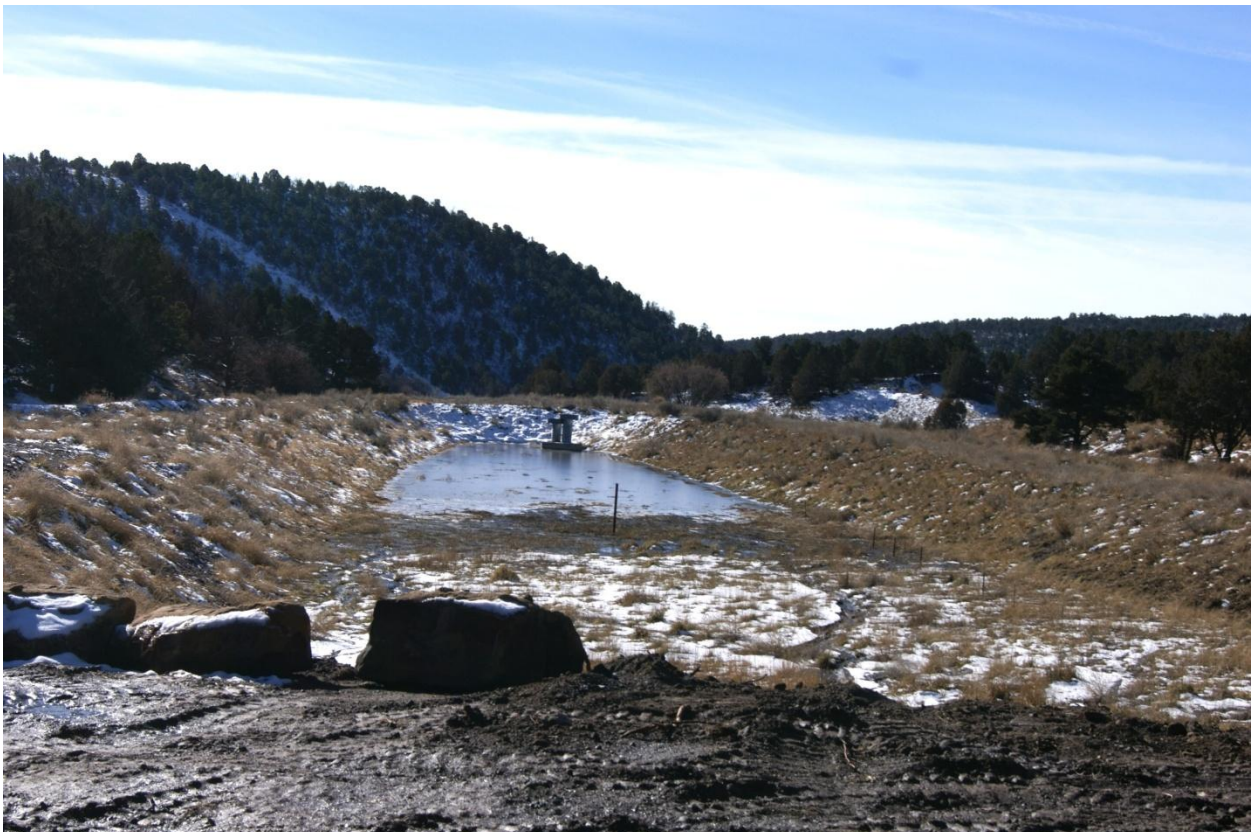
King I Sedimentation Pond, looking S
