**COLORADO DIVISION OF RECLAMATION, MINING AND SAFETY  
COAL PROGRAM INSPECTION REPORT**

<b>Permit Number:</b> C-1980-007 <b>Mine Name:</b> West Elk Mine <b>Operator:</b> Mountain Coal Company, LLC <b>Operator Address:</b> Ms Kathleen G Welt P.O. Box 591 Somerset, CO 81434	<b>County:</b> Delta, Gunnison <b>Operation Type:</b> Underground <b>Permit Status:</b> Active <b>Ownership:</b> Federal
<b>Operator Representative Present:</b>  Jessica Loveland	
<b>Operator Representative Signature: (Field Issuance Only)</b>  N/A – Report Issued from Denver Office

<b>Inspection Start Date:</b> November 19, 2013 <b>Inspection Start Time:</b> 08:00 <b>Inspection End Date:</b> November 19, 2013 <b>Inspection End Time:</b> 13:30	<b>Inspection Type:</b> Coal Complete Inspection <b>Inspection Reason:</b> Normal I&E Program <b>Weather:</b> Clear
<b>Joint Inspection Agency:</b>  None	<b>Joint Inspection Contacts:</b>
<b>Post Inspection Agency:</b>  None	<b>Post Inspection Contacts:</b>
<b>Inspector(s):</b>  James R. Stark	<b>Inspector's Signature:</b>

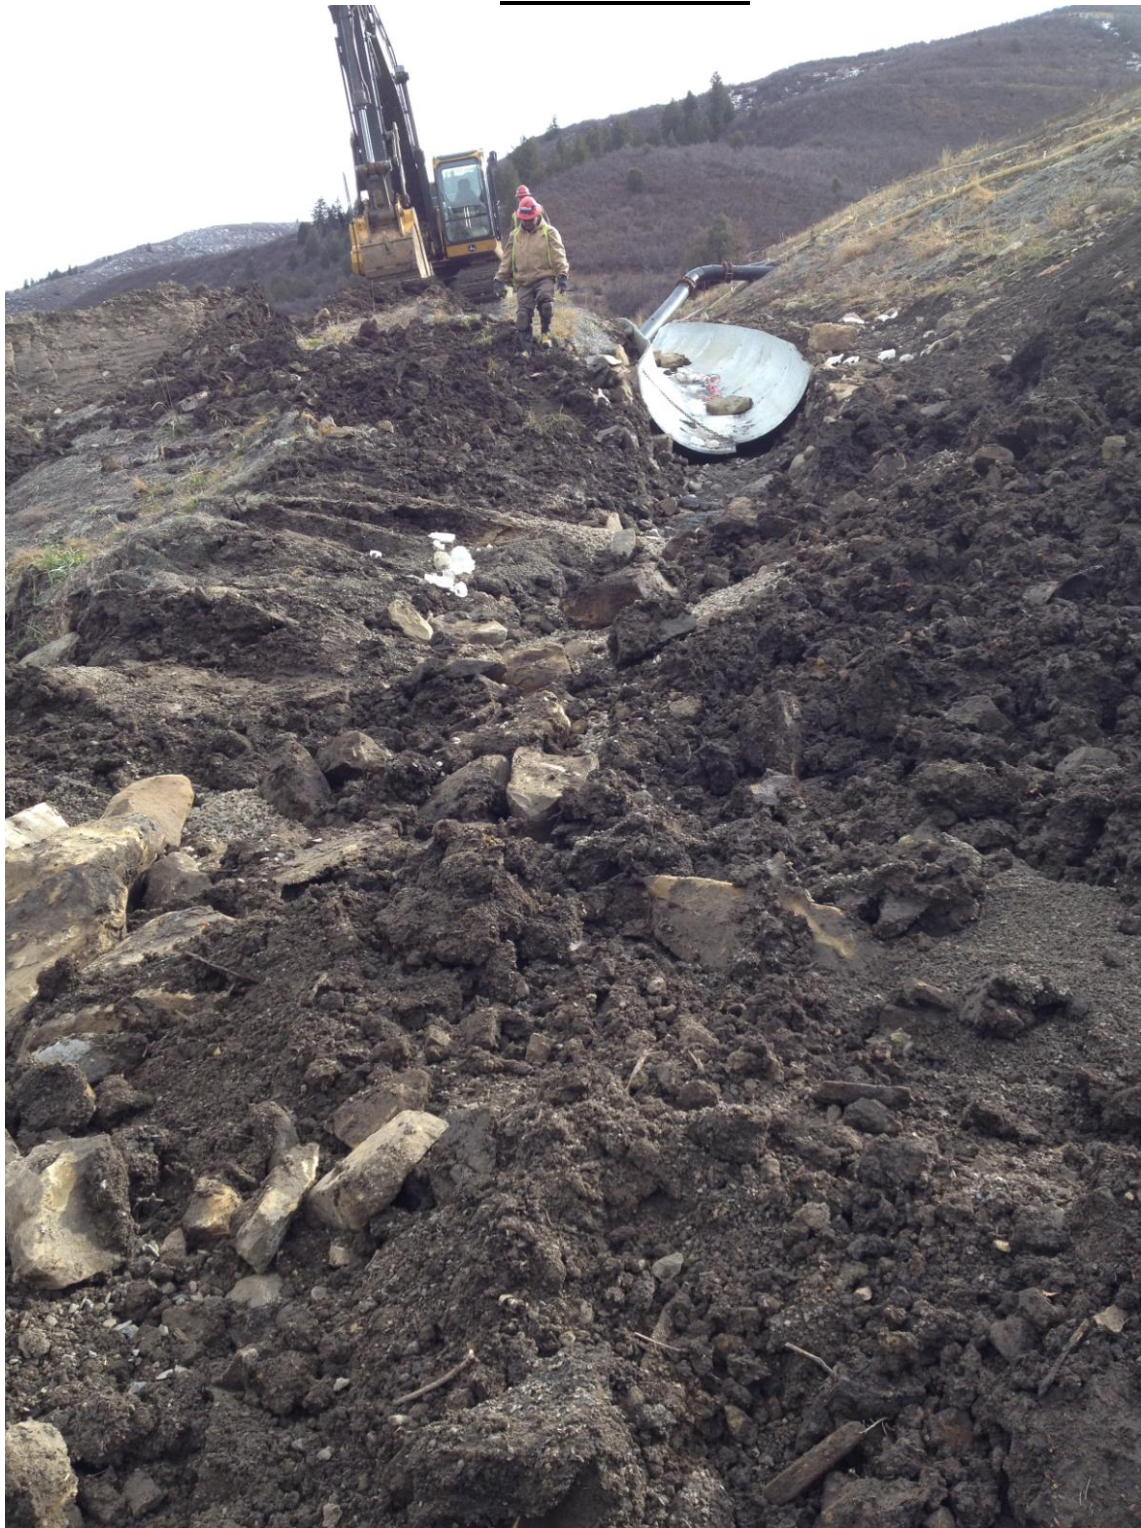
- West Elk was working on replacing the lower portion of the half-culvert for the RPEE sediment control ditch. The portion that is being replaced is the portion that flows into the RPE pond to a point just above the highest French drain outlet. The ditch is being changed from the half-culvert to an open, riprapped channel. The first 3-4 sections of the culvert were removed at the time of the inspection. The operator will leave the bentonite mat that is currently under the half-culvert. There will also be a layer of gravel or crushed rock to help lock in/stabilize the riprap and channel. This riprapped channel will help with the overall stability of the RPEE ditch. West Elk needs to make sure that the correct size of riprap is used in the channel. This ditch modification was approved with Minor Revision 401.

RPEE sediment ditch work

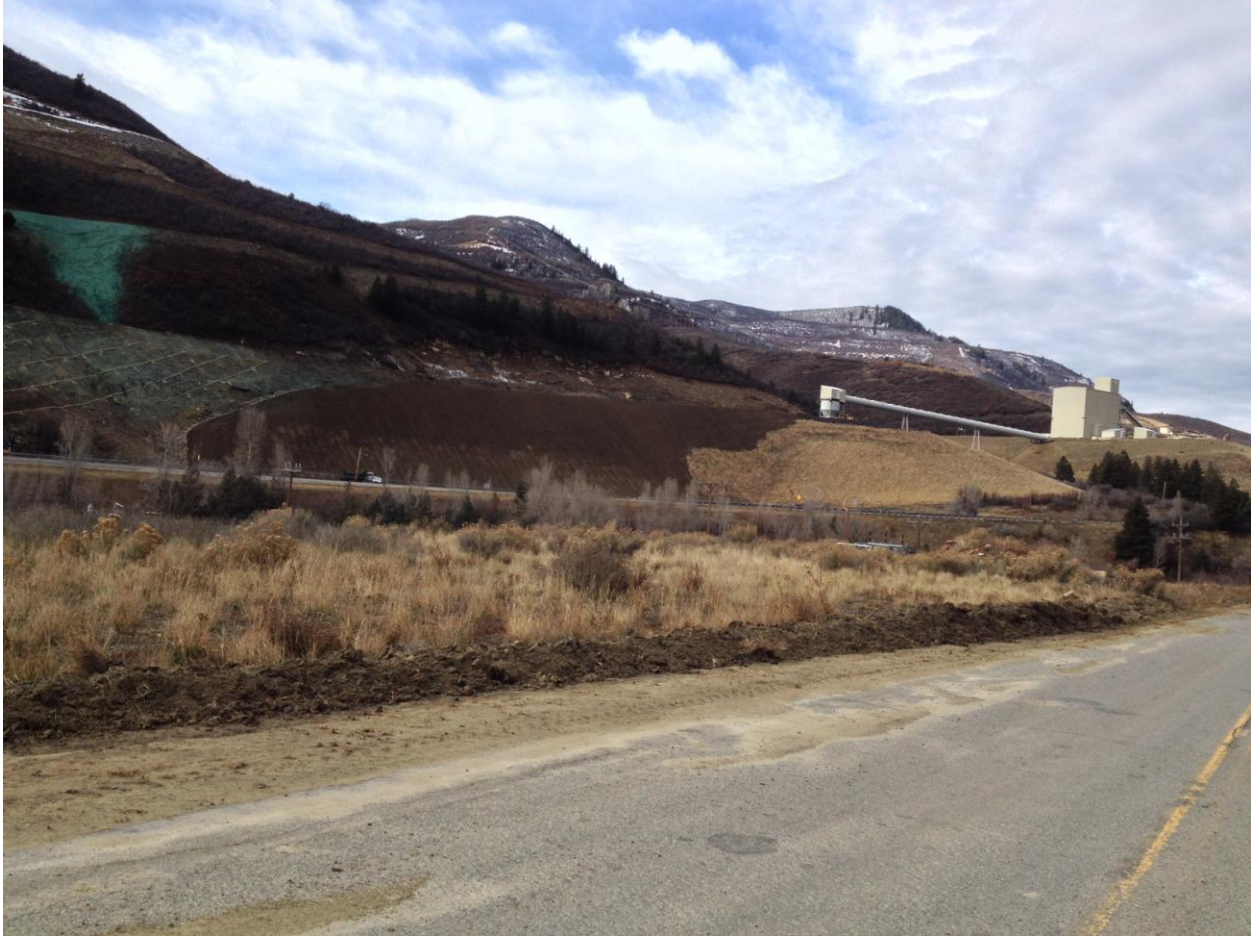
- West Elk has completed the subsoil and topsoil replacement on the outslopes of the RPE. These areas have been graded to a slope of approximately 40%, which is the slope that is in the approved permit. A contractor was working on completing hydroseeding on the RPEE at the time of the inspection. The surface of the RPE was well graded and stable at the time of the inspection. There is positive drainage on the pile and there are was no water pooling on the surface. the surface of the pile is being used to store equipment (trucks, excavators, compactors, etc.) that are being used for the RPE and RPEE.

Regraded RPE slopes prior to hydroseeding

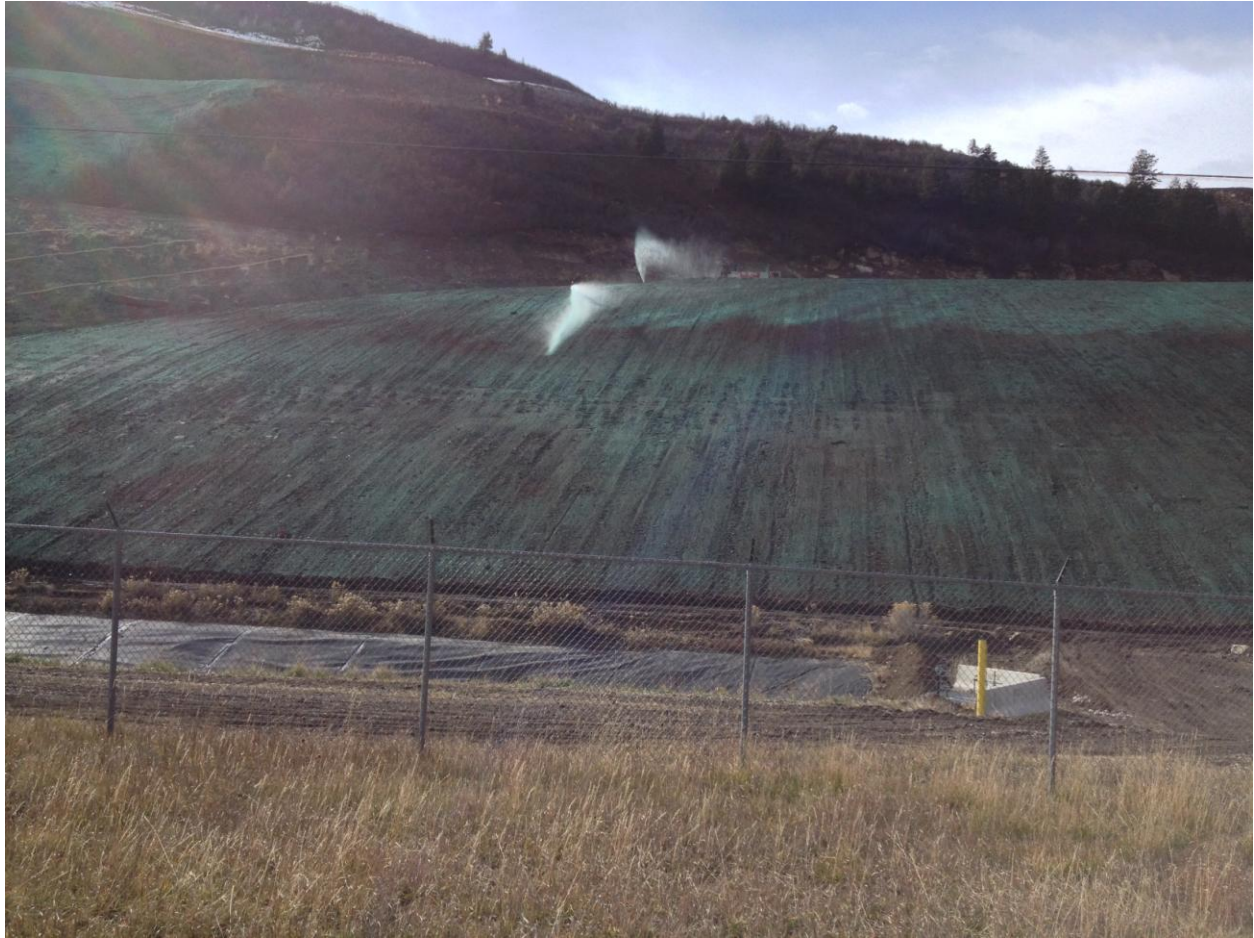
Hydroseeding RPE

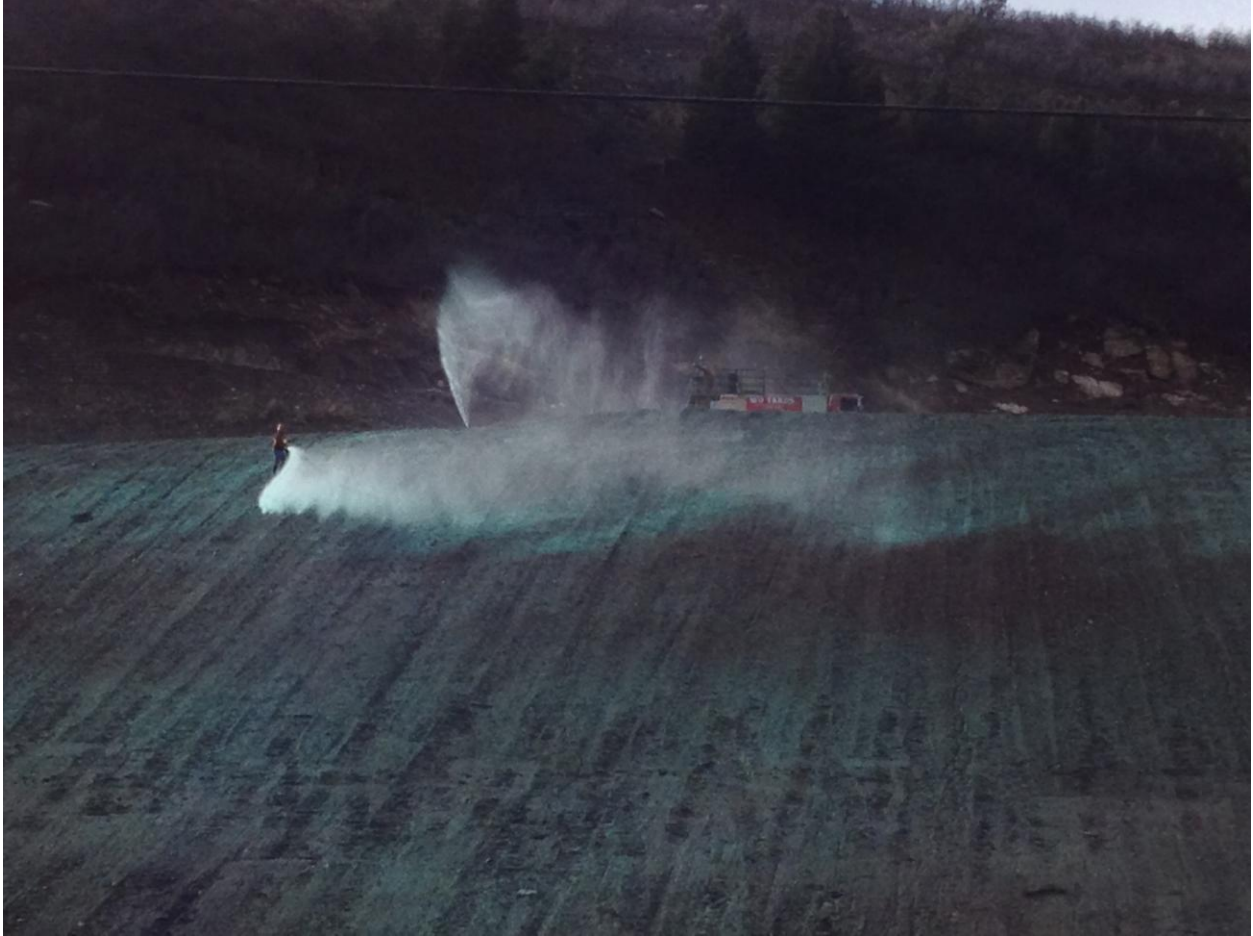
Hydroseeding RPE

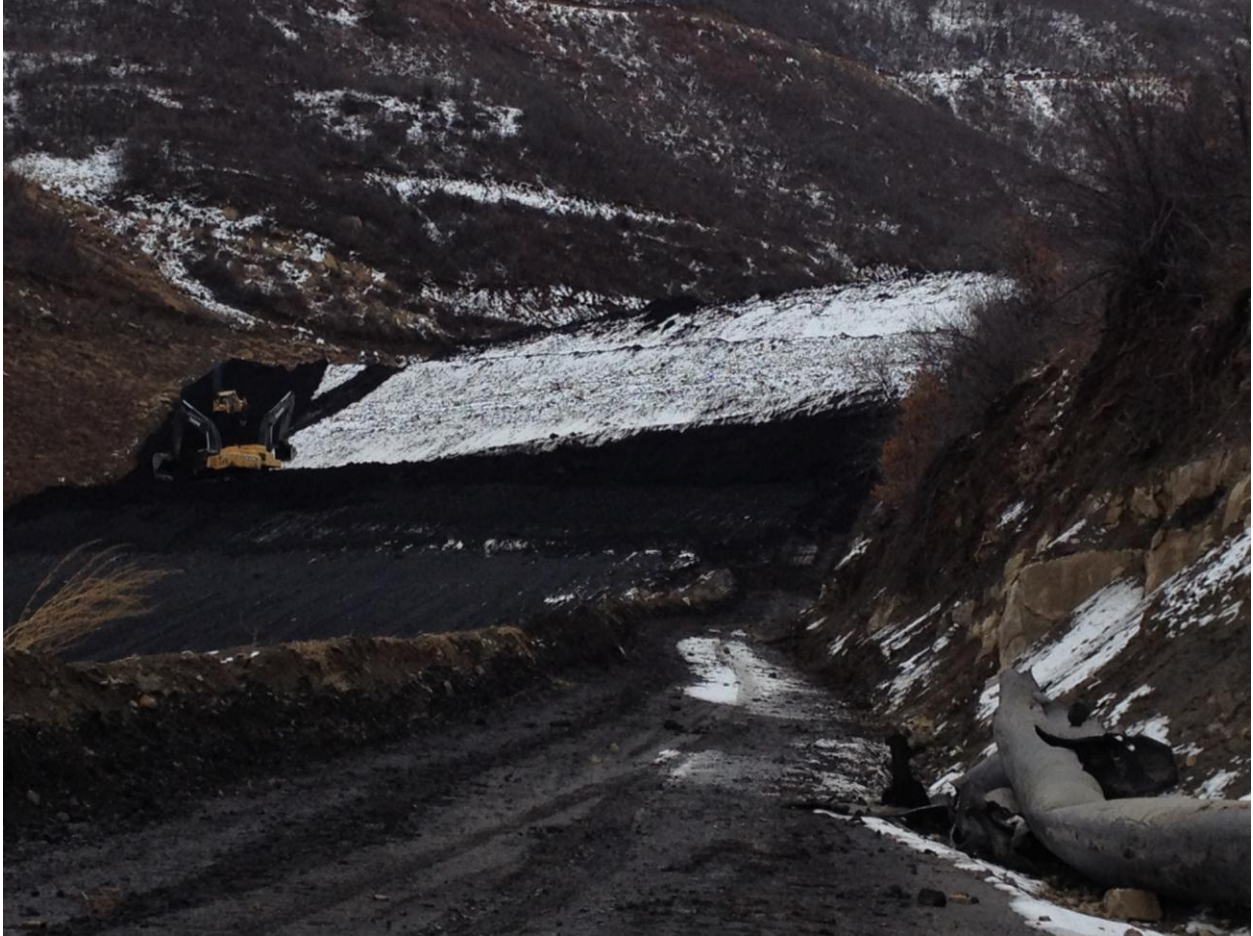
- West Elk was working on removing the internal haul road at the RPEE and dressing up the outslopes in the process. They were working on the road at the third lift. Each of the lifts is approximately 50 feet and there is a small, approximately ten foot wide, terrace bench between each of these lifts. The outslopes were all stable and there were no erosional problems noted. They were also working on hauling, spreading and compacting the remaining refuse from the top of the LRP to the RPEE. This work will be the last work on the RPEE until it is “shut down” for the winter. The top of the pile was graded to allow for positive drainage and no water was pooling on the pile at the time of the inspection.

Removing internal haul roads at RPEE
