**COLORADO DIVISION OF RECLAMATION, MINING AND SAFETY  
COAL PROGRAM INSPECTION REPORT**

<b>Permit Number:</b> C-1981-018 <b>Mine Name:</b> Deserado Mine <b>Operator:</b> Blue Mountain Energy, Inc <b>Operator Address:</b> Mr Scott Wanstedt 3607 County Road 65 Rangely, CO 81648	<b>County:</b> Rio Blanco <b>Operation Type:</b> Underground <b>Permit Status:</b> Active <b>Ownership:</b> Federal
	<b>Operator Representative Present:</b>  Scott Wanstedt
<b>Operator Representative Signature: (Field Issuance Only)</b>

<b>Inspection Start Date:</b> November 21, 2013 <b>Inspection Start Time:</b> 11:00 <b>Inspection End Date:</b> November 21, 2013 <b>Inspection End Time:</b> 14:00	<b>Inspection Type:</b> Coal Partial Inspection <b>Inspection Reason:</b> Normal I&E Program <b>Weather:</b> Snowing
<b>Joint Inspection Agency:</b>  None	<b>Joint Inspection Contacts:</b>  None
<b>Post Inspection Agency:</b>  None	<b>Post Inspection Contacts:</b>  None
<b>Inspector(s):</b>  Zach T. Trujillo	<b>Inspector's Signature:</b>

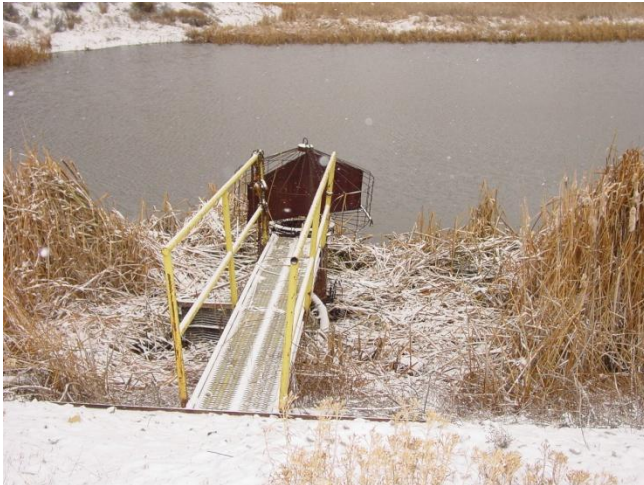
Pond DP-1 held water but with no discharge. Cattails around the primary spillway noted in previous inspection reports have been trimmed around the inlet. The embankment was stable with no issues in stability or erosion observed. The main ditch that feeds DP-1 from the facility bench was inspected. The ditch was stable with rip rap. No erosion or cutting was observed.

Pond DP-1 with cattails removed from around inlet.

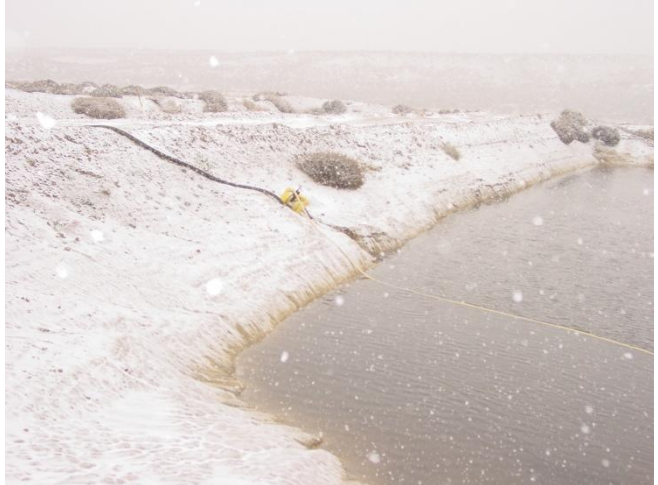
The Mine Dewatering pump was operating during the time of the inspection. Water was present up to the 5th pond where it was then pumped into the artificial wetlands. The wetlands held water up to the final cell. The Last Chance Pond held minimal water from rain and snow what was collected directly from the Last Chance Pond area. No water has been pumped into the Last Chance Pond from the artificial wetlands section. To the date of this inspection, no water has been pumped into or has been discharged from the Last Chance Pond.

Pumping from dewatering pond 5 to artificial wetlands.
