**COLORADO DIVISION OF RECLAMATION, MINING AND SAFETY**  
**MINERALS PROGRAM INSPECTION REPORT**  
**PHONE: (303) 866-3567**

<b>MINE NAME:</b> RBK Pit No. 30	<b>MINE/PROSPECTING ID#:</b> M-1990-106	<b>MINERAL:</b> Gravel	<b>COUNTY:</b> Pueblo
<b>INSPECTION TYPE:</b> Monitoring	<b>INSPECTOR(S):</b> Timothy A. Cazier	<b>INSP. DATE:</b> November 15, 2013	<b>INSP. TIME:</b> 09:05
<b>OPERATOR:</b> RBK Construction, Inc.	<b>OPERATOR REPRESENTATIVE:</b> Joe Baxter	<b>TYPE OF OPERATION:</b> 110c - Construction Limited Impact

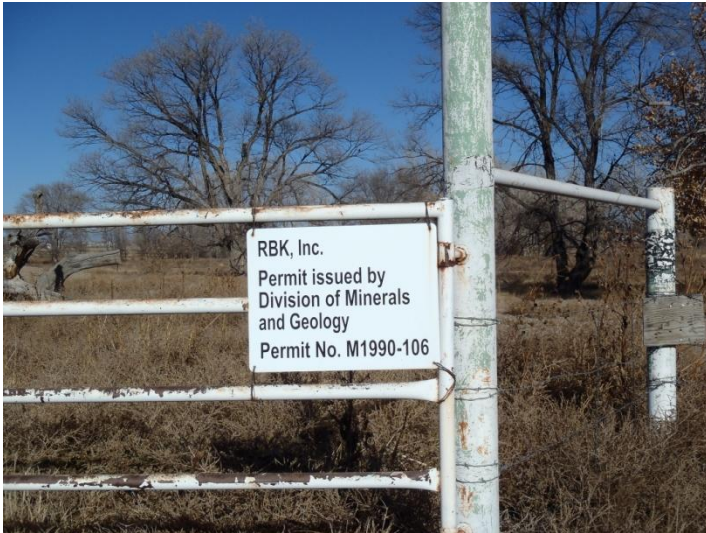
A permit sign was displayed at the site entrance (see **Photo 1**), and the site is surrounded by fence (see **Photo 2**).

Photo 1. Required permit sign.

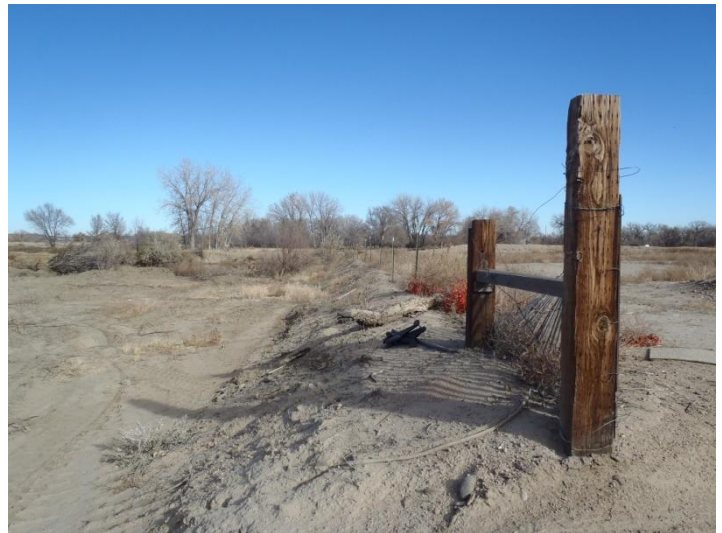
Photo 2. Site fence (looking north from entrance).

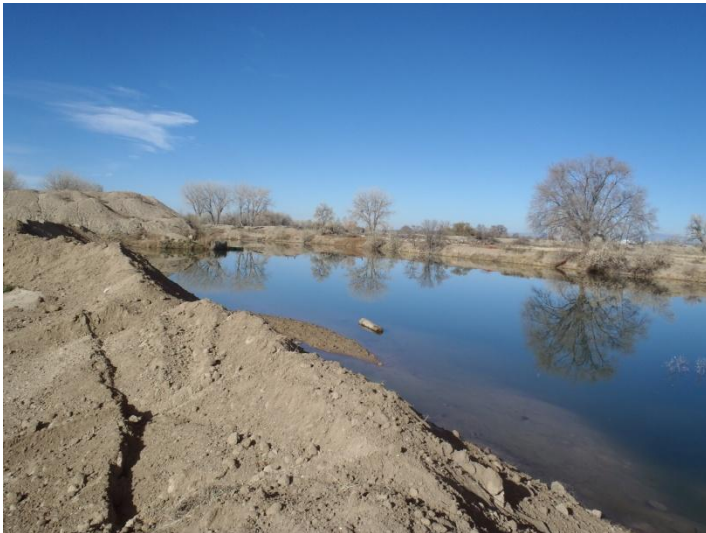
Mr. Baxter indicated the pit is essentially mined out and they are in the process of backfilling the pit (see **Photos 3 and 4**). A portable J-stand with a pump submerged in the pit pond was observed on site (see **Photo 5**). Mr. Baxter explained they are dewatering the pond to facilitate the backfilling operation. The Operator hopes to have enough overburden/process fines to backfill the entire pit. A loader and dozer were observed along with two smaller product stockpiles (see **Photos 6 and 7**) and one larger overburden/process fines stockpile (see **Photo 8**). Mr. Baxter indicated that the topsoil stockpile is in the northwest corner of the site, west of the process fines stockpile.

Photo 3. Pit/Pond – back fill in progress (looking west).

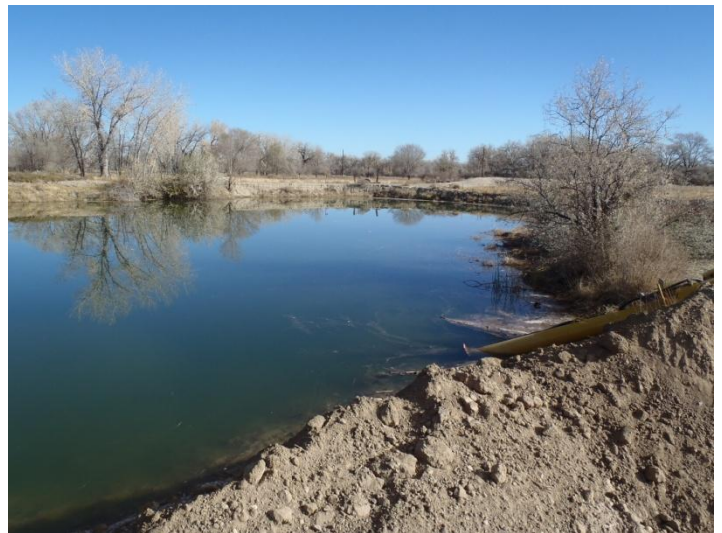
Photo 4. Pit/Pond – back fill in progress (looking east).

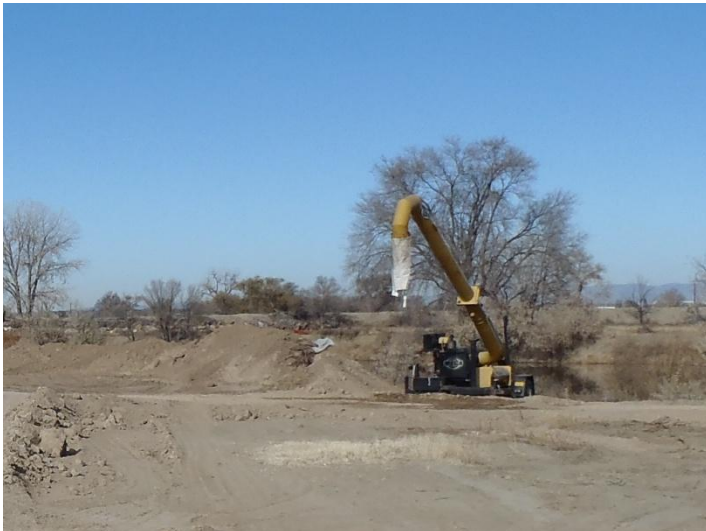
Photo 5. Portable J-stand w/ submersible pump.

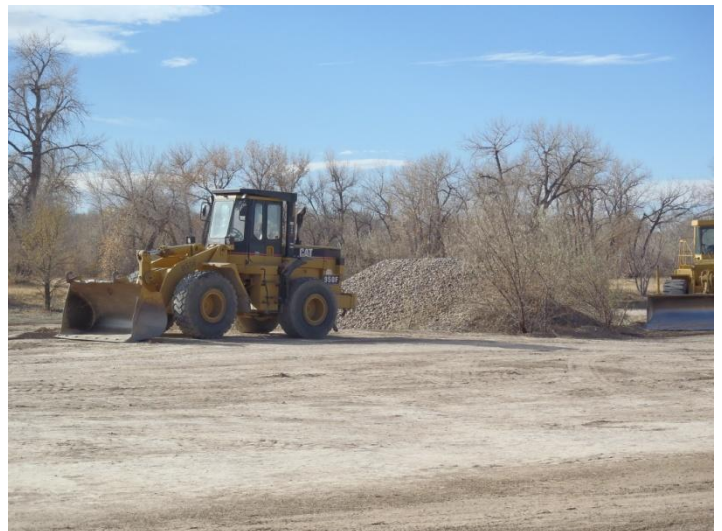
Photo 6. Loader, dozer and small material stockpile.

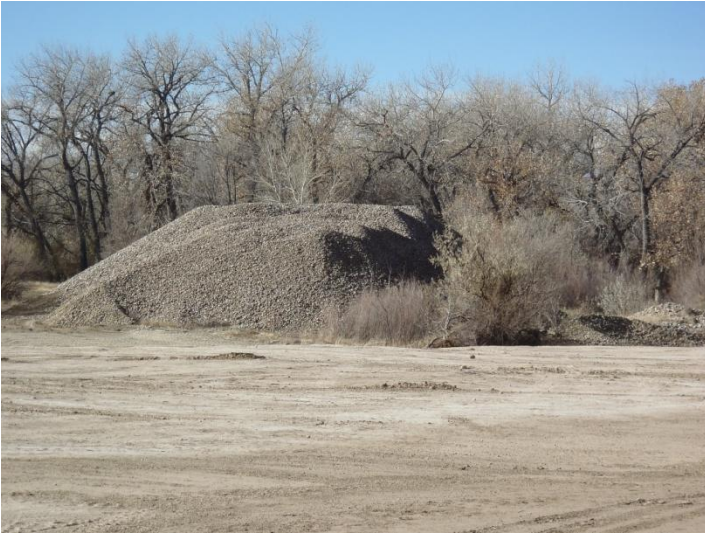
Photo 7. Processed material stockpile (looking SW).

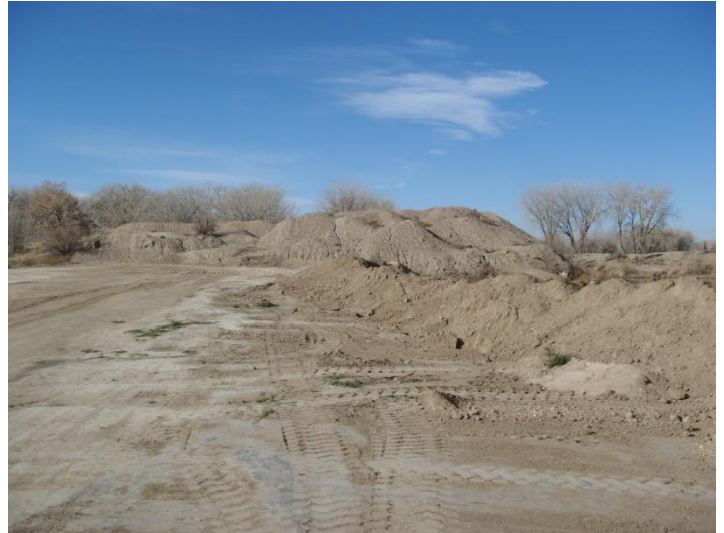
Photo 8. Overburden/process fines stockpile (looking W).
