COLORADO DIVISION OF RECLAMATION, MINING AND SAFETY COAL PROGRAM INSPECTION REPORT

Permit Number: C-1981-022 Mine Name: Elk Creek Mine Operator: Oxbow Mining, LLC Operator Address: Mr Jim Kiger P.O. Box 535 3737 Highway 133 Somerset, CO 81434	County: Delta, Gunnison Operation Type: Underground Permit Status: Active Ownership: Federal
	Operator Representative Present: Jim Kiger
Operator Representative Signature: (Field Issuance Only)

Inspection Start Date: December 11, 2013 Inspection Start Time: 14:00 Inspection End Date: December 11, 2013 Inspection End Time: 15:40		Inspection Type: Coal Partial Inspection Inspection Reason: Normal I&E Program Weather: Clear	
Joint Inspection Agency: None		Joint Inspection Contacts:	
Post Inspection Agency: None		Post Inspection Contacts:	
Inspector(s): Susan L. Burgmaier	Inspector's Signature:

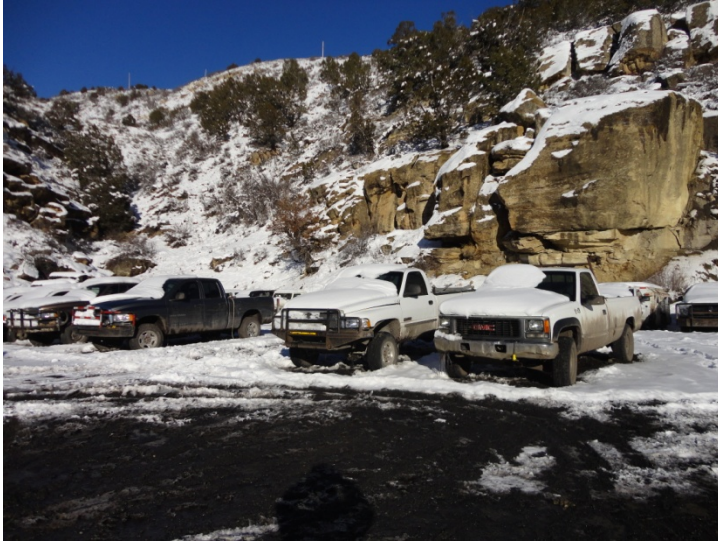
The temporary refuse storage area at the top of the West Valley Coal Refuse Pile was inspected. There was no uncompacted material being stored on the pile. The area was being utilized for storage of underground mine vehicles that have been temporarily removed from service.

Vehicles stored on top of West Valley Refuse Area

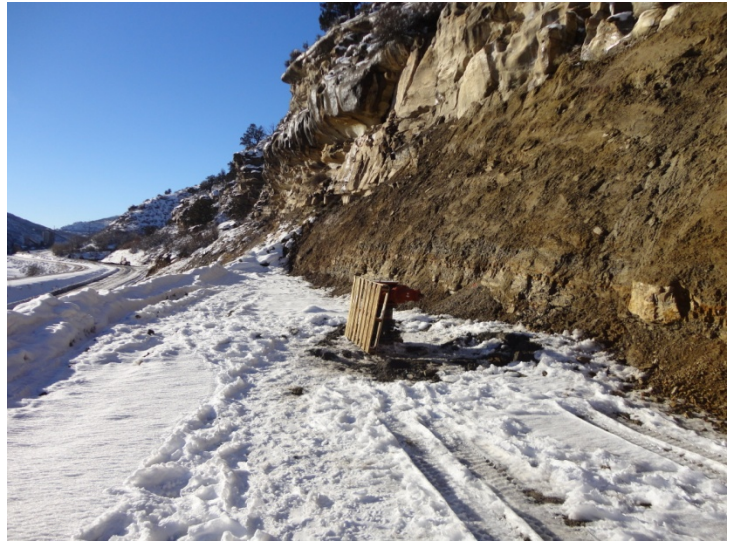
Gas well located at Sanborn Creek portals

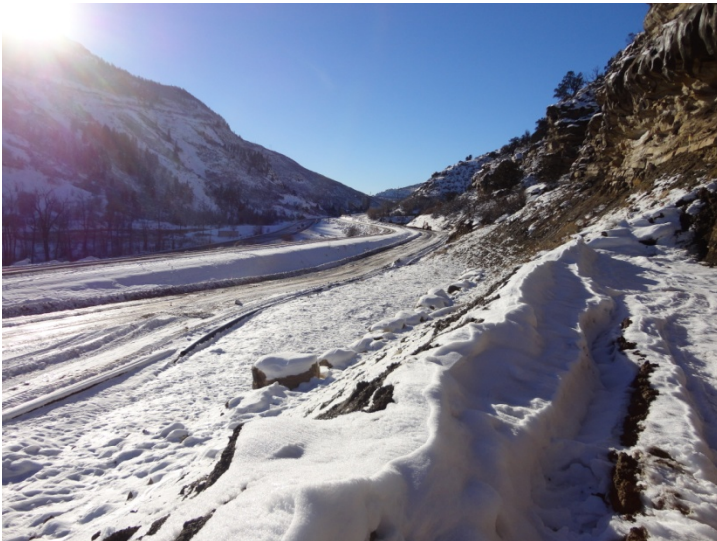
Straw wattles were in place on the outslope of the Sanborn Creek portal slope, where a bench had been constructed for installation of a COGCC permitted gas well for Vessels Coal Gas, Inc.

Outslope of Sanborn Creek portal gas well bench- west

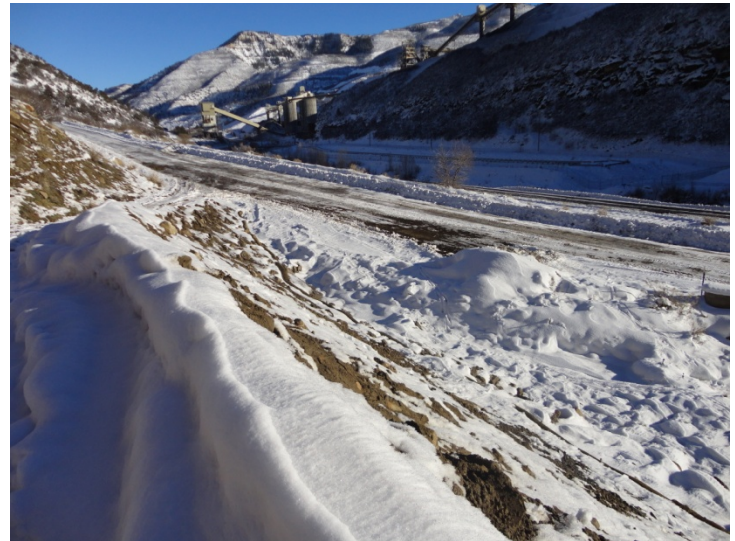
Outslope of Sanborn Creek portal gas well bench - east
