COLORADO DIVISION OF RECLAMATION, MINING AND SAFETY COAL PROGRAM INSPECTION REPORT

Permit Number: C-1981-035 Mine Name: King Coal Mine Operator: GCC Energy, LLC Operator Address: Mr. Tom Bird 6473 County Road 120 Hesperus, CO 81326	County: La Plata Operation Type: Underground Permit Status: Active Ownership: Federal
	Operator Representative Present: Wade Wymore
Operator Representative Signature: (Field Issuance Only) This report was issued electronically from the Division's Durango Field Office.

Inspection Start Date: December 18, 2013 Inspection Start Time: 10:20 Inspection End Date: December 18, 2013 Inspection End Time: 13:15		Inspection Type: Coal Complete Inspection Inspection Reason: Normal I&E Program Weather: Clear	
Joint Inspection Agency: None		Joint Inspection Contacts:	
Post Inspection Agency: None		Post Inspection Contacts:	
Inspector(s): Marcia L. Talvitie, P.E.	Inspector's Signature:

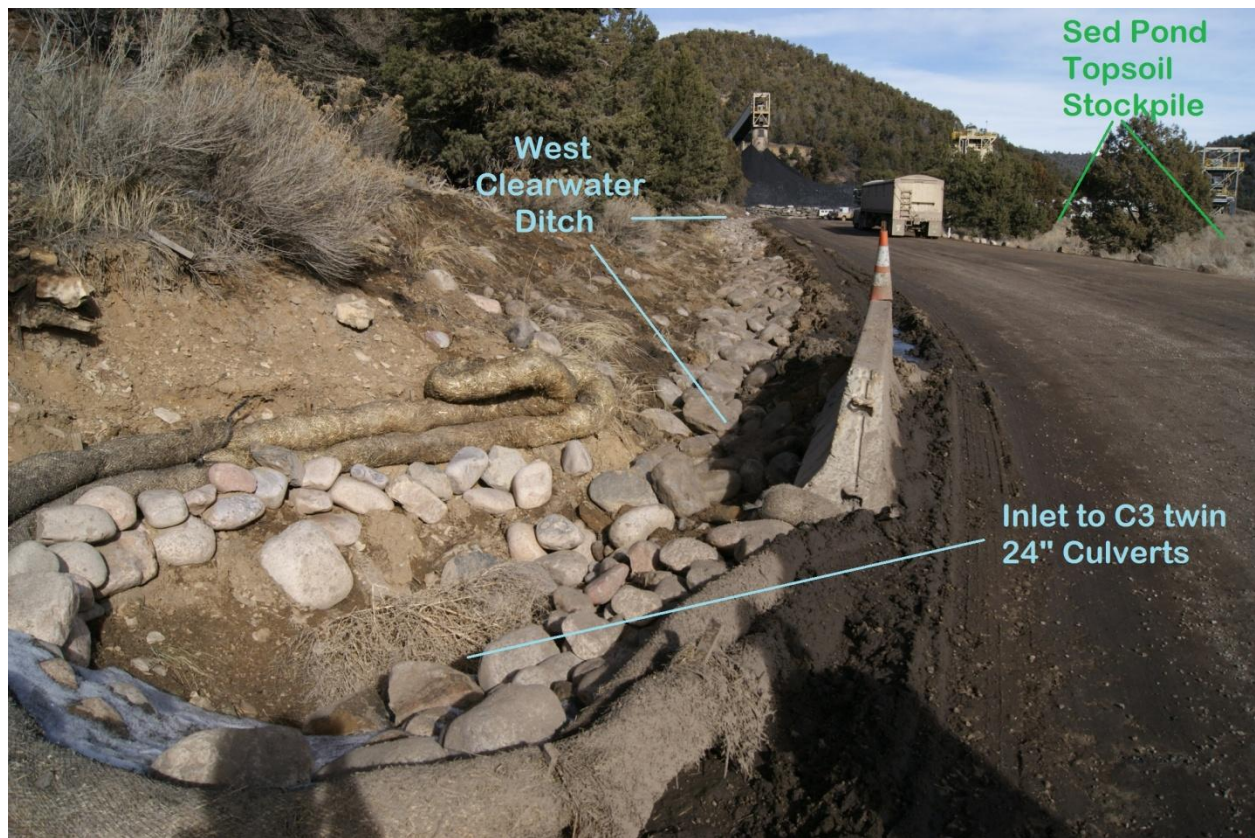
- Ditches throughout the disturbed area at King II were found to be in good repair and functioning as designed. The operator has replaced straw wattles in the ditches with rock check dams - to slow the velocity of the flow, without silting-up.

- Inlets at King II were clear. A new grate-style inlet protection has been installed at culvert C11, adjacent to the truck scale. Mr. Wymore said this is working better than the straw wattles did previously. Water is allowed to pass through, together with finer sediment, but any larger objects are kept out.

- The topsoil piles at King II were well vegetated, stable, and protected from erosion.

King II Haul Road, ditch, inlet, and topsoil stockpile

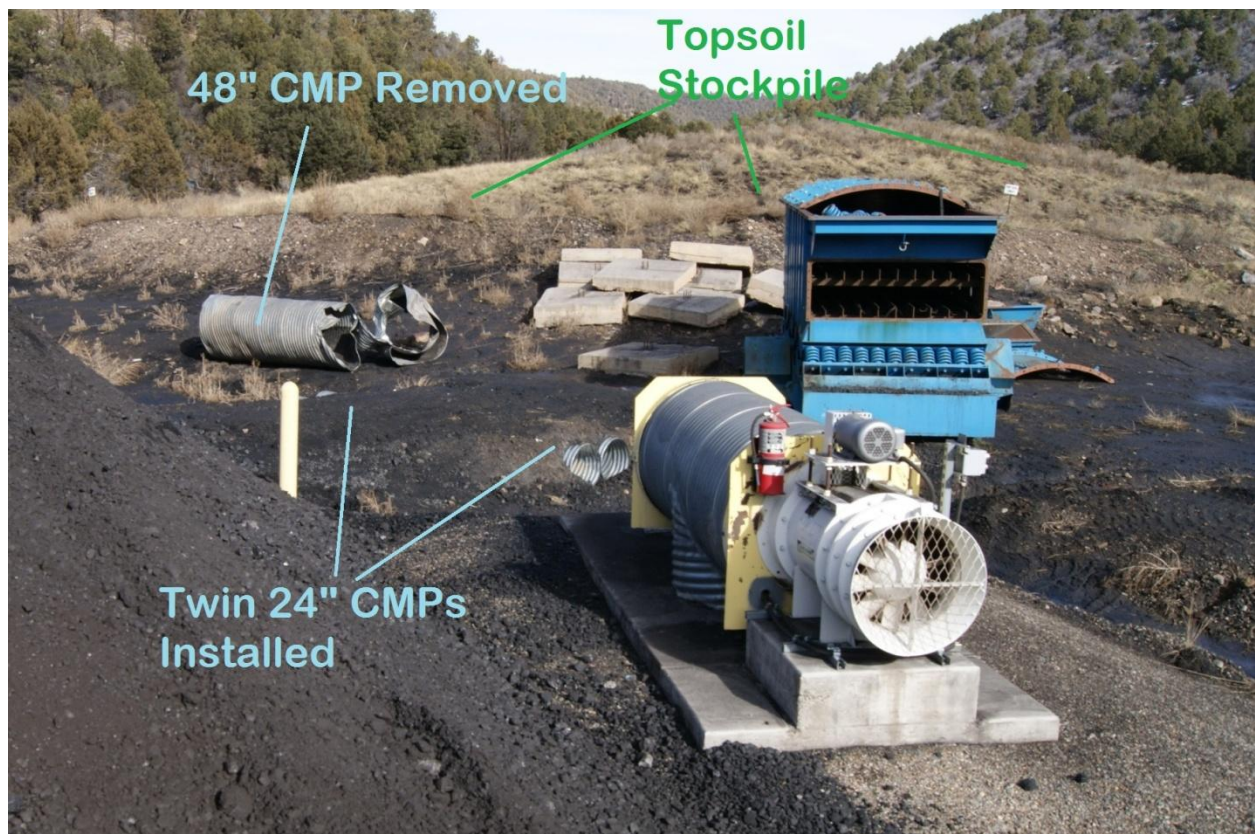
Damaged culvert pipe (replaced) and King II topsoil stockpile

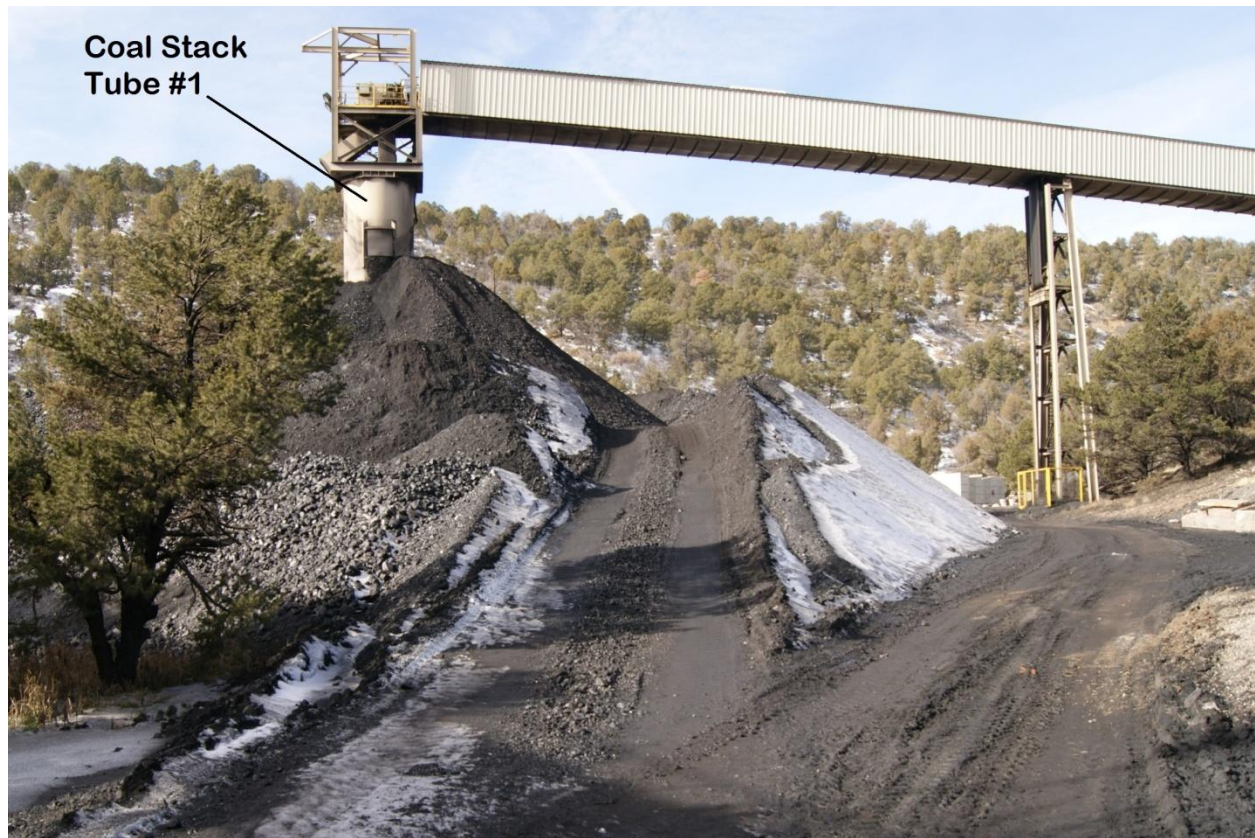
Stockpile of coal at Stack Tube #1

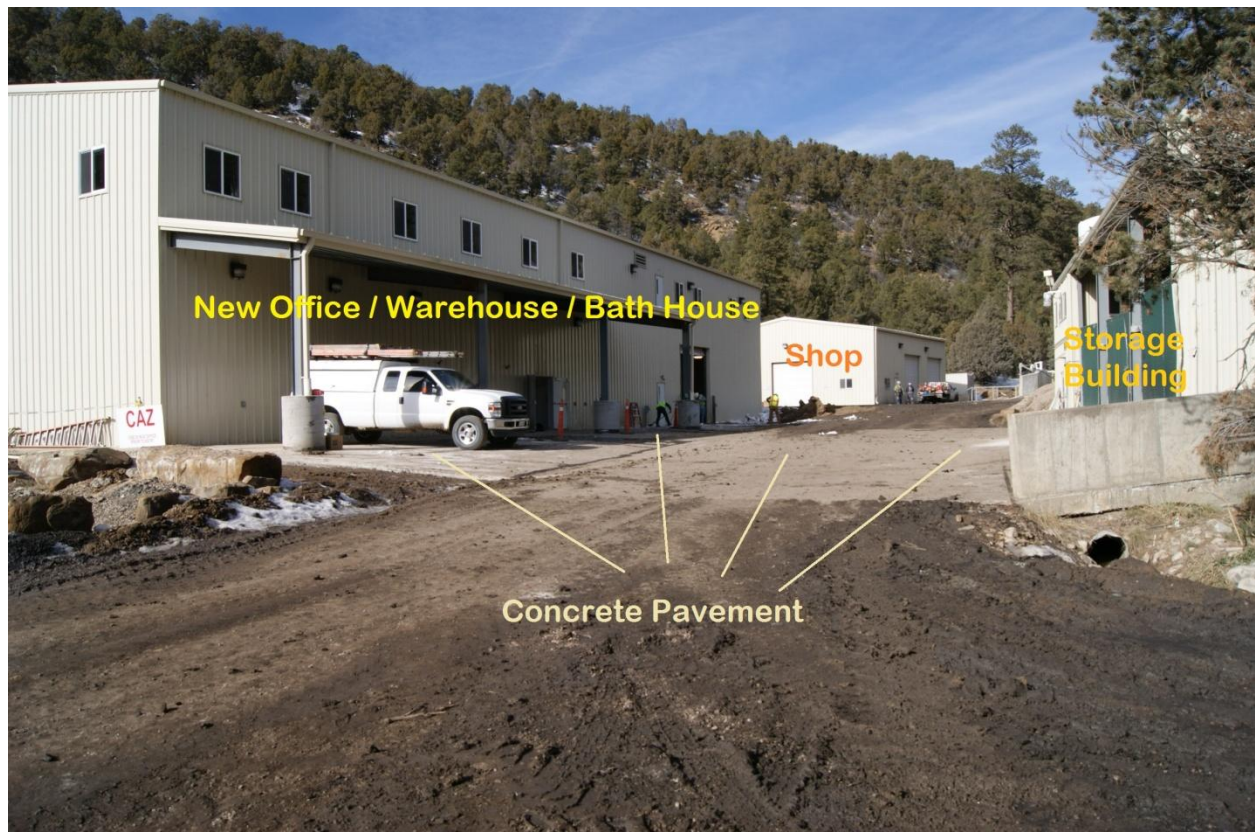
- GCC's contractor continues to make progress on the new office / warehouse / bath house at King II. The exterior of the building appears to be completed. Concrete pavement spans the area between this building and the three-sided storage building.

East side of new building

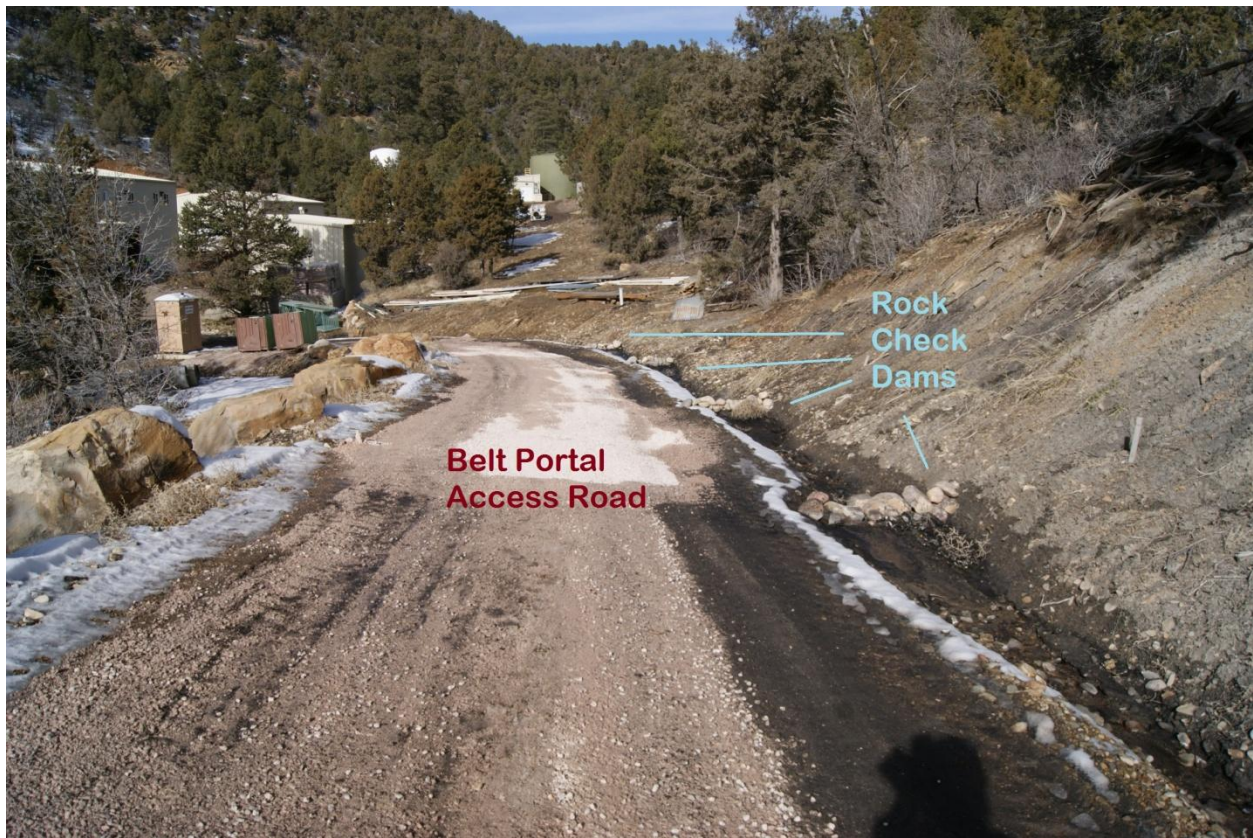
Access Road to belt portal, looking north

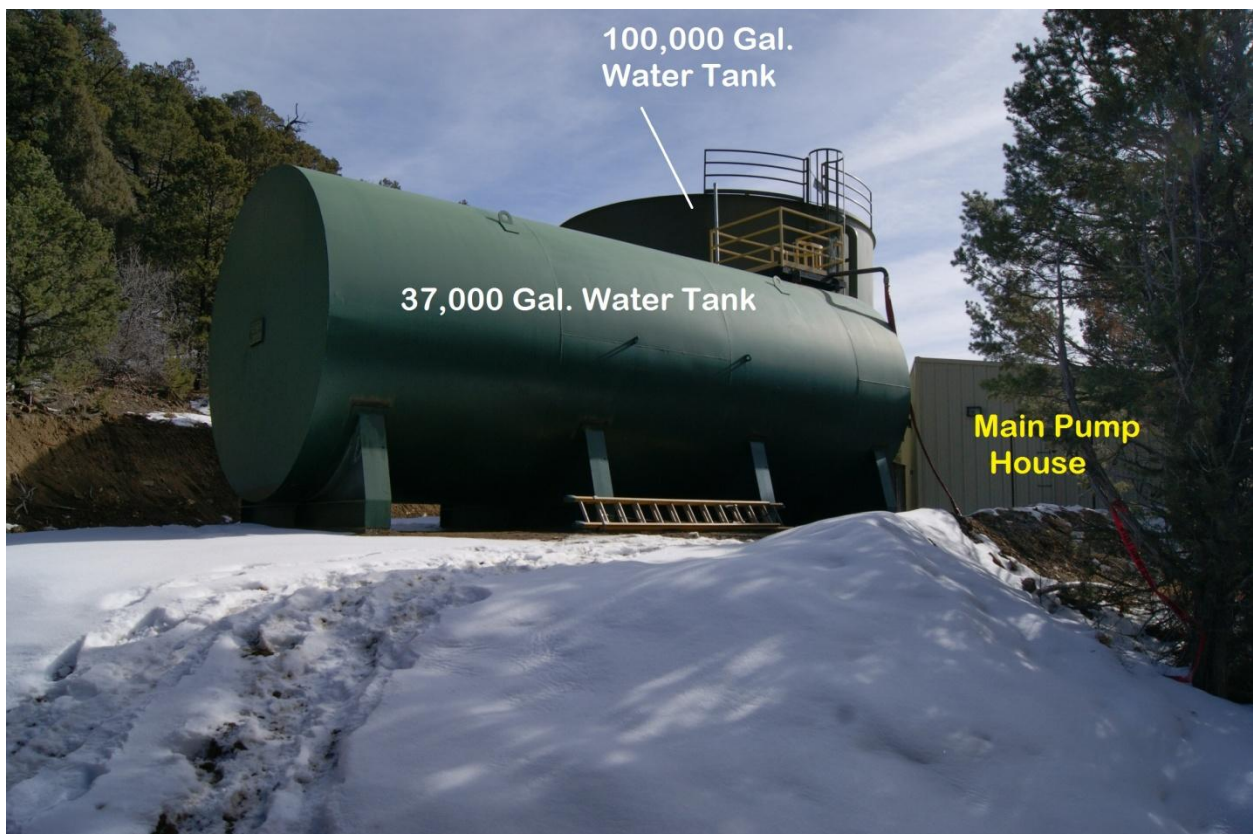
Water tank relocated from King I

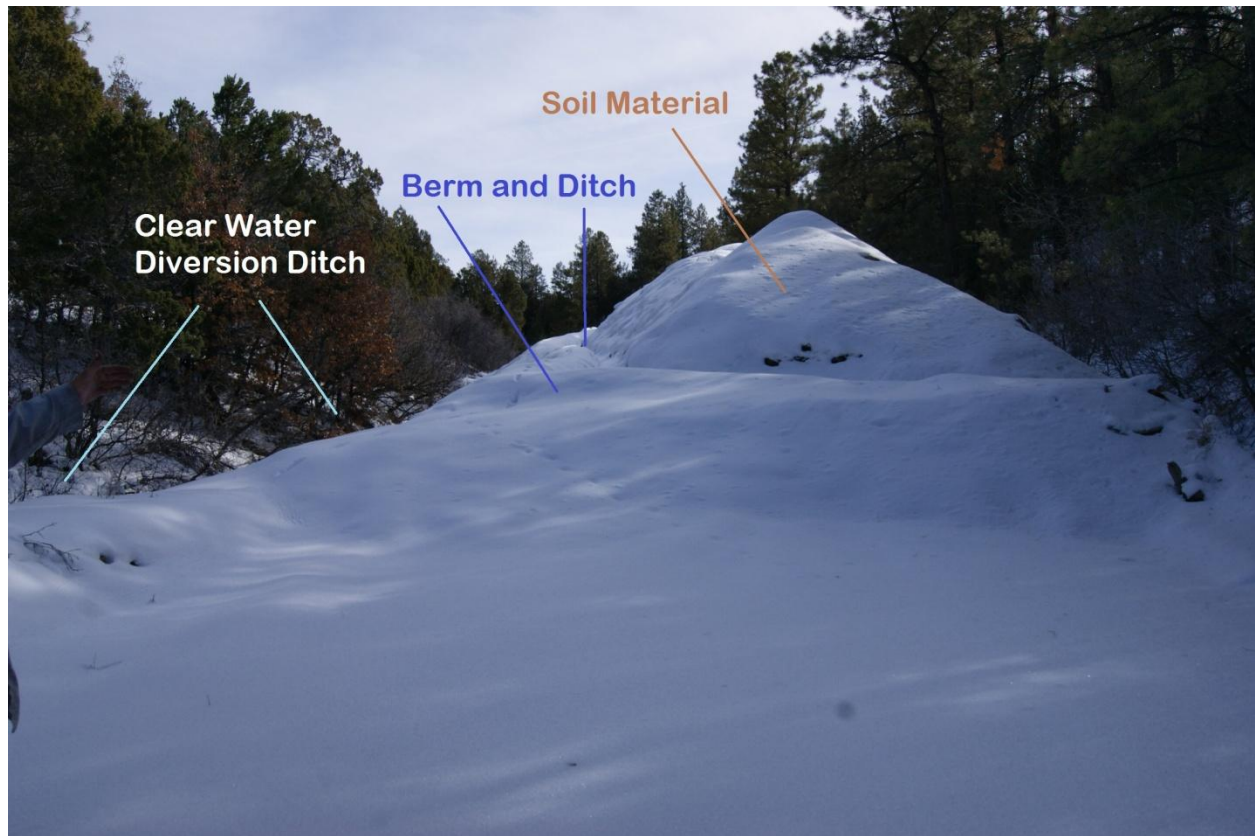
- The soil pile located up the valley from the refuse pile has been protected with a ditch and berm. Any runoff from the pile will be directed to the collection ditch.

Soil Material up-valley from King I Refuse Pile

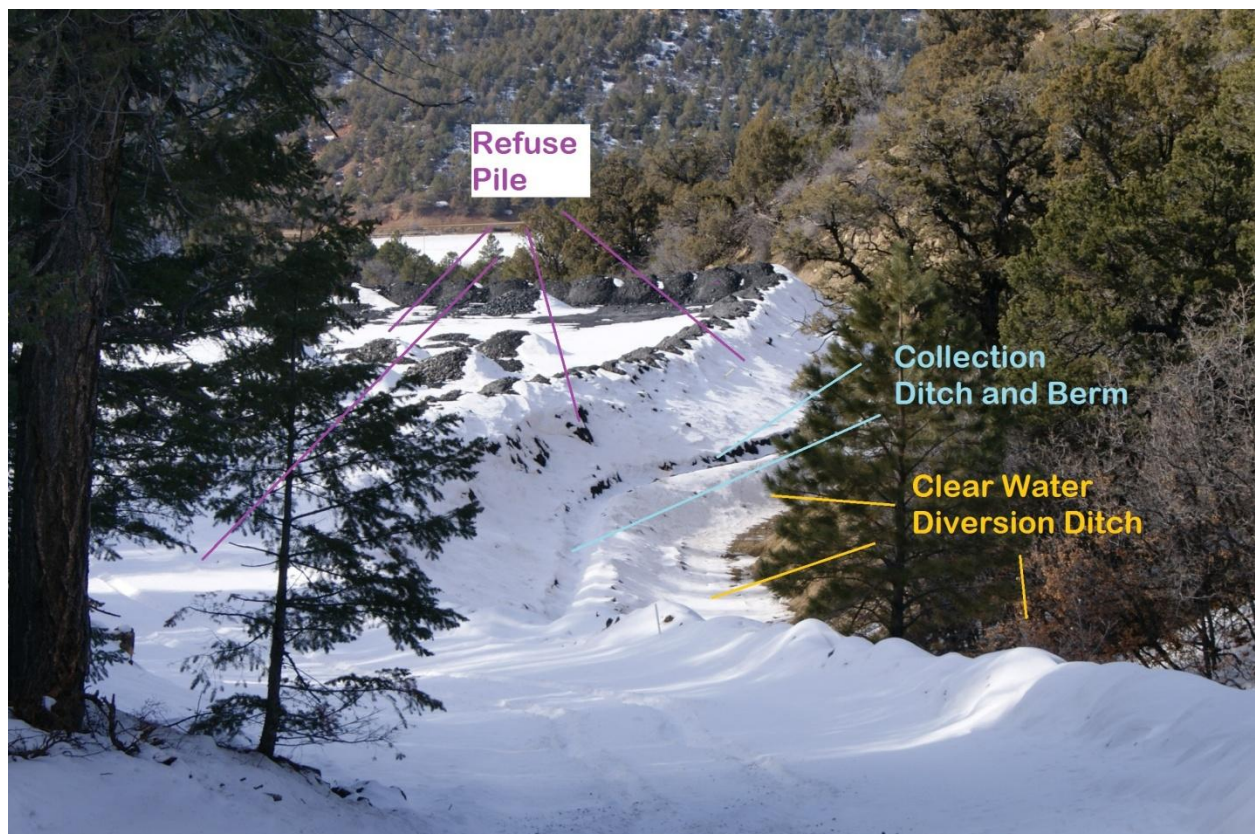
- The top surface of the refuse pile was covered with approximately six inches of snow. The surface appeared to have been graded in accordance with the approved design. A few loads of CMW had been dumped along the northern (uphill) side of the pile, before the snow fell. Subsequent loads had been dumped in the coal storage area below.

- The clear water diversion ditch, which flows along the northern side of the refuse pile, is now lower in elevation than the pile's top surface. The operator is considering options for shifting the clear water ditch further up the hillside. In the meantime, runoff from the northern side of the refuse pile is collected in a ditch, carried across the top front of the pile, and directed into the main collection ditch.

Refuse pile and Clear Water ditch as seen from above
