**RE: Mary's Mountain Gravel Pit, DRMS File No. M-2003-068  
Follow-up on an unresolved problem**

**COLORADO DIVISION OF RECLAMATION, MINING AND SAFETY  
MINERALS PROGRAM INSPECTION REPORT**

<b>MINE NAME:</b> Mary's Mountain Gravel Pit	<b>MINE/PROSPECTING ID#:</b> M-2003-068	<b>MINERAL:</b> Sand and gravel	<b>COUNTY:</b> Huerfano
<b>INSPECTION TYPE:</b> Monitoring	<b>INSPECTOR(S):</b> Tyler V. O'Donnell	<b>INSP. DATE:</b> July 26, 2013	<b>INSP. TIME:</b> 11:30
<b>OPERATOR:</b> Craig J. Walker Revocable Trust	<b>OPERATOR REPRESENTATIVE:</b> Ken Lutz	<b>TYPE OF OPERATION:</b> 110c - Construction Limited Impact

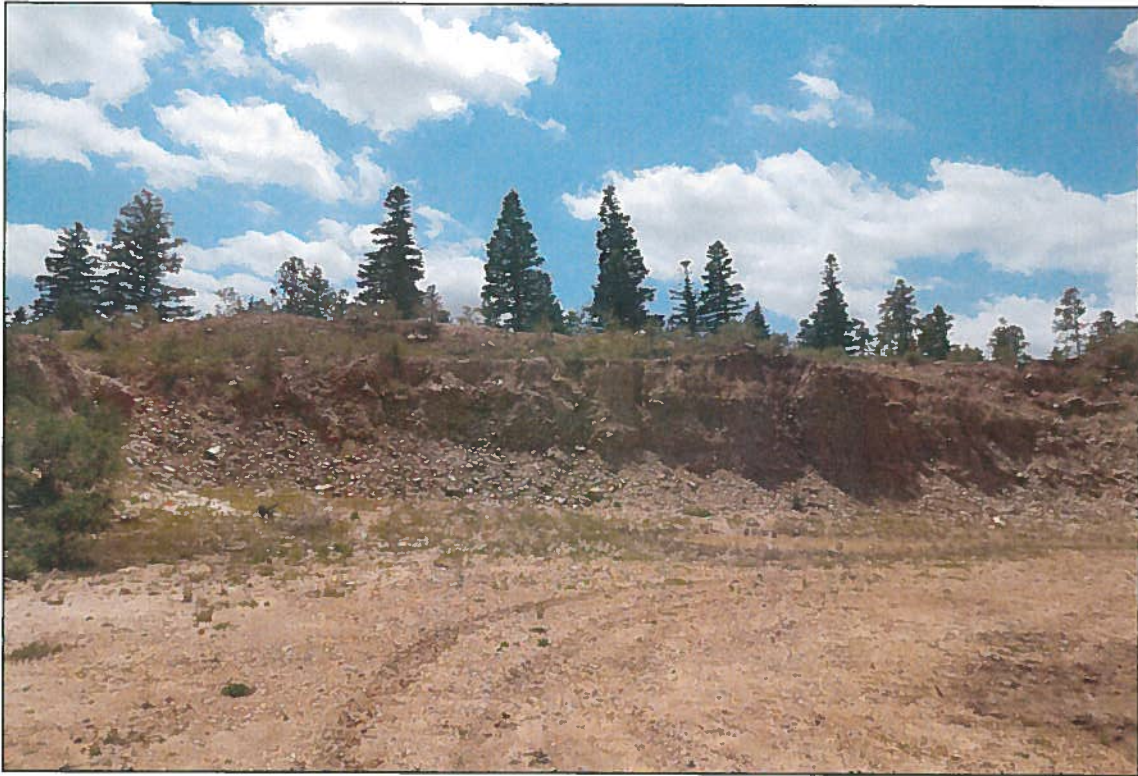
There was evidence of erosion on the mining highwall.

**Photo 1:** View looking south, mining highwall in the background with erosion features.

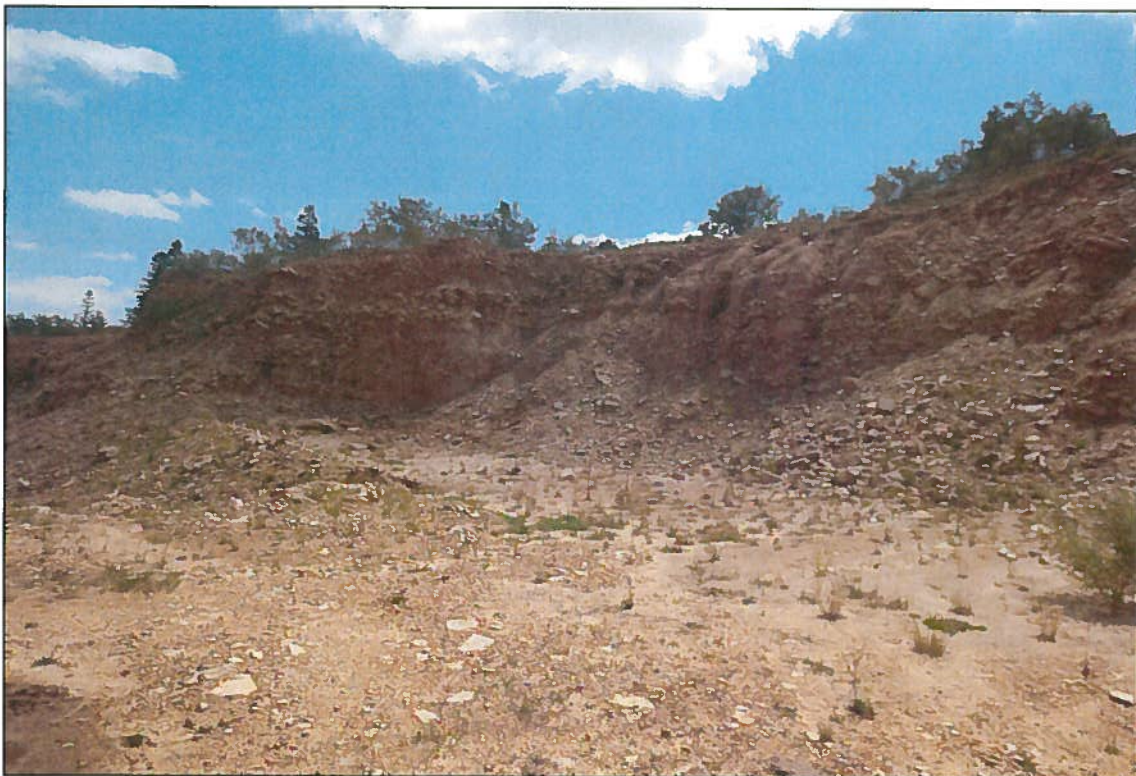
**Photo 2:** View looking southeast, mining highwall in the background with erosion features.

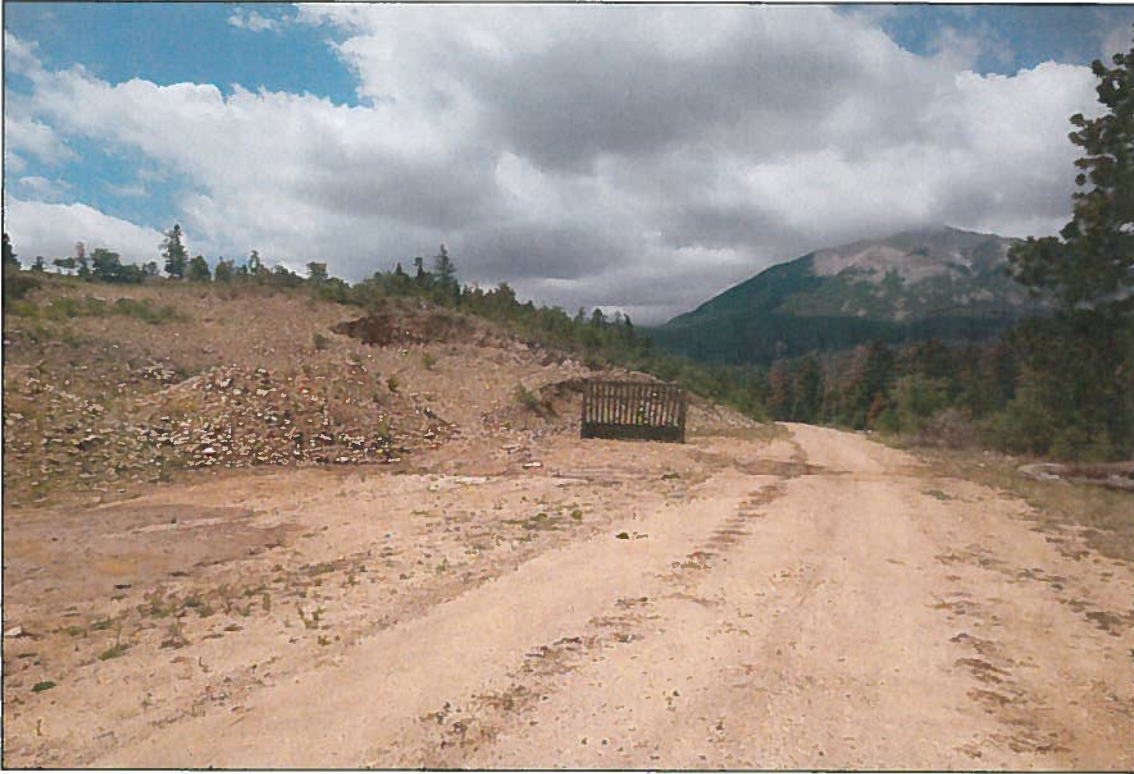
There were annual weeds and a few thistles observed during the inspection. There was plant growth on the stockpiles and very little vegetation growth elsewhere in the disturbed area. The growth appeared to be volunteer vegetation.

**Photo 3:** View looking west/southwest, stockpiles in the left side of the photo.

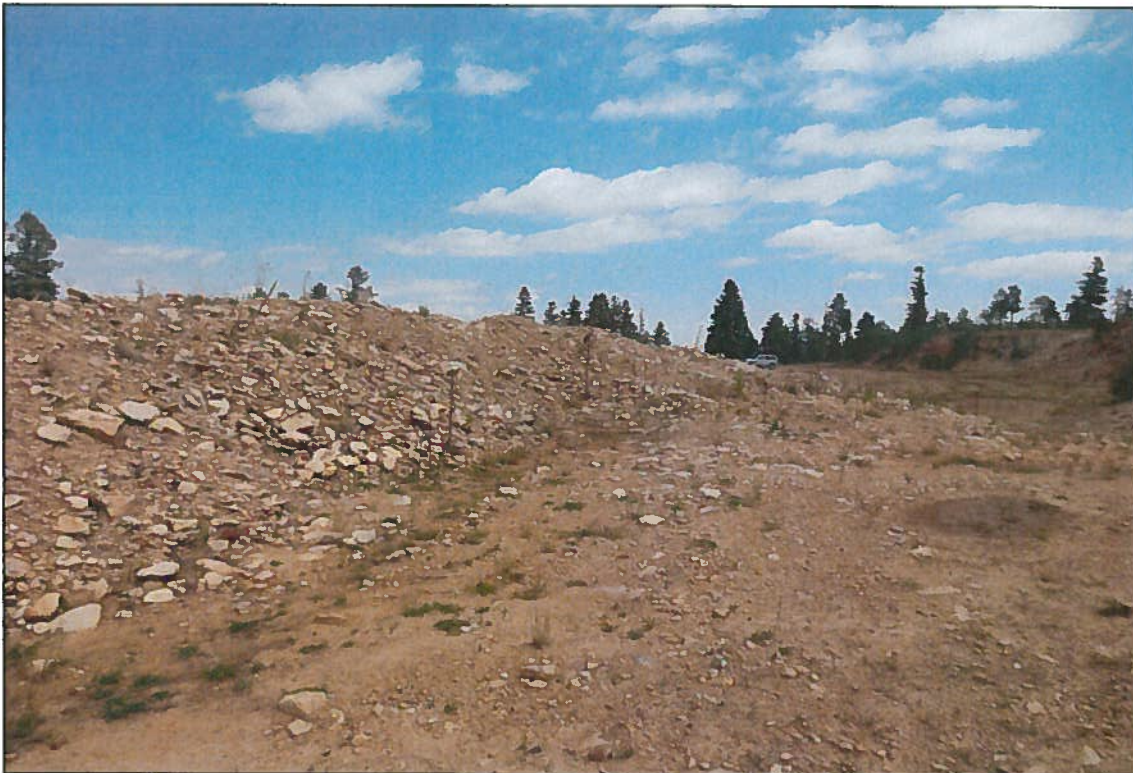
**Photo 4:** View looking east from within the pit.
