COLORADO DIVISION OF RECLAMATION, MINING AND SAFETY
MINERALS PROGRAM INSPECTION REPORT
PHONE: (303) 866-3567

MINE NAME: Cresson Project	MINE/PROSPECTING ID#: M-1980-244	MINERAL: Gold	COUNTY: Teller
INSPECTION TYPE: Aerial Inspection	INSPECTOR(S): Timothy A. Cazier	INSP. DATE: July 23, 2013	INSP. TIME: 15:10
OPERATOR: Cripple Creek & Victor Gold Mining Company	OPERATOR REPRESENTATIVE: N/A	TYPE OF OPERATION: 112d-3 - Designated Mining Operation

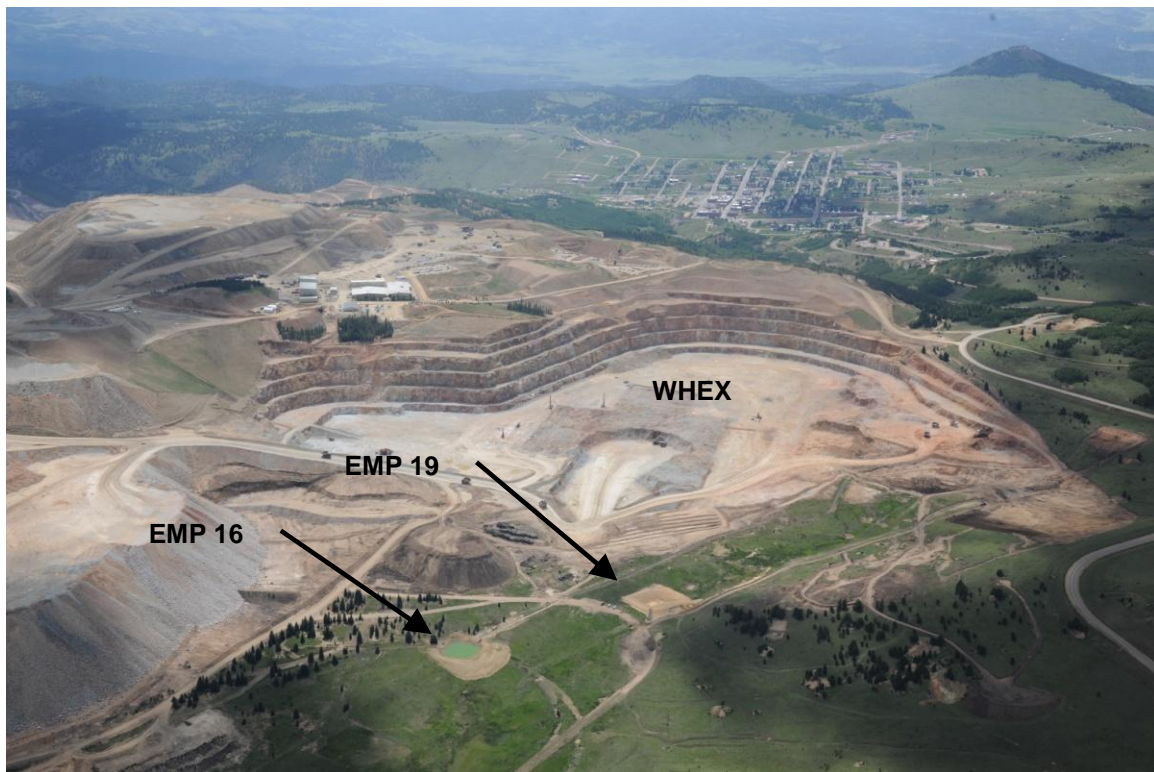
Photo 1. Wildhorse Extension Pit (Looking west).

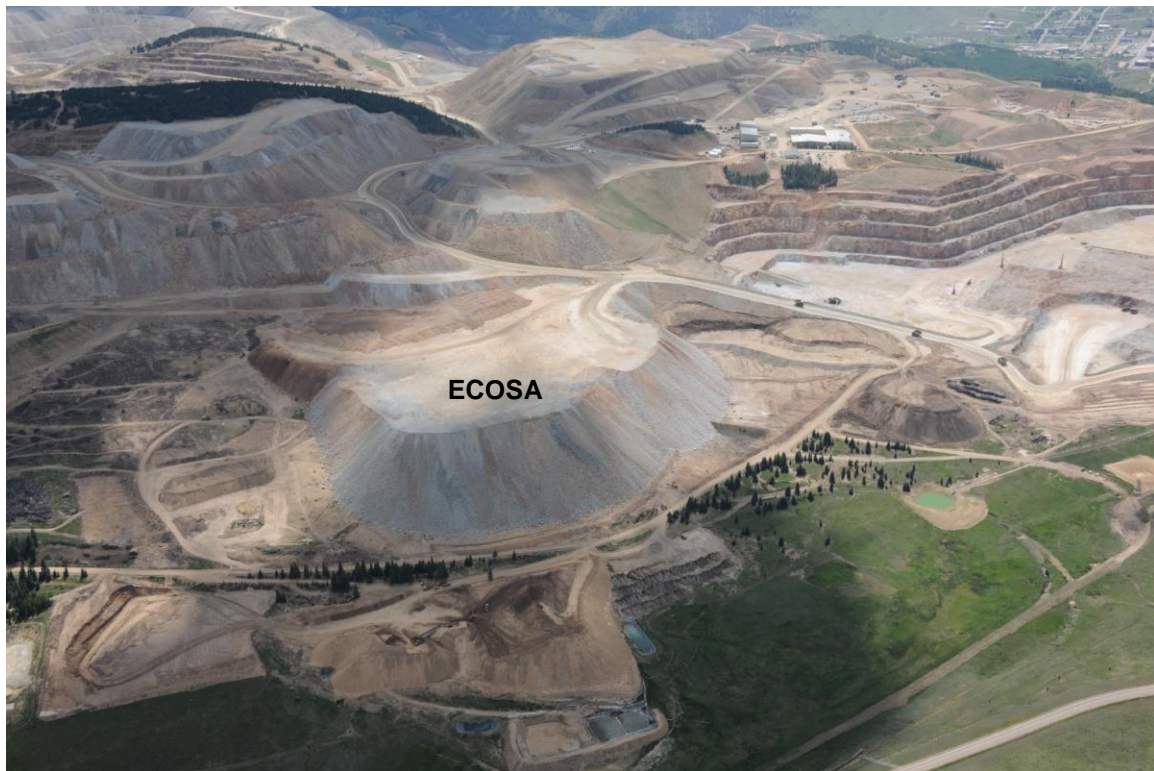
Photo 2. East Cresson OSA (Looking NW).

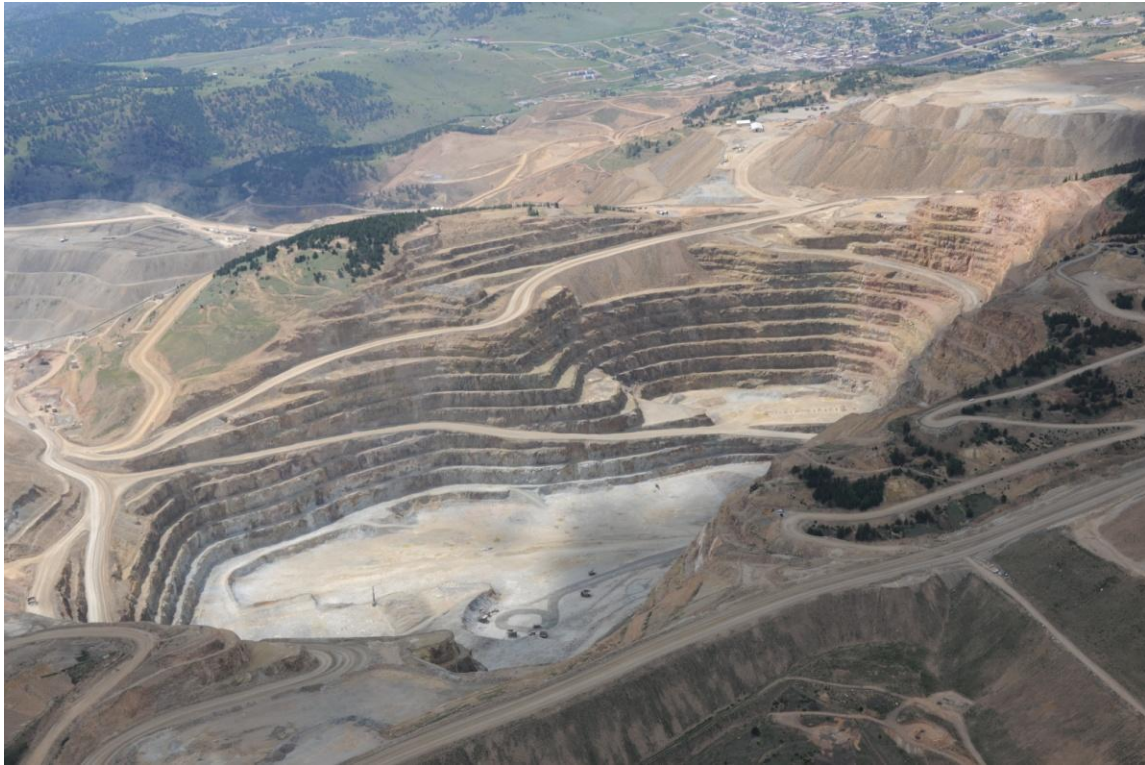
Photo 3. Main Cresson Pit (looking NW).

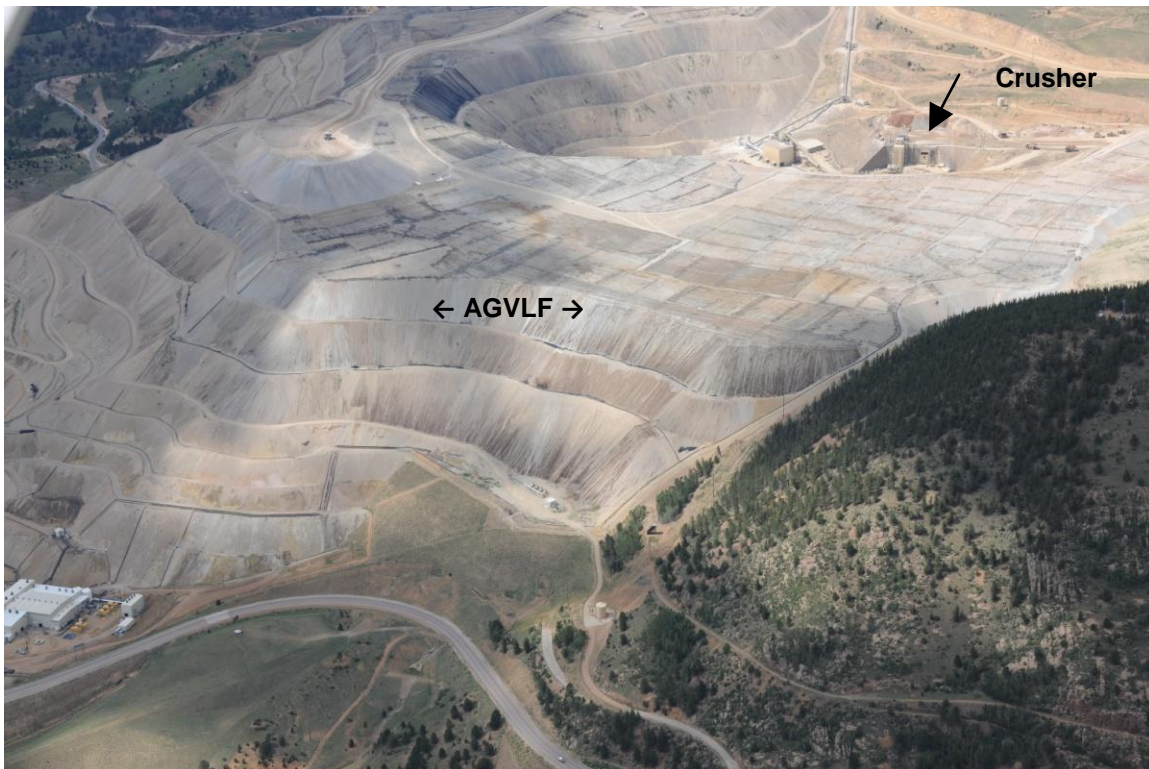
Photo 4. Arequa Gulch VLF (looking NE).

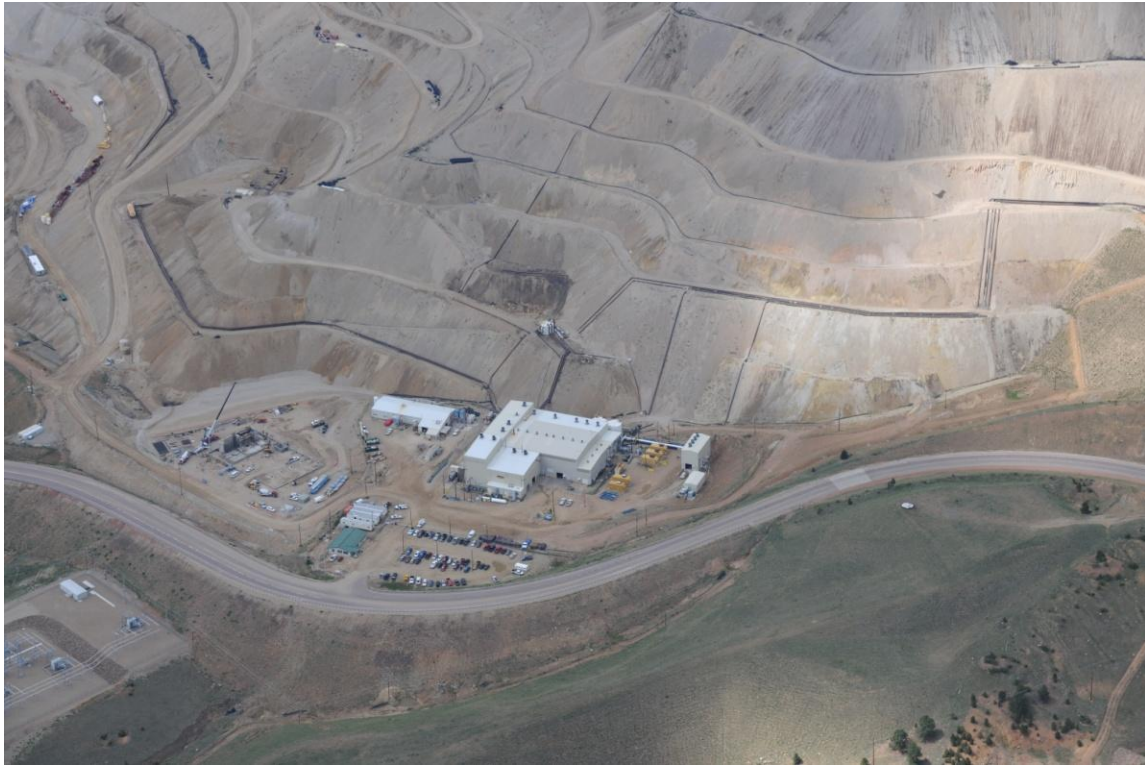
Photo 5. Arequa Gulch ADR (Looking north).

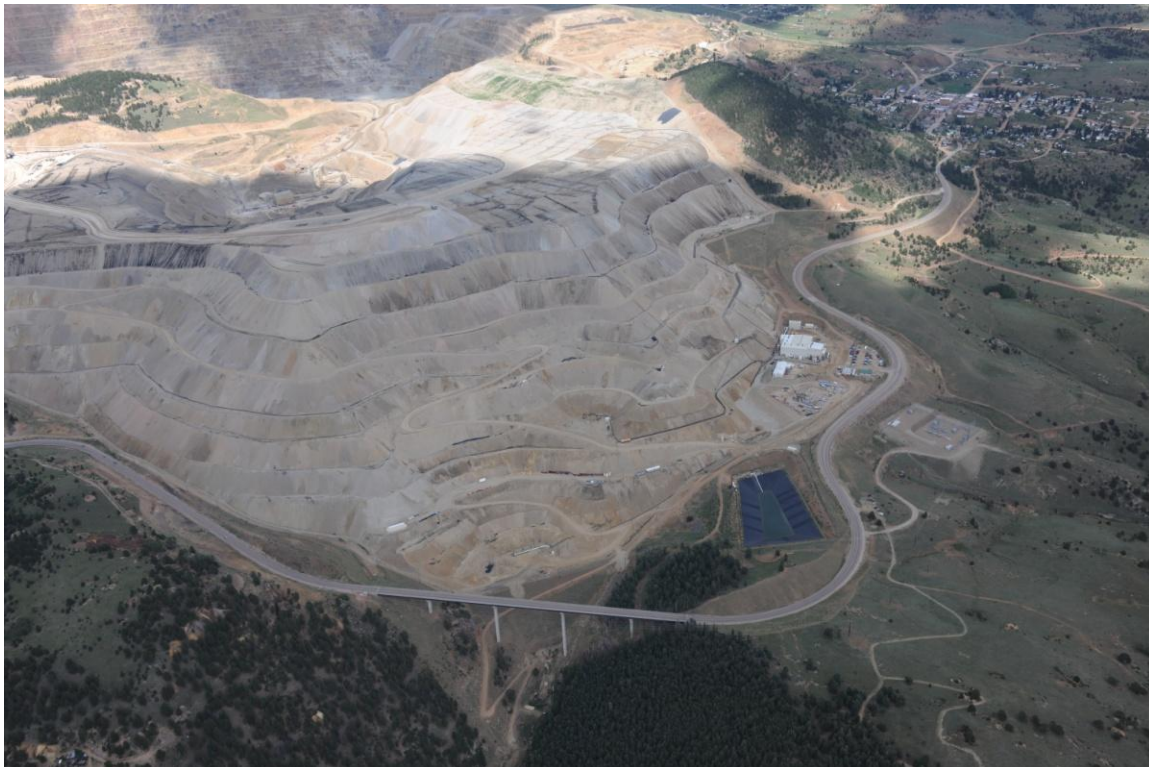
Photo 6. Arequa Gulch VLF (looking east).

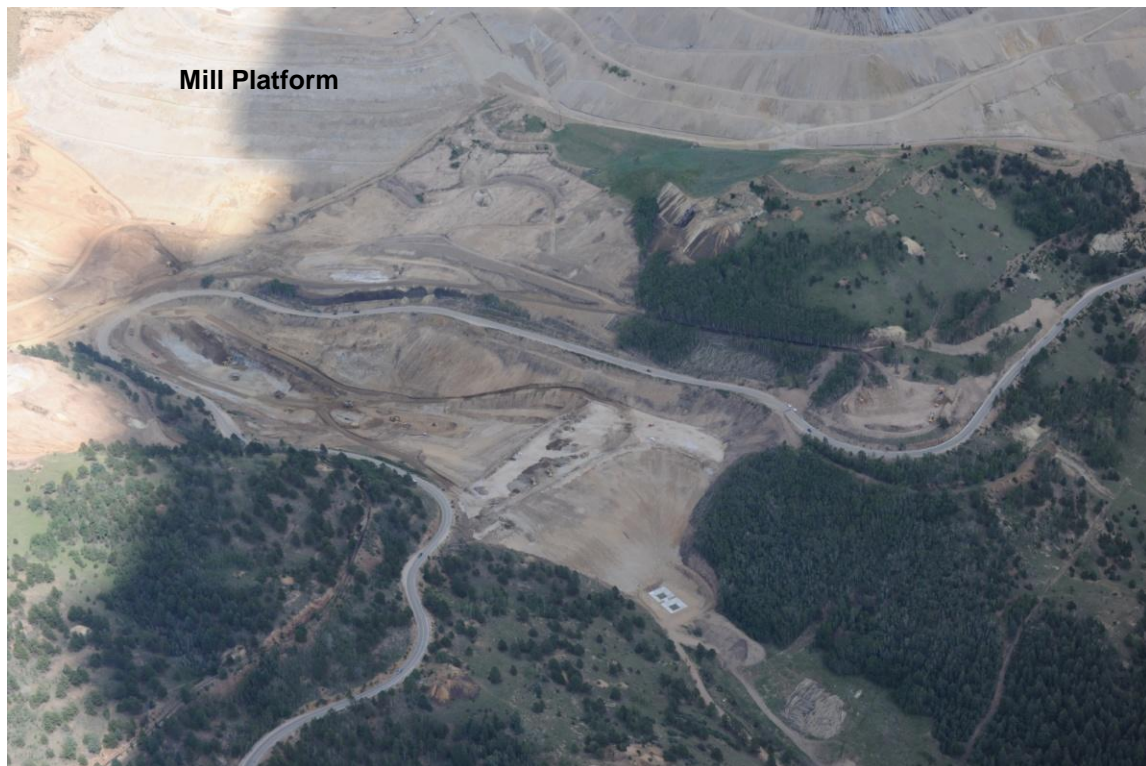
Photo 7. Squaw Gulch VLF area (looking east).

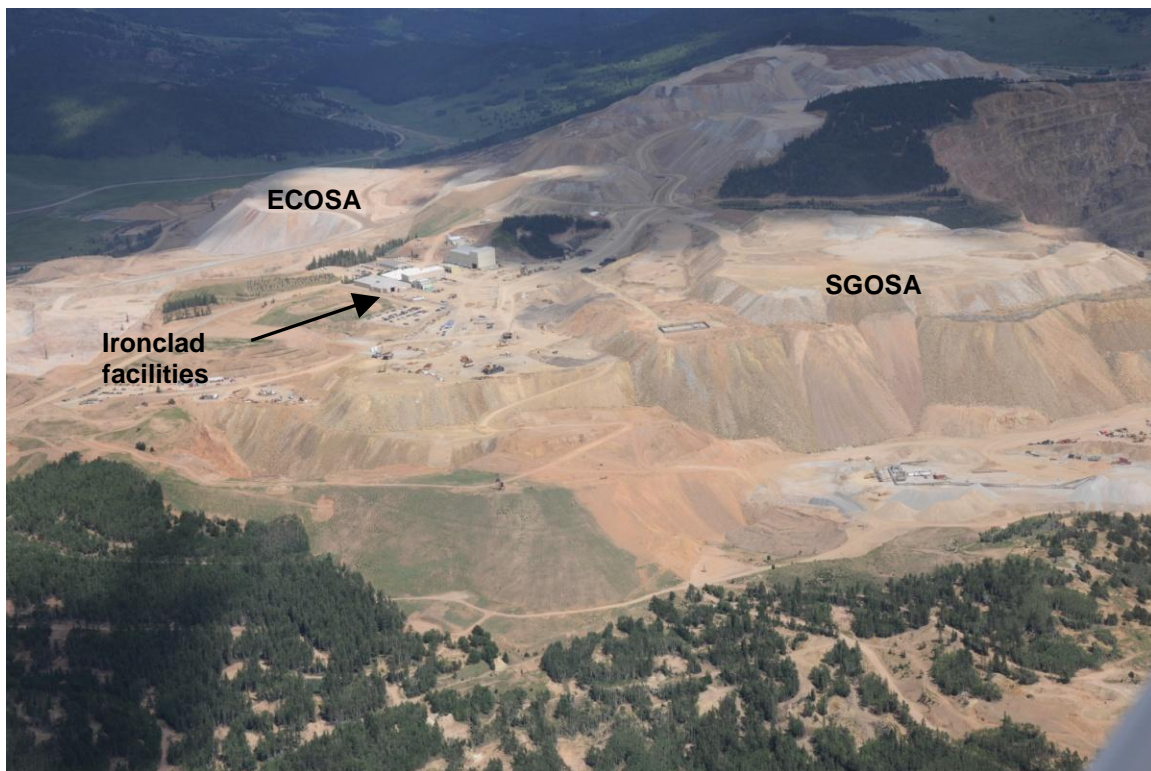
Photo 8. Squaw Gulch OSA (Looking east).

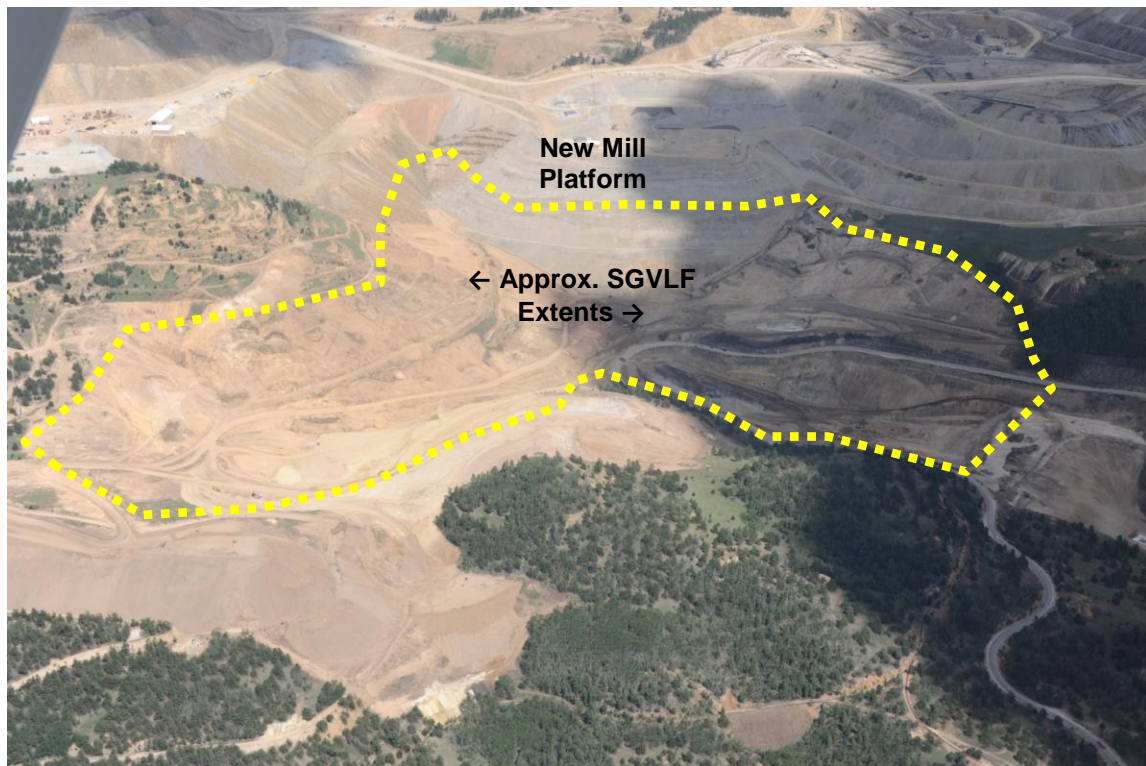
Photo 9. Squaw Gulch VLF (Looking SE).

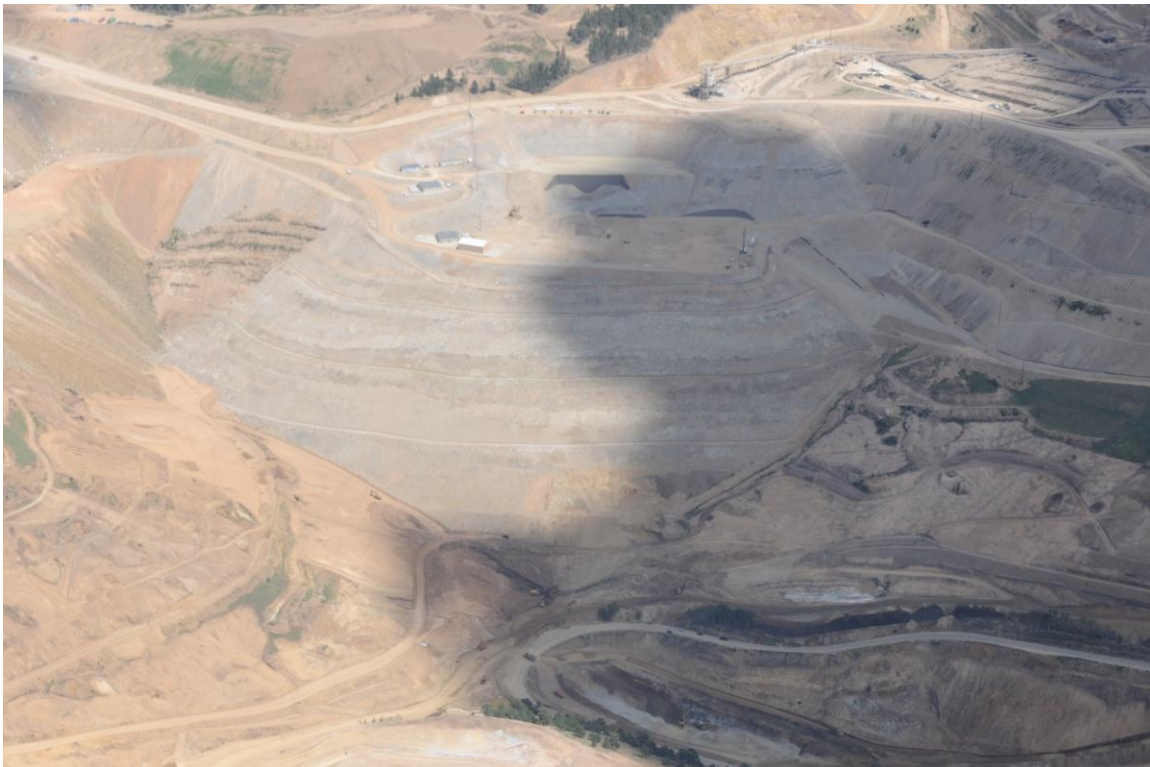
Photo 10. New High Grade Mill Platform (Looking SE).
