COLORADO DIVISION OF RECLAMATION, MINING AND SAFETY
MINERALS PROGRAM INSPECTION REPORT
PHONE: (303) 866-3567

| MINE NAME: Orphan View Gravel Pit | MINE/PROSPECTING ID#: M-2013-016 | MINERAL: Borrow material for construction, gravel & sand | COUNTY: Huerfano |
| INSPECTION TYPE: Preoperation Inspection | INSPECTOR(S): Timothy A. Cazier | INSP. DATE: April 30, 2013 | INSP. TIME: 10:20 |

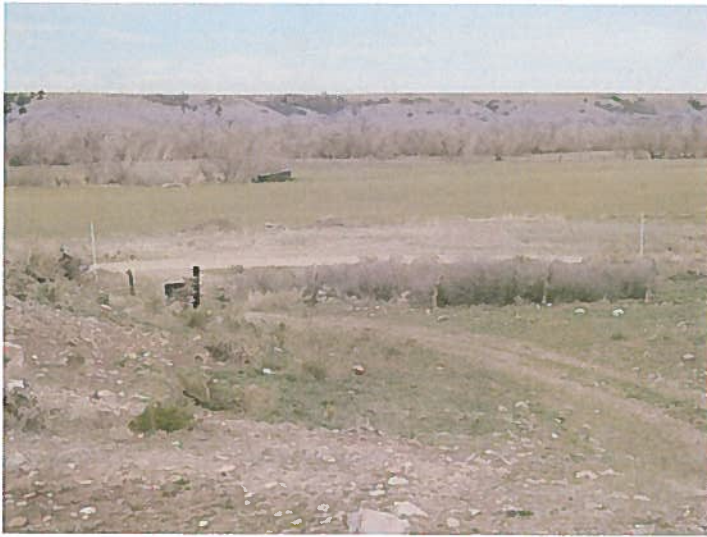
The access road is controlled by a gate (see **Photo 1**). Site corners were marked with T-posts and PVC pipe extensions (see **Photos 2 and 3**). The east and west boundaries are coincident with approved gravel pits: M-1998-066 – Hribar Pit on the east; and M-2009-027 – WSG-Hribar on the west (see **Photo 4**).

Photo 1. Access road/Proposed haul road (looking north).

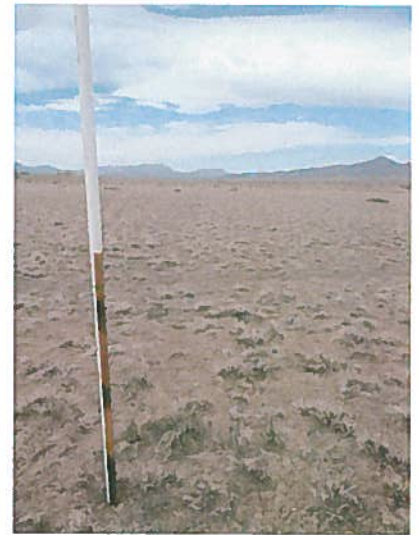
Photo 2. Typical T-post w/ extension.

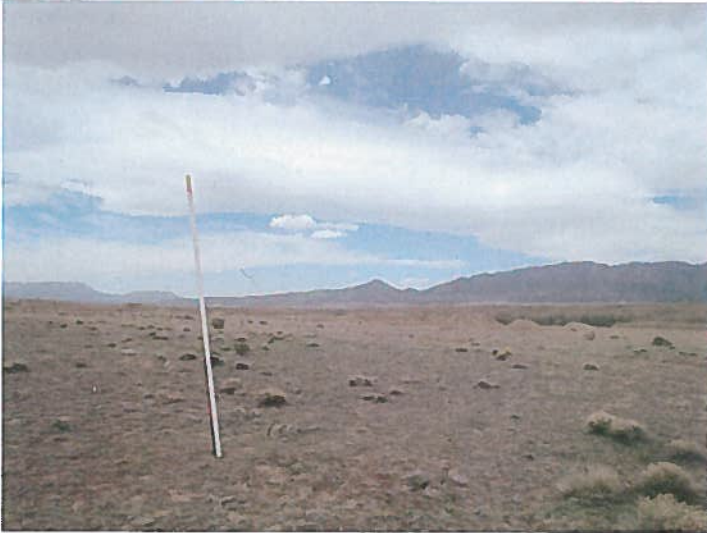
Photo 3. Southern boundary marker.

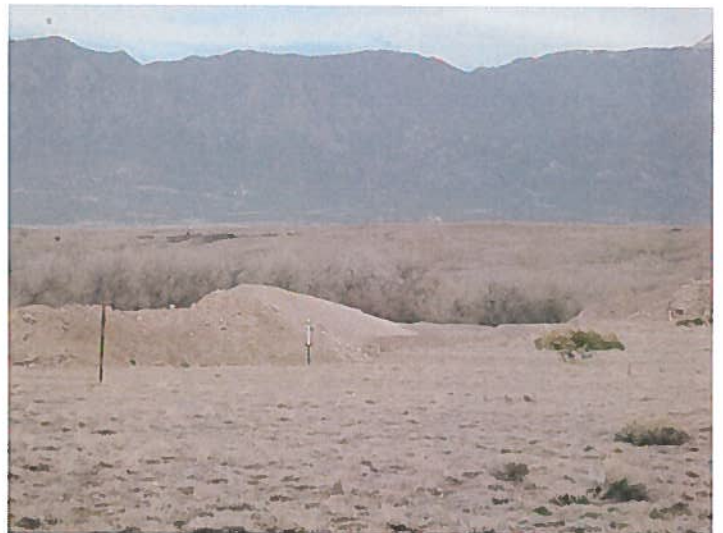
Photo 4. East boundary WSG-Hribar on the west.

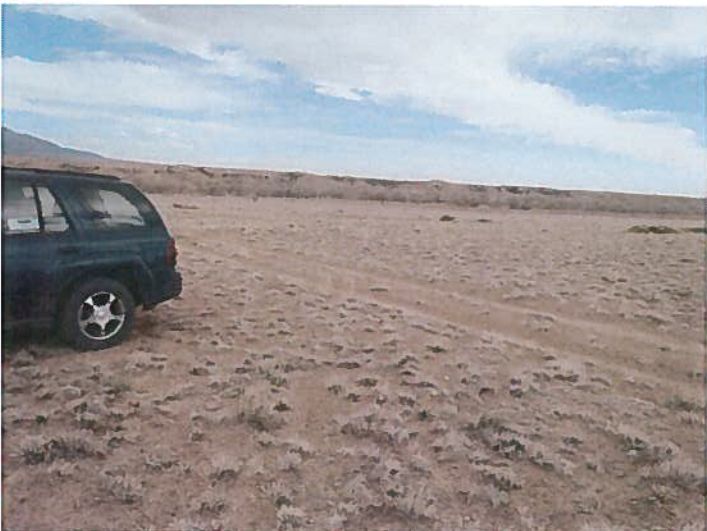
Observed vegetation is sparse (see **Photo 5**).

Photo 5. Typical sparse vegetation the bluff (looking N).

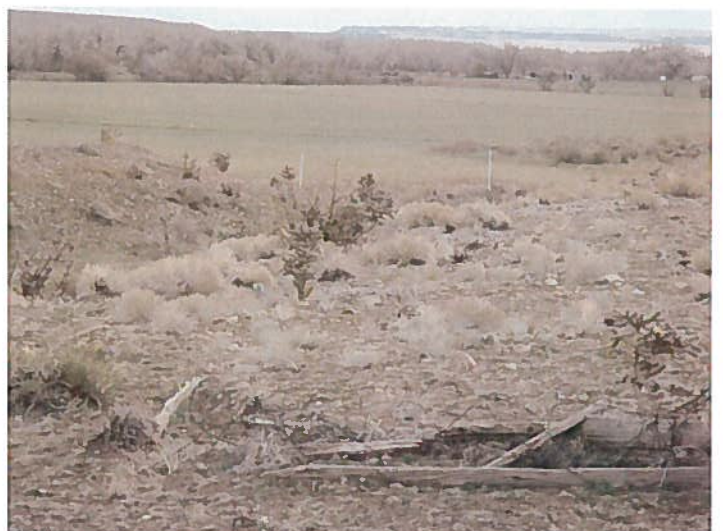
The only structures observed were site fences, some in need of repair (see **Photo 6**), and a power line on the north side that crosses the proposed haul road. Mr. Gagliano indicated there is a buried water line near the east boundary, but outside the area planned to be mined.

Photo 6. Barbed-wire fence, needing repair (looking NE).
