COLORADO DIVISION OF RECLAMATION, MINING AND SAFETY
MINERALS PROGRAM INSPECTION REPORT
PHONE: (303) 866-3567

MINE NAME: Cresson Project	MINE/PROSPECTING ID#: M-1980-244	MINERAL: Gold	COUNTY: Teller
INSPECTION TYPE: Aerial Inspection	INSPECTOR(S): Timothy A. Cazier	INSP. DATE: December 18, 2013	INSP. TIME: 10:27
OPERATOR: Cripple Creek & Victor Gold Mining Company	OPERATOR REPRESENTATIVE: None	TYPE OF OPERATION: 112d-3 - Designated Mining Operation

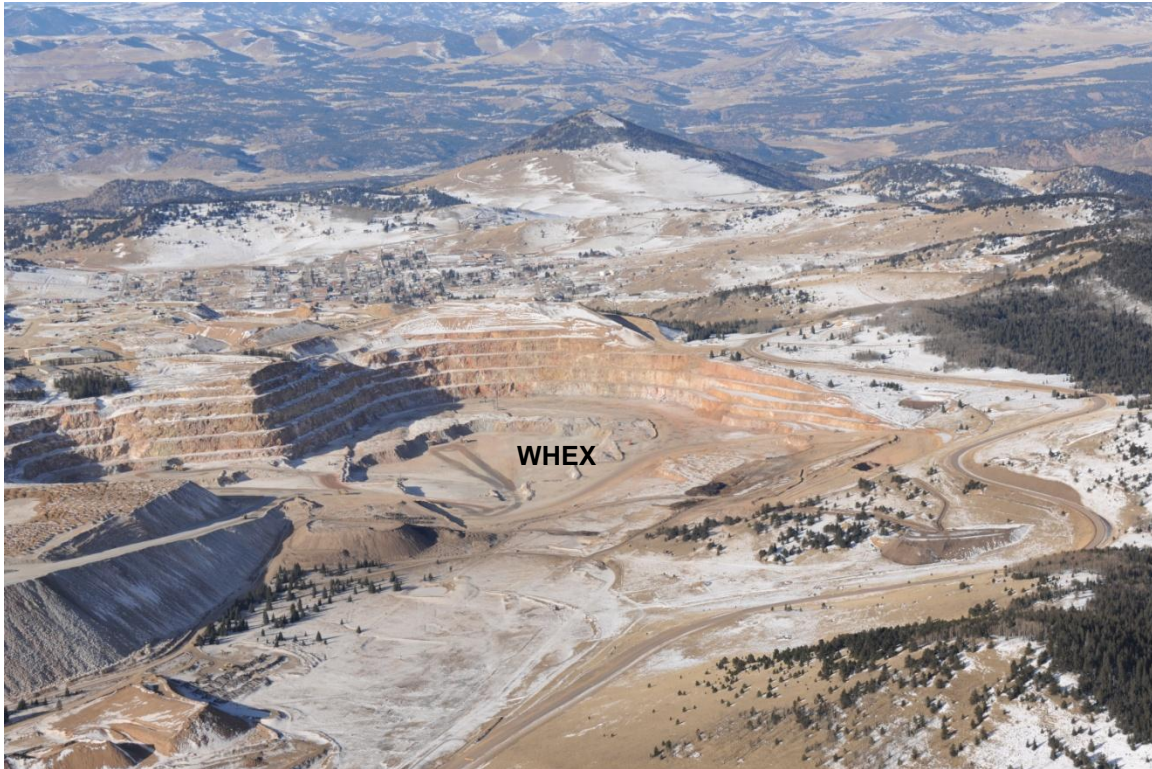
Photo 1. Wildhorse Extension Pit (Looking west).

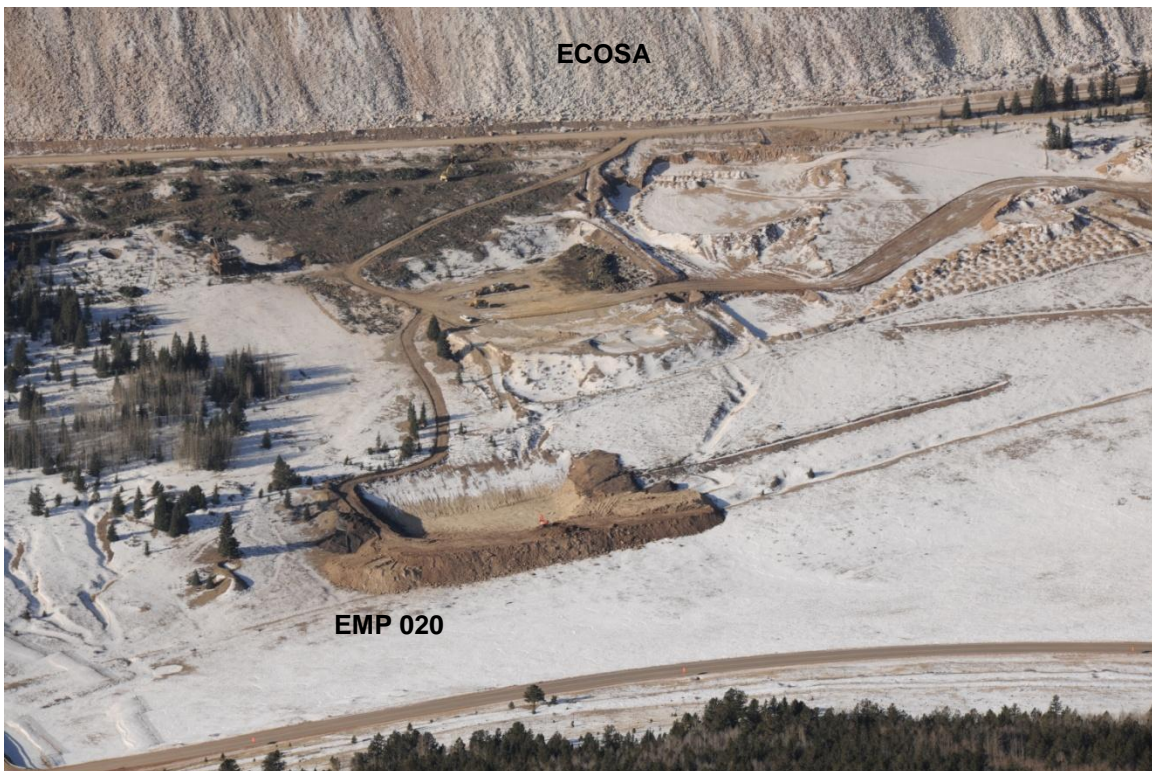
Photo 2. Enhanced Management Pond (Looking west).

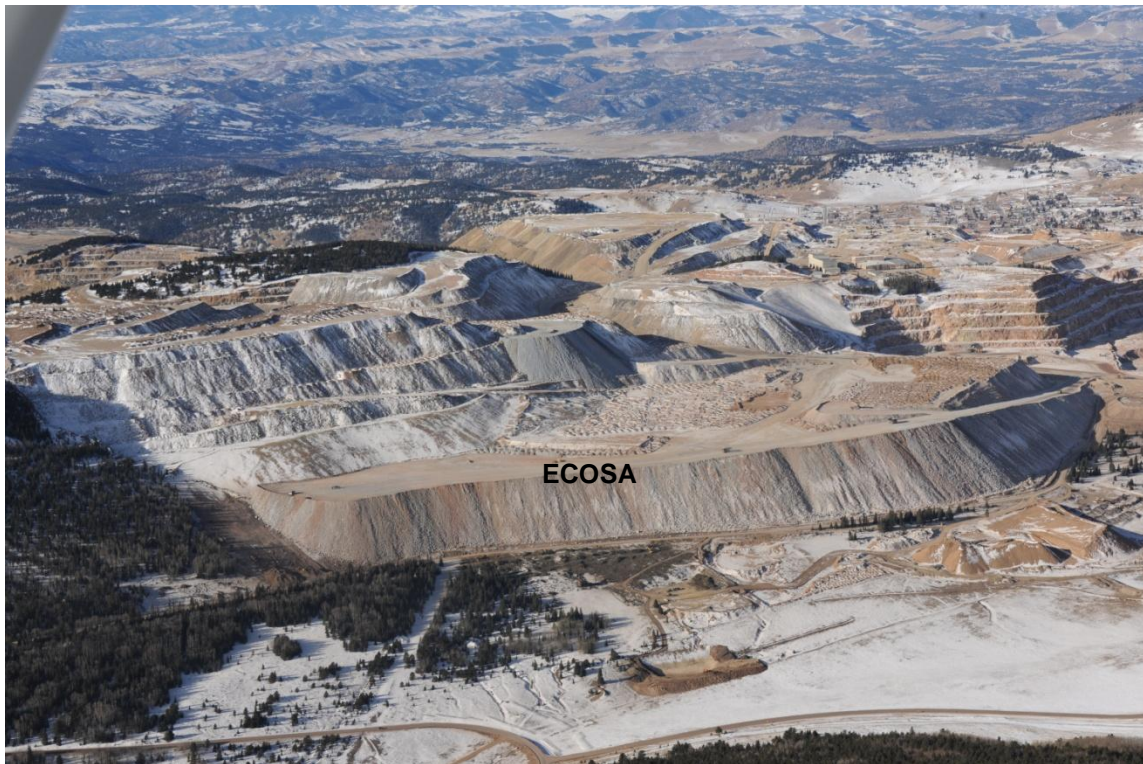
Photo 3. East Cresson OSA (looking NW).

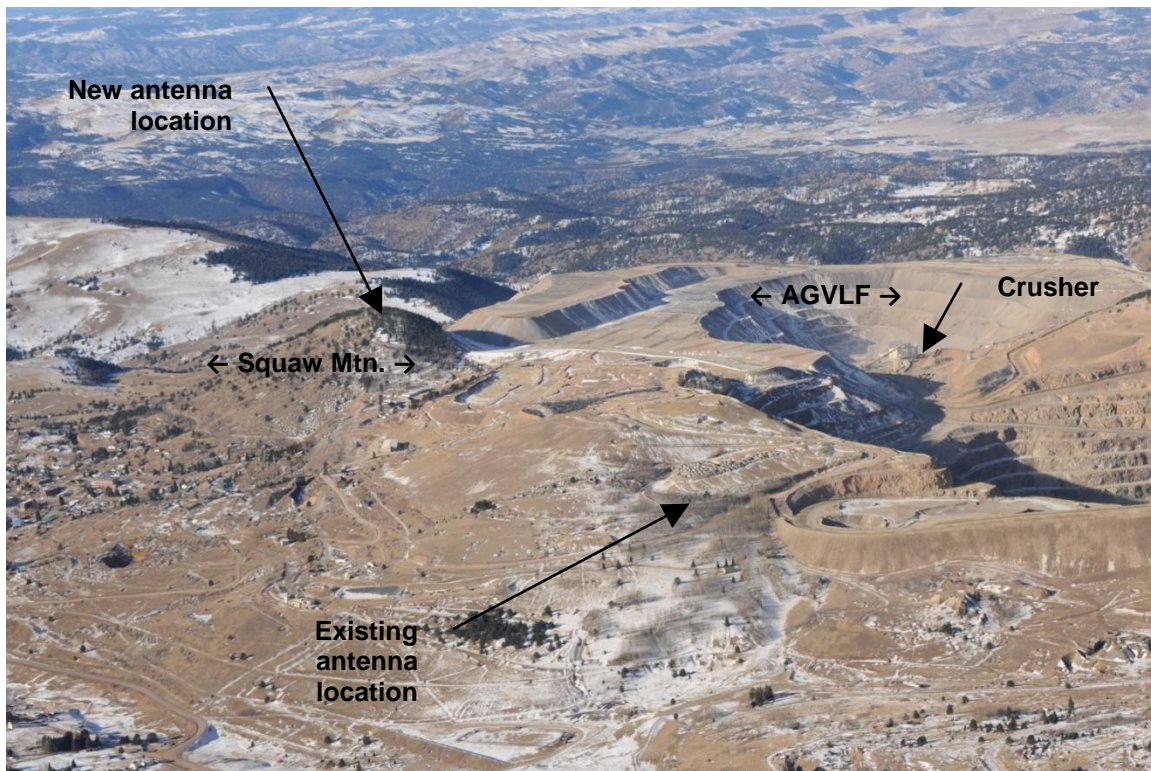
Photo 4. South Cresson (looking west).

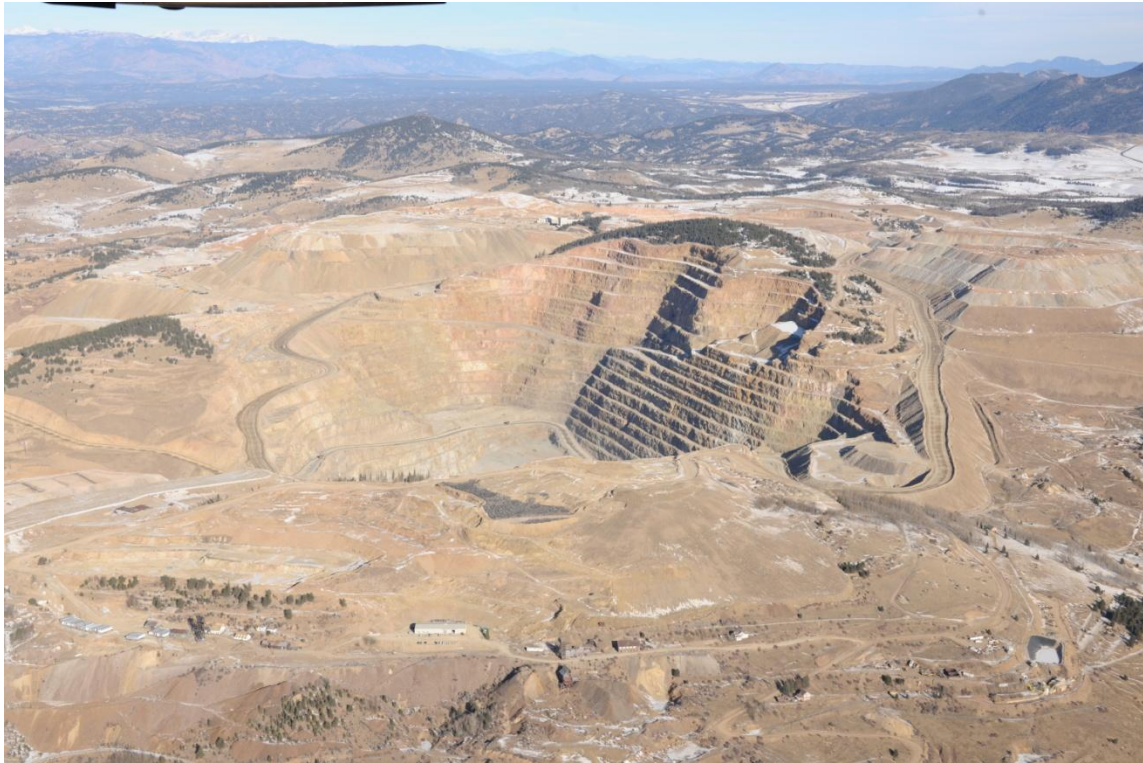
Photo 5. Main Cresson Pit (looking NW).

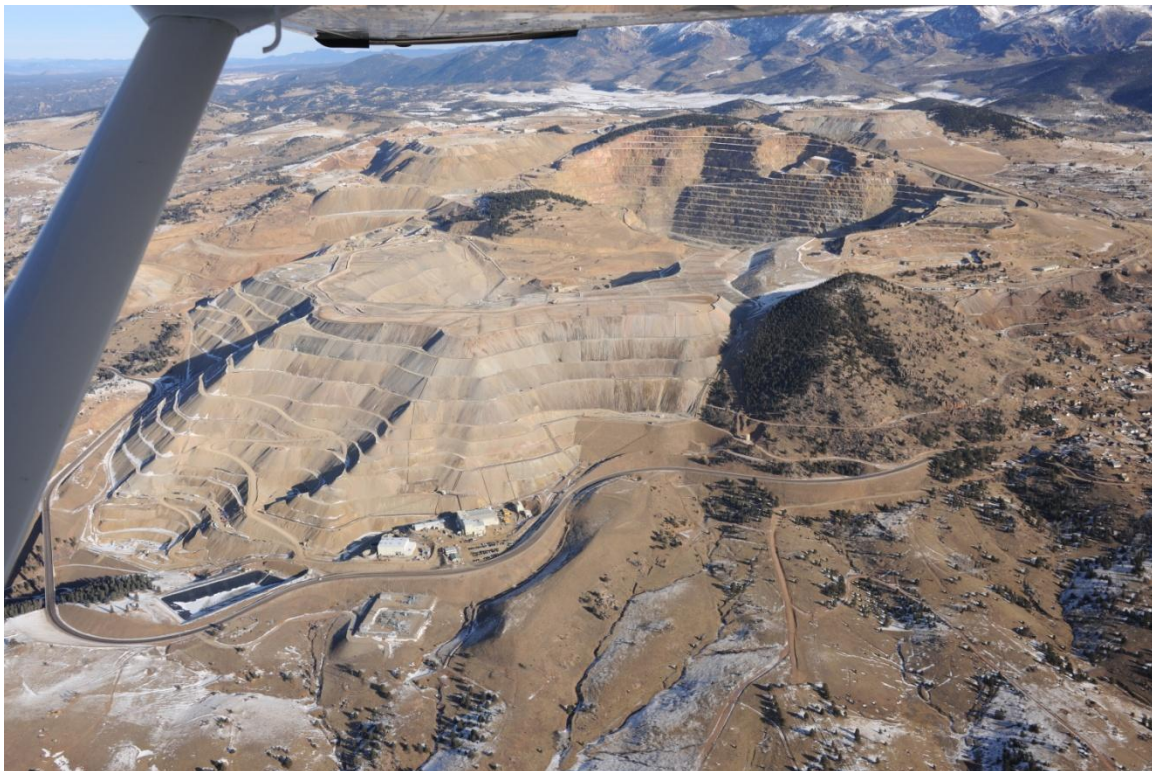
Photo 6. Arequa Gulch VLF (looking north).

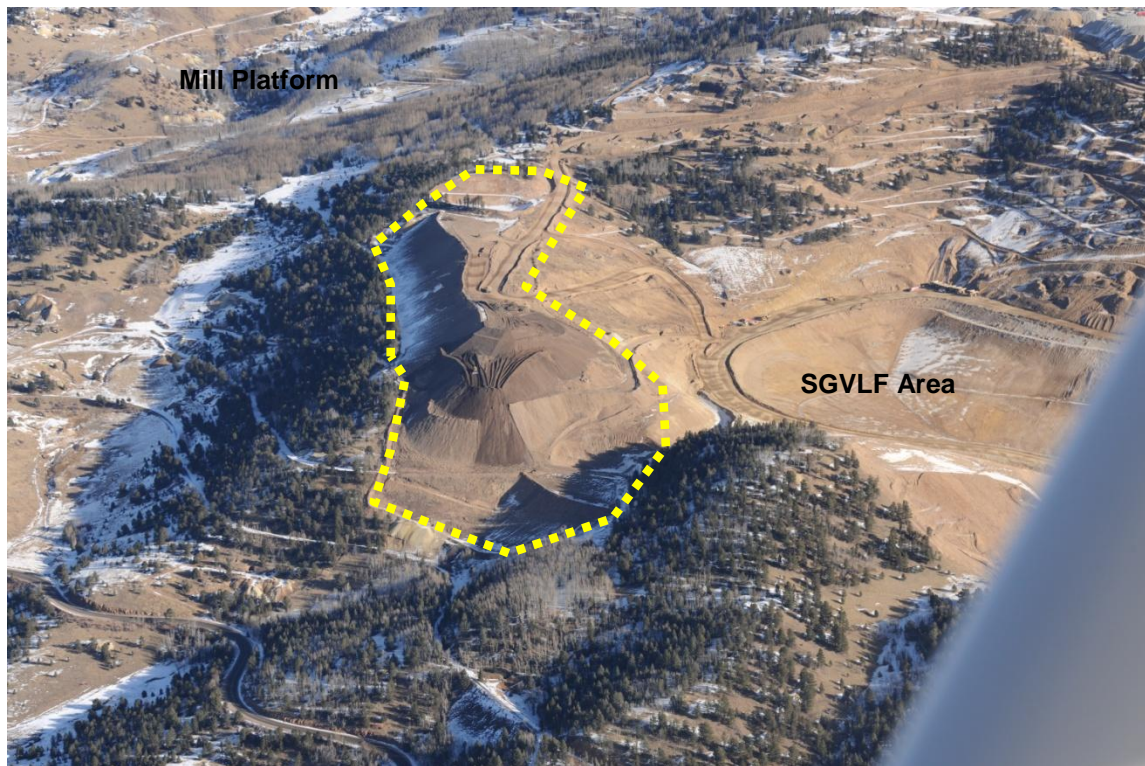
Photo 7. New growth medium stockpile #34 (looking NE).

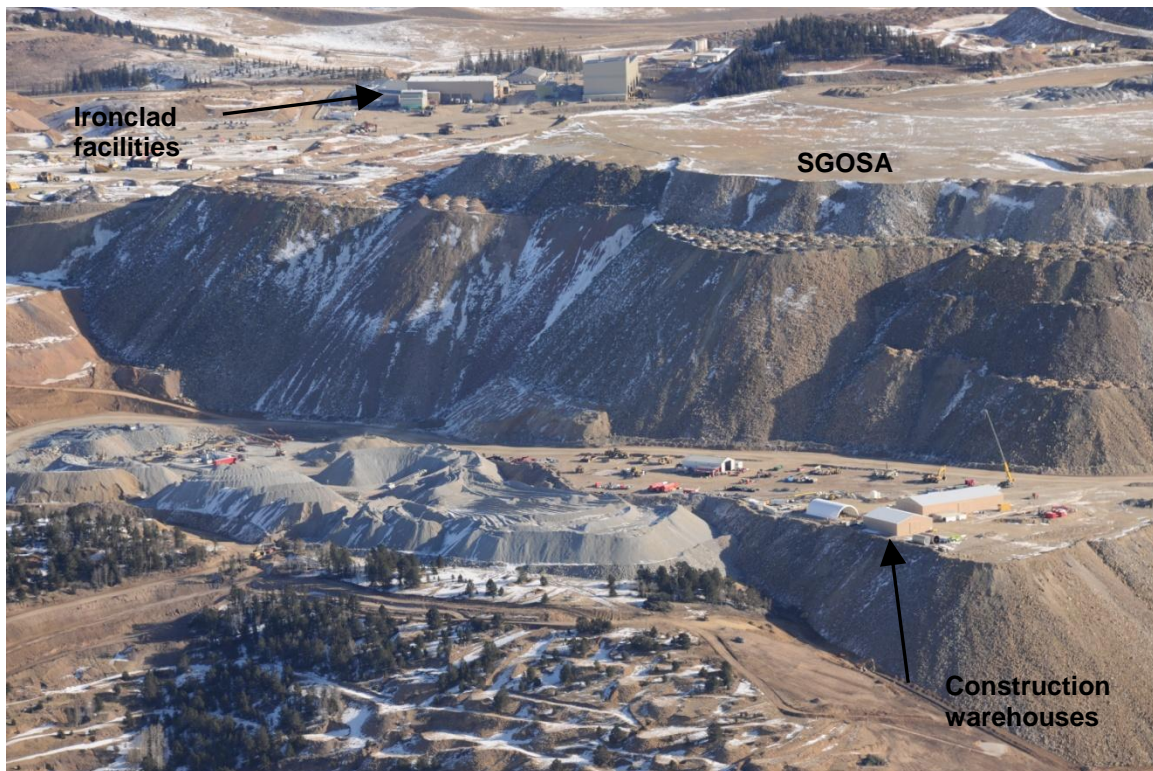
Photo 8. Squaw Gulch OSA (Looking SE).

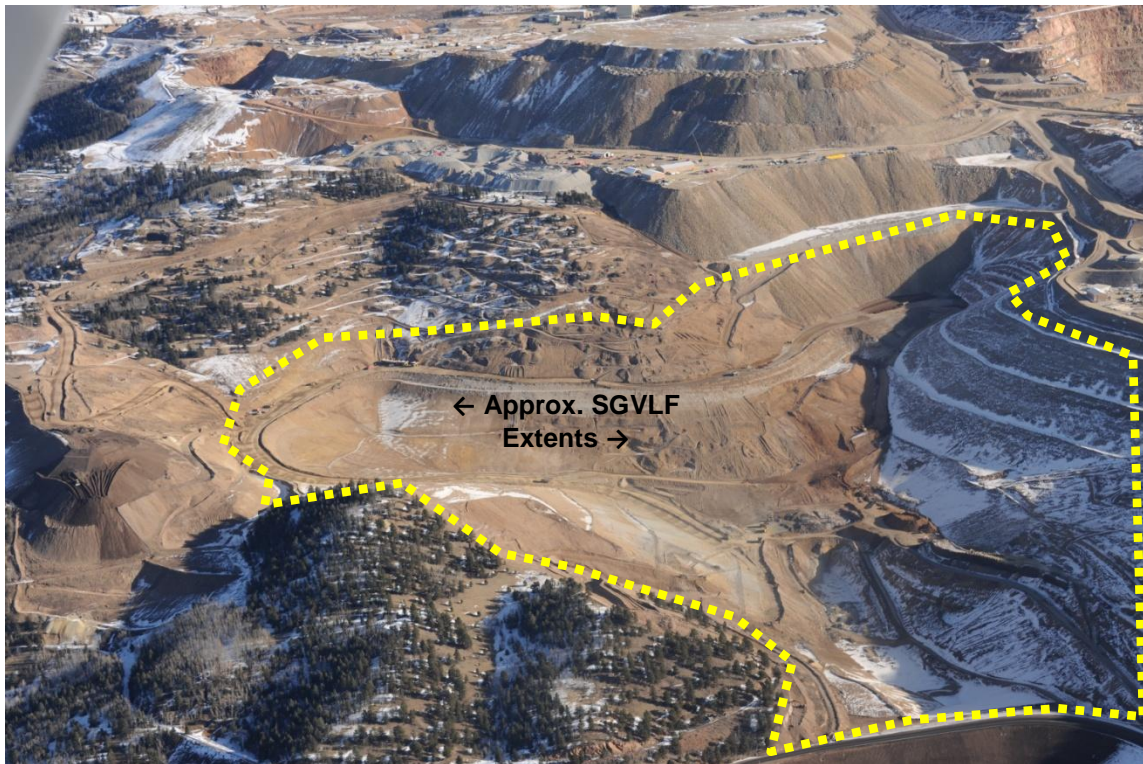
Photo 9. Squaw Gulch VLF (Looking east).

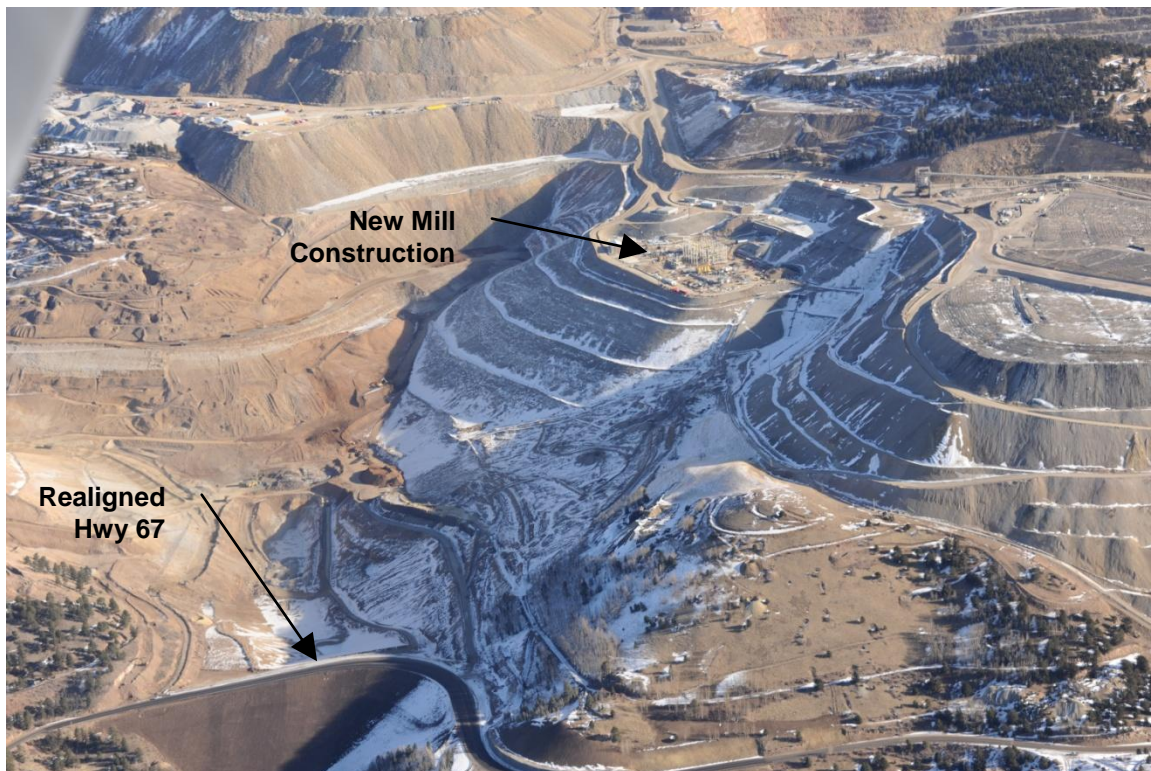
Photo 10. New High Grade Mill Platform (Looking NE).
