COLORADO DIVISION OF RECLAMATION, MINING AND SAFETY
MINERALS PROGRAM INSPECTION REPORT
PHONE: (303) 866-3567

MINE NAME: Howard Creek Pit #1 & #2	MINE/PROSPECTING ID#: M-1999-033	MINERAL: Gravel	COUNTY: Fremont
INSPECTION TYPE: Monitoring	INSPECTOR(S): Timothy A. Cazier	INSP. DATE: March 14, 2013	INSP. TIME: 10:10
OPERATOR: Fremont County Board of Commissioners	OPERATOR REPRESENTATIVE: Curtis Stone	TYPE OF OPERATION: 110c - Construction Limited Impact

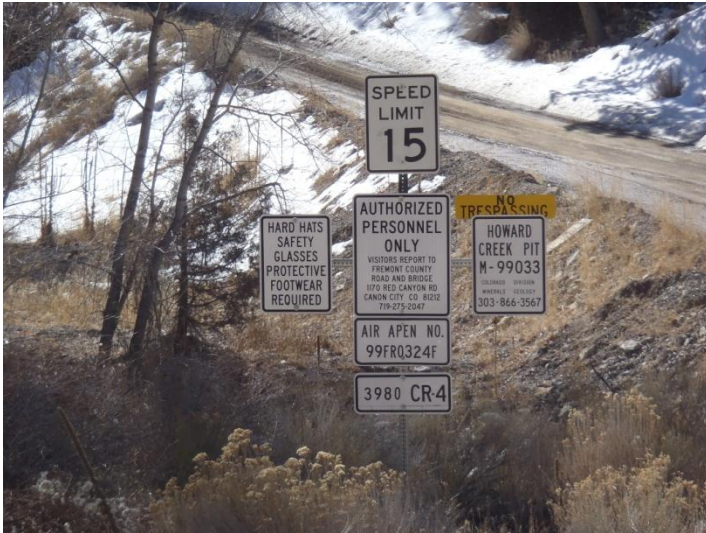
A permit sign had been displayed at the site entrance (see **Photo 1**). A topsoil stockpile was observed to be stable (see **Photo 2**).

Photo 1. Required permit sign.

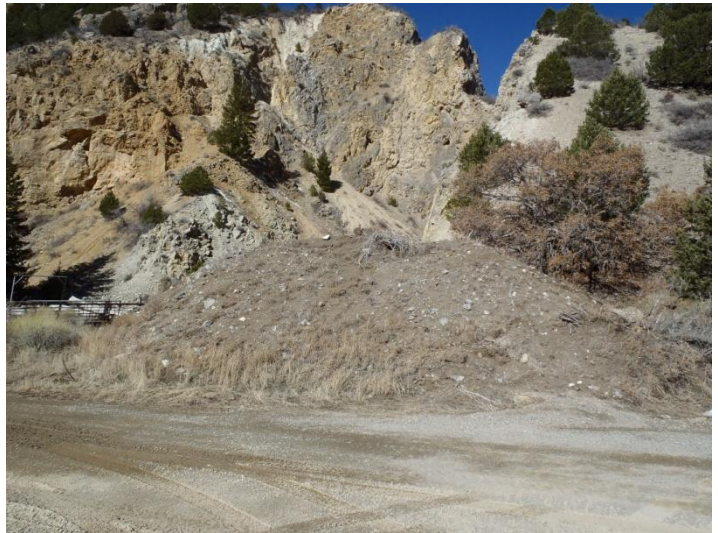
Photo 2. East pit topsoil stockpile (south side, looking SW).

1. The Operator should either flatten or begin backfilling slopes adjacent to the east pit access road such that the slope is near 3H:1V for the stability and safety of the access road.
2. The Operator should update the mine map for the 2014 Annual Report to show current working areas.
3. Signs identifying topsoil stockpiles should be placed on topsoil piles similar to those used by Fremont County on their other pits.

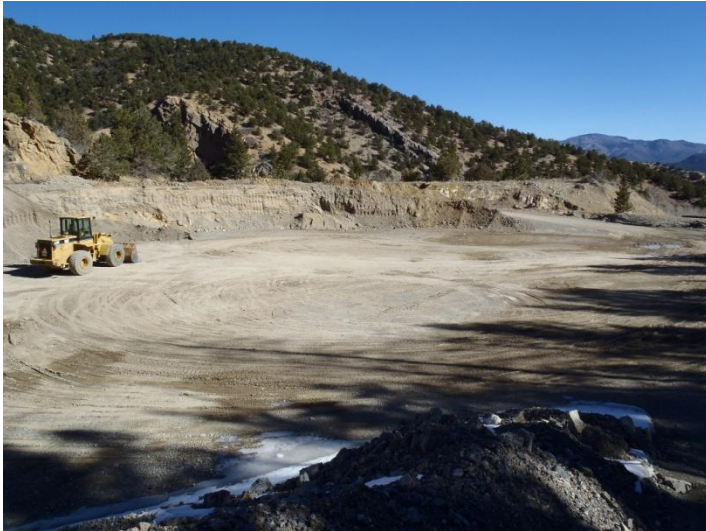
The pit was not active at the time of the inspection. Some stockpiled material was observed in the east pit. Mr. Curtis explained the County hires a contractor to crush the material. A Cat 938F loader was observed on site in the east pit where the county is currently operating. Based on the loader specifications (height), the pit wall is estimated to be about 15 feet high (see **Photo 3**). The highwall in the east portion of the pit is near vertical. However, no sloughing other than loose material that would be expected from the observed loader working the face was observed. This inspector expressed concerns about the stability of the access road (see **Photo 4**) and how the road will be maintained to allow the landowner to access the property to the south. The south boundary of the east pit is marked with a fence and a gate (see **Photo 5**).

Photo 3. East pit highwall & loader (looking north).

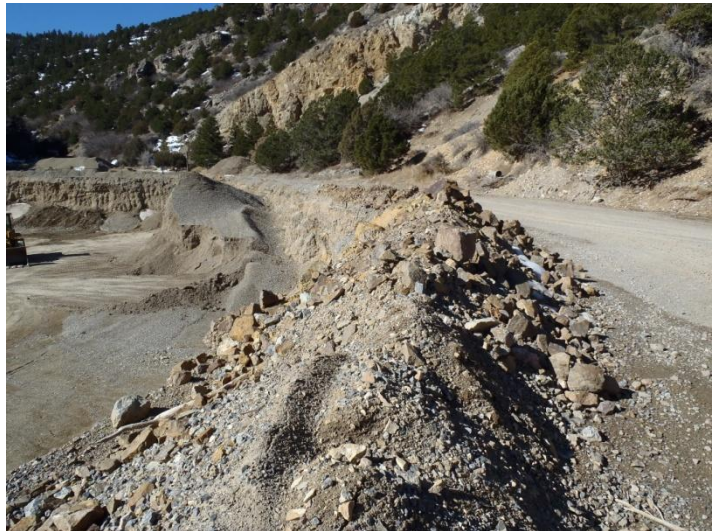
Photo 4. East pit highwall & access road (looking south).

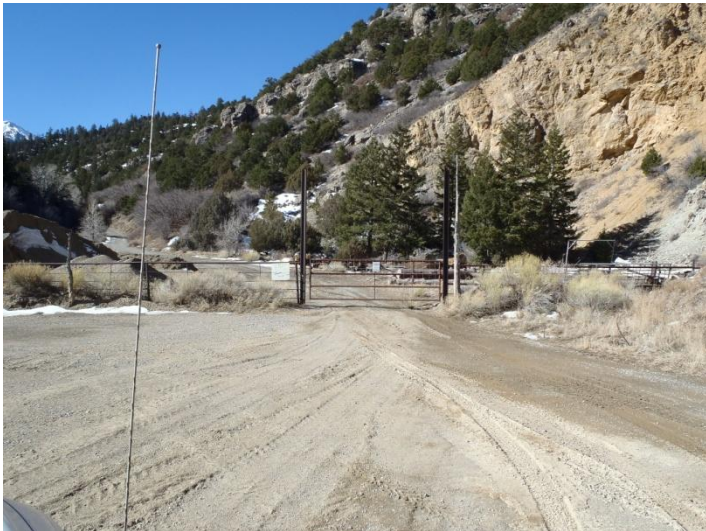
Photo 5. South boundary gate & fence (looking south).

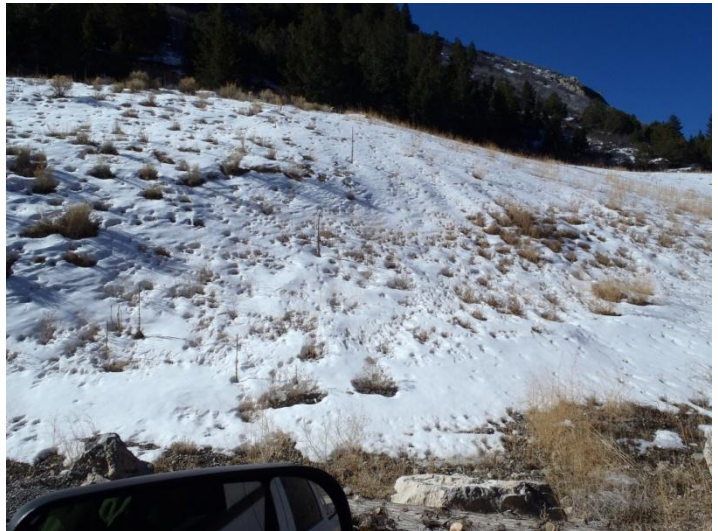
The west side pit has been mined out and reclaimed. The reclaimed slope is north facing and had some snow cover. Vegetation was observed poking through the snow (see **Photo 6**).

Photo 6. West pit reclamation (looking SW).
