Reference: Cripple Creek & Victor Gold Mining Company,
Cresson Project Squaw Gulch (VLF), Hwy 67 Realignment

Subject: Weekly Construction Quality Assurance ("CQA") Report:
AMEC: Squaw Gulch (VLF), Hwy 67 Realignment - Weeks ending 12/14/13 and
12/21/13

CRIPPLE CREEK & VICTOR GOLD MINING Co.
Squaw Gulch (VLF), HWY 67 Realignment Field Monitoring Summary Weekly Report

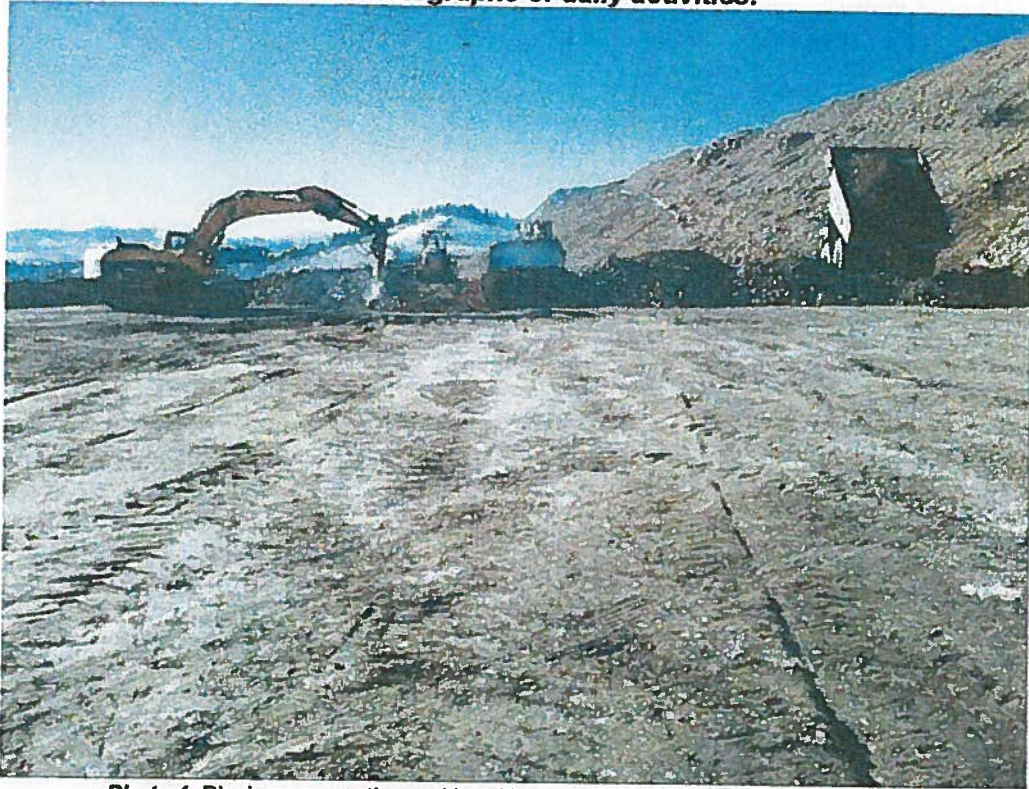
Cat 992 loaders and a John Deere 870 excavator removed structural material from near Bench A between approximate stations A6+00 and A20+00. The material was loaded into 777 haul trucks and transported to the buttress fill area between Dump 4 and the Ball Mill fill. The material was placed and compacted primarily between approximate stations H24+00 to H30+00. A Cat D8 and D9 dozer were used to spread the loose lifts and compaction was achieved utilizing a Cat CS56 smooth drum roller by method specification. Any oversized material encountered was broken with a Cat excavator hammer-hoe.

Photo 1: Placing, compacting and breaking oversize rocks at the buttress fill area.

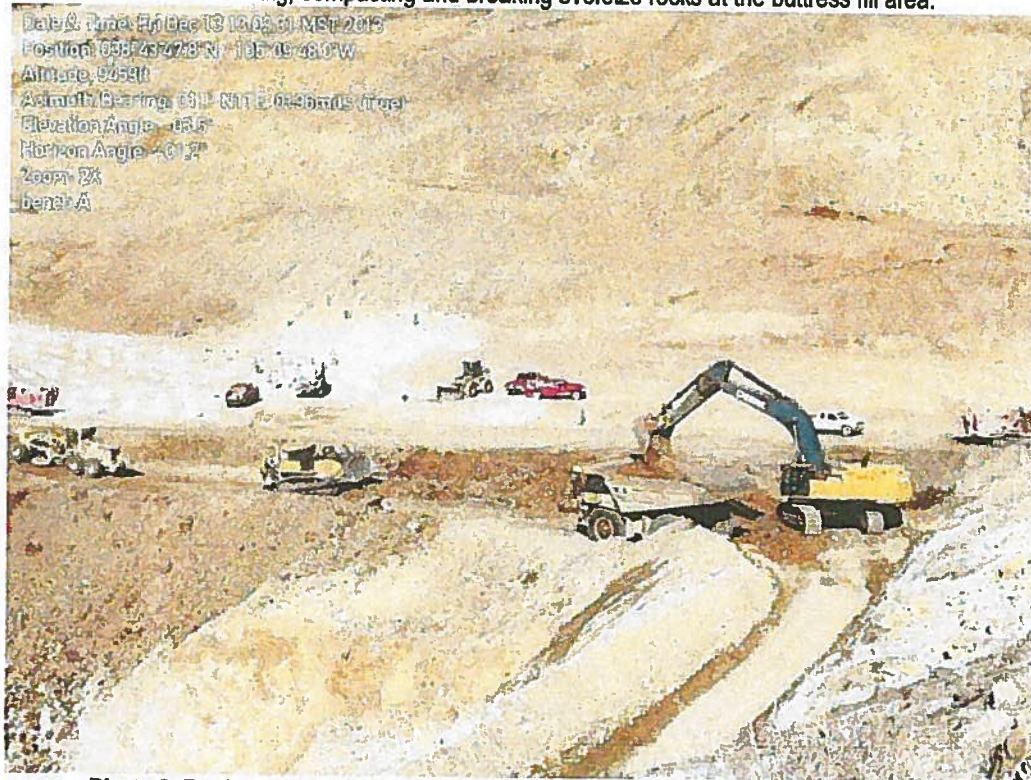
Photo 2: Production drilling near Station A16+00 and cut removal near station A18+00.

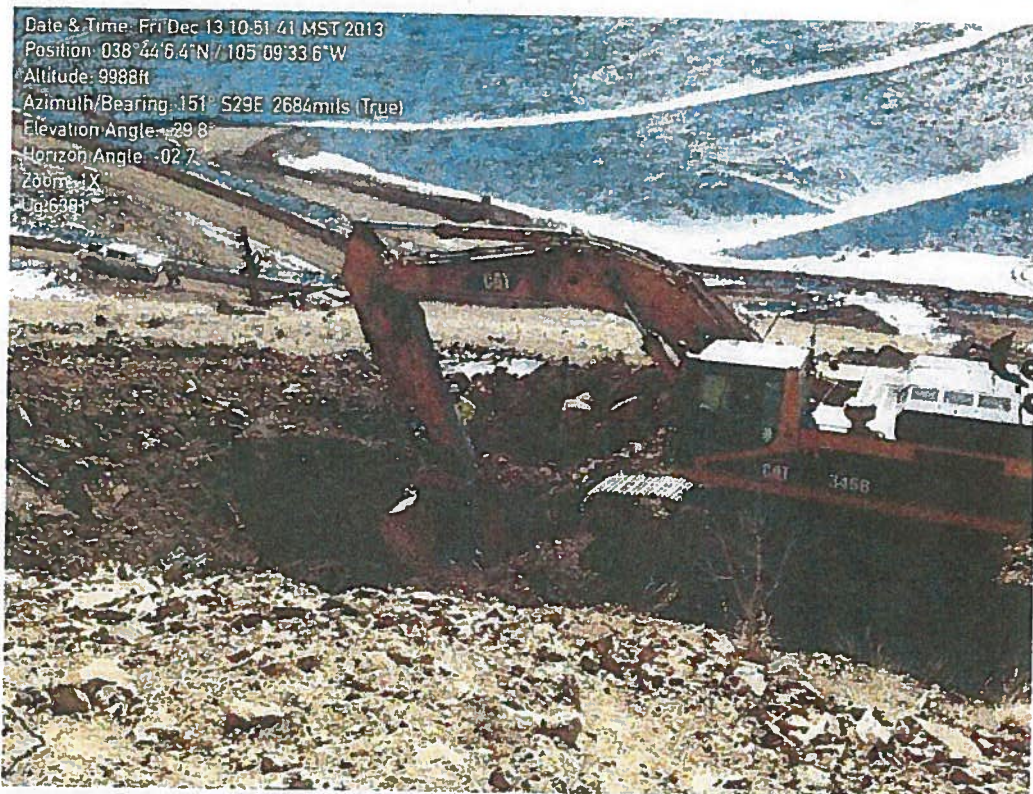
Underground workings No. 6336, 6337, 6338, U6366, U6367, U6368, U6369, U6370, 6371, U6373, U6375, 6376, U6377, U6380, U6381, U6382, U6383, U6393, and U6396 were excavated to competent bedrock, then backfilled and compacted. The workings are considered remediated.

Photo 3: Excavating UG #6381-northwest side of the working.

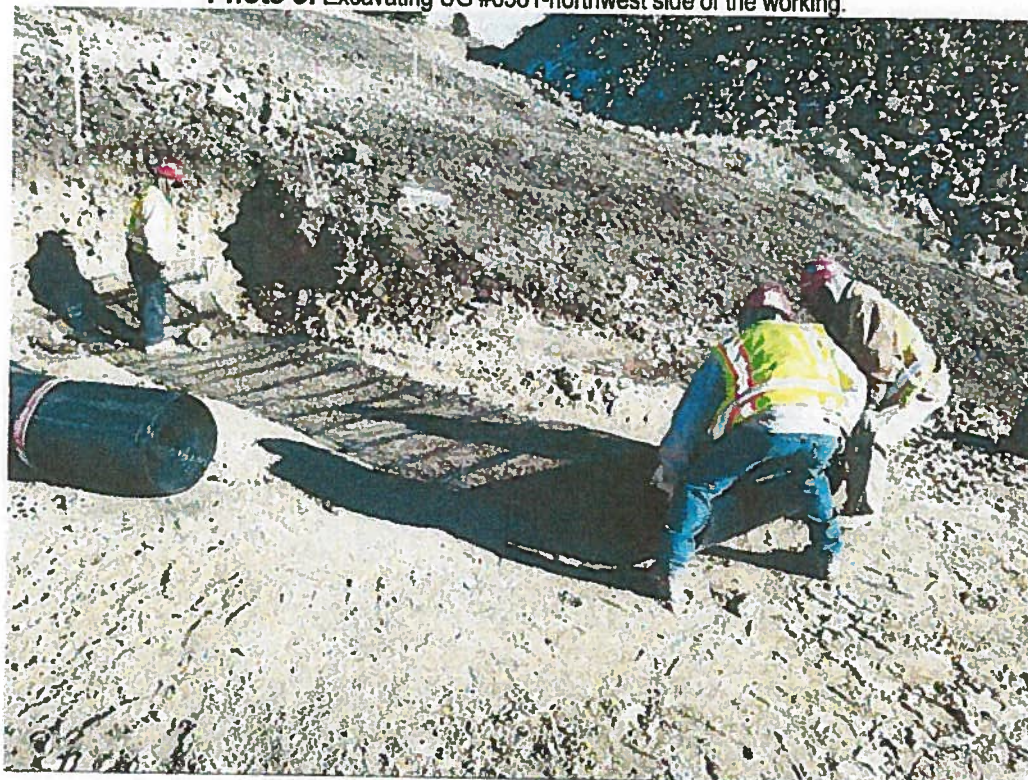
Underground working No.6372 and 6374 were filled with coarse shaft back fill material and prepared for remediation using a 2-layered geogrid system. UG 6372 has been remediated with geogrid. UG 6374 requires further work.

Photo 4: Geogrid installation on UG #6372.

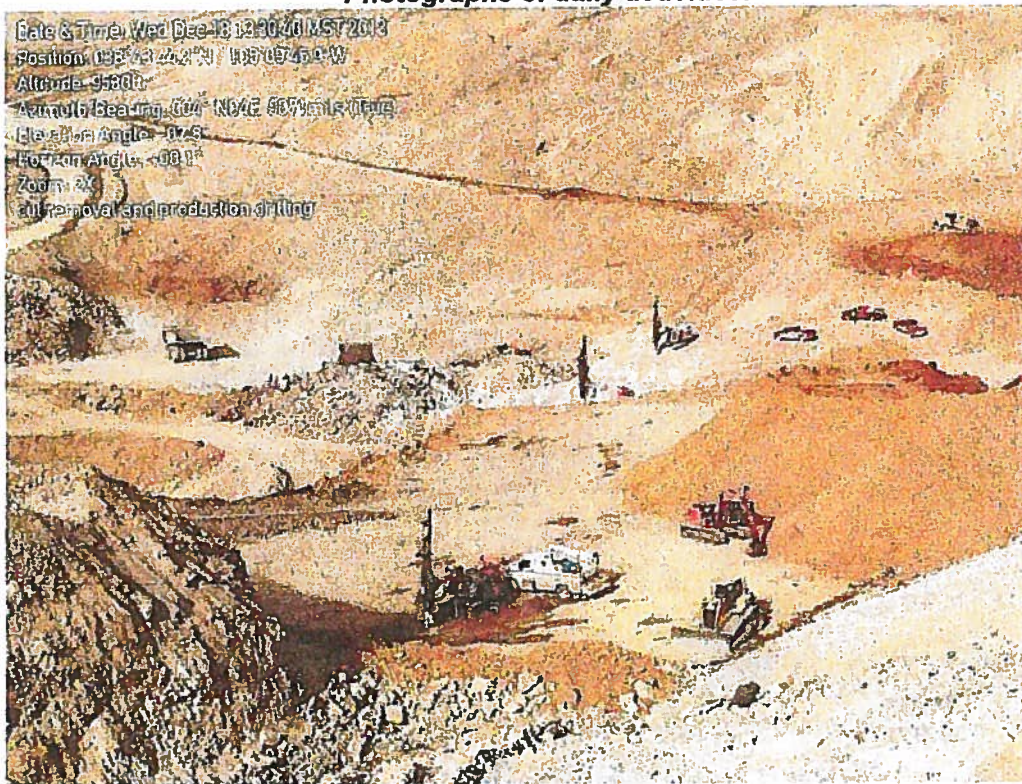
Photo 1: Cut removal and production drilling along Bench A.

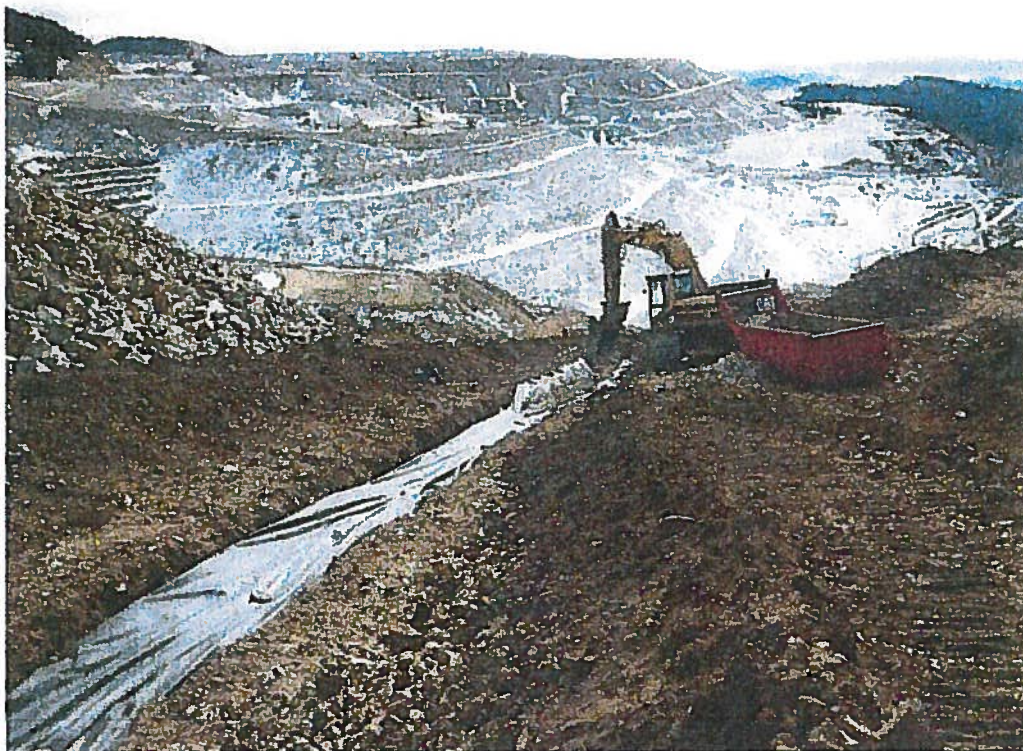
Secondary Underdrain: Approximately, 200 feet of secondary underdrain was installed between stations C6+00 and E11+00 and 810 feet was installed in the Phase 2 diversion Channel area adjacent to Dump. Approximately, a total of 5,064 feet of Secondary underdrain has been completed.

Photo 2: Secondary underdrain installation near the Phase 2 Diversion Channel.

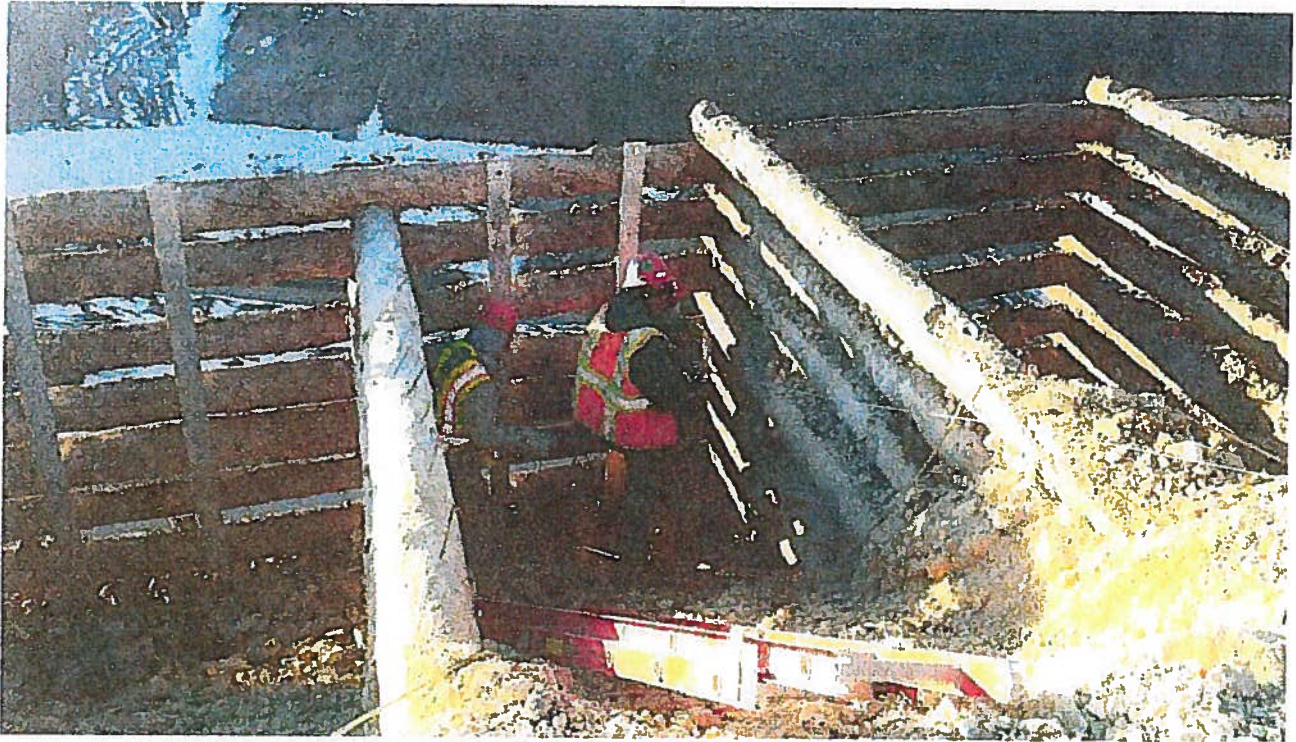
No significant activities occurred at the South MSE Wall; however, Ames worked on removing tailings and timbers from the Crib Wall. The timbers will be used as the facade at the south MSE wall; the tailings were stockpiled for later removal.

Photo 3: Preparation for timber removal at the Crib Wall

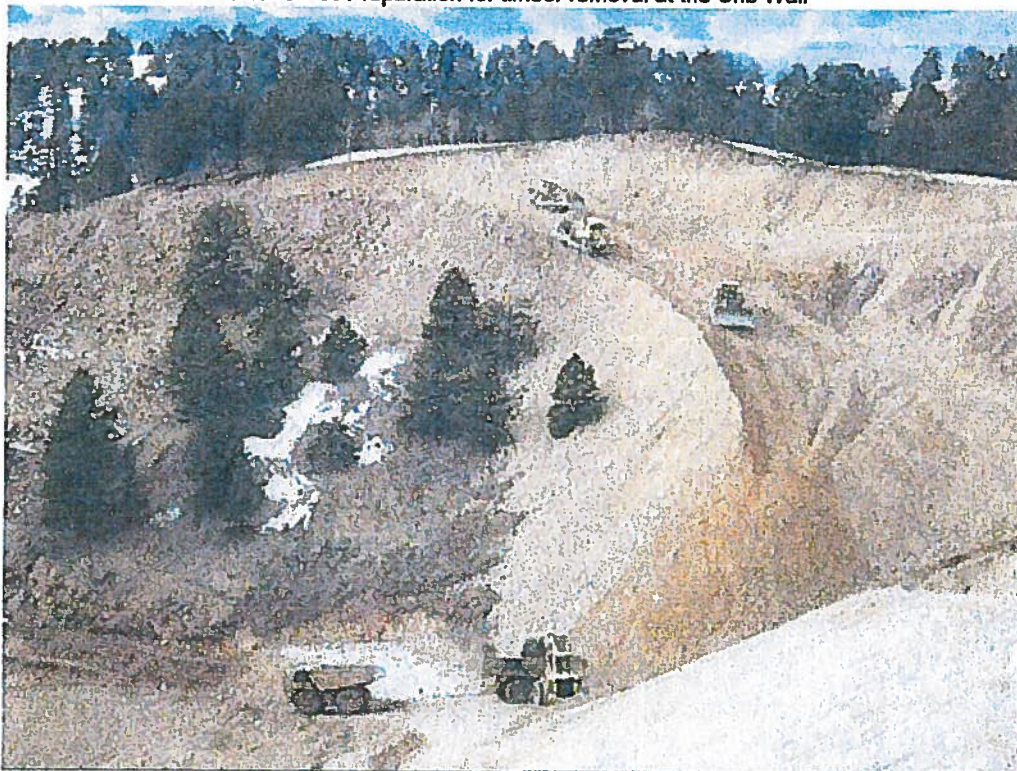
Photo 4: Cut operations between stations Q6+00 and A6+00.
