**COLORADO DIVISION OF RECLAMATION, MINING AND SAFETY
COAL PROGRAM INSPECTION REPORT**

Permit Number: C-1981-018 Mine Name: Deserado Mine Operator: Blue Mountain Energy, Inc Operator Address: Mr Scott Wanstedt 3607 County Road 65 Rangely, CO 81648	County: Rio Blanco Operation Type: Underground Permit Status: Active Ownership: Federal
	Operator Representative Present: Scott Wanstedt
Operator Representative Signature: (Field Issuance Only)

Inspection Start Date: December 19, 2013 Inspection Start Time: 11:30 Inspection End Date: December 19, 2013 Inspection End Time: 14:00	Inspection Type: Coal Complete Inspection Inspection Reason: Normal I&E Program Weather: Sunny
Joint Inspection Agency: None	Joint Inspection Contacts: None
Post Inspection Agency: None	Post Inspection Contacts: None
Inspector(s): Zach T. Trujillo	Inspector's Signature:

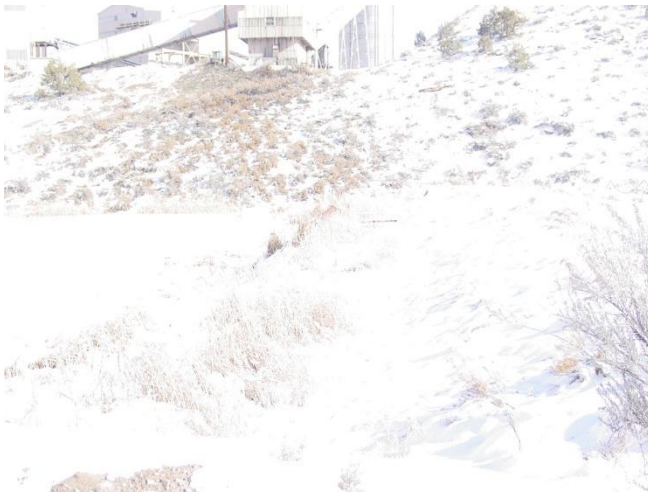
Pond DP-1 is the primary pond for the entire facility area. The pond's embankments were stable. The primary discharge is a riser pipe with the inlet was clear of debris. Cattails have been recently removed around the inlet to this spillway. The emergency spill way was well armored with rip rap and a concrete cutoff wall. The main channel from the intermediate facility bench was stabilized with rip rap. No cutting or instability was observed. The secondary channel for the same facility bench was also stable and showed no signs of cutting. The beginning of the secondary ditch is constructed with a rock check dam as additional sediment control prior to entering Pond DP-1.

Pond DP-1.

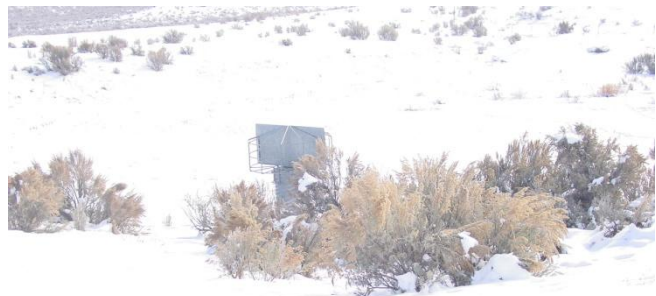
All refuse pile ponds were inspected. RP-1 collects runoff from the reclaimed Refuse Pile 1. RP-1 was dry and snow covered. The riser pipe primary spillway inlet and outlet were clear of any debris. Embankments were stable and no signs of instability. Pond RP-2/3 consists of three cells. Runoff from Refuse Pile 2/3/4 are directed into two upper cells. Once water fills to the spill way of these two upper cells, water then enters the larger third cell. The primary discharge is a riser pipe. The emergency spillway was armored with rip rap. The pond was dry at the time of the inspection. RP-4 was dry at the time of the inspection. Primary discharge is a riser pipe with a rip rap armored channel as its emergency spillway. Both spillways were clear. No issues with the embankments were noted. Pond RP-5 was also dry. RP-5 has a combination primary/emergency spillway and was armored with rip rap. Embankments were stable and vegetated.

Primary spillway for pond RP-1.

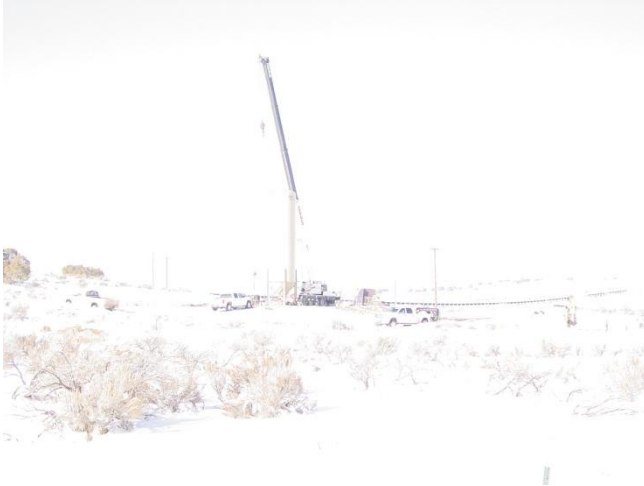
The rock dust tank along the access road to the rail road loop was being installed during the time of inspection. No issues were observed.

Rock dust tank being installed.
