COLORADO DIVISION OF RECLAMATION, MINING AND SAFETY
MINERALS PROGRAM INSPECTION REPORT
PHONE: (303) 866-3567

MINE NAME: Lob Lolly Pit	MINE/PROSPECTING ID#: M-2013-066	MINERAL: Borrow material for gravel and sand	COUNTY: Archuleta
INSPECTION TYPE: Preoperation Inspection	INSPECTOR(S): Kate A. Pickford	INSP. DATE: December 27, 2013	INSP. TIME: 10:30
OPERATOR: Arboles Sand & Stone	OPERATOR REPRESENTATIVE:	TYPE OF OPERATION: 112c - Construction Regular Operation

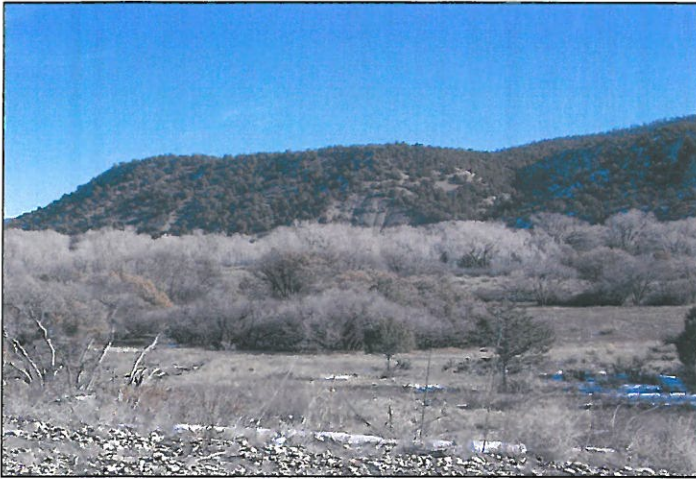
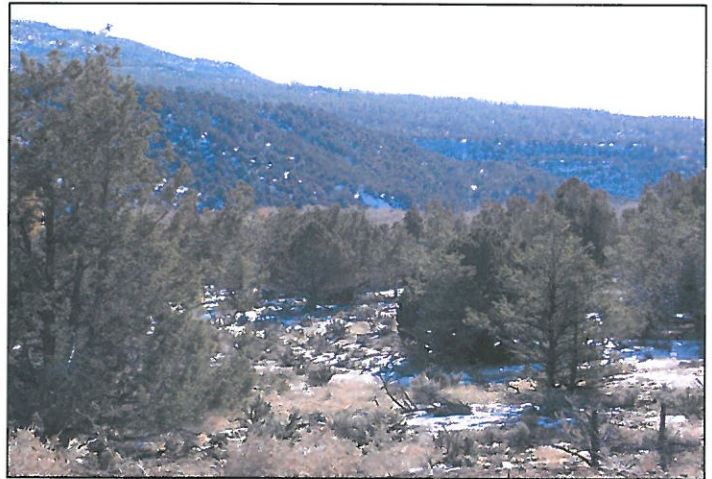
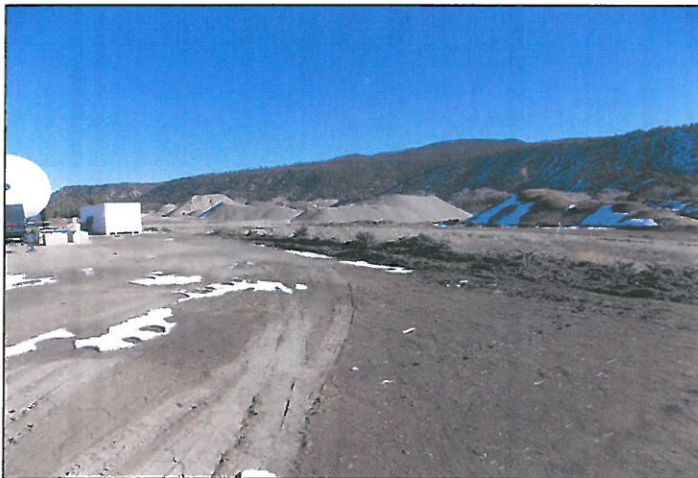
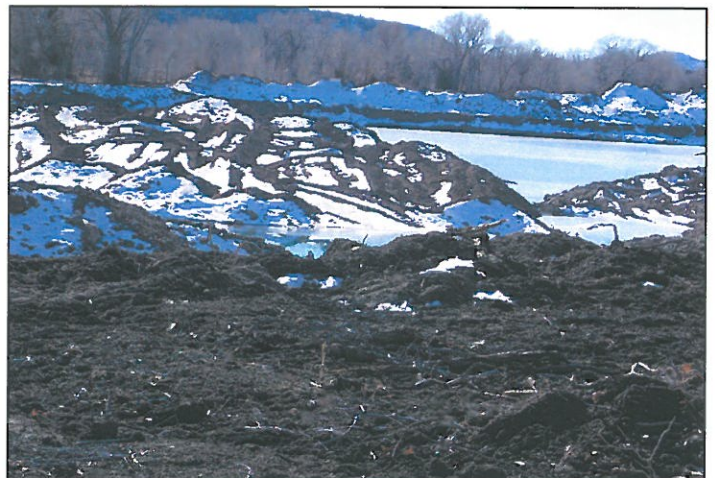
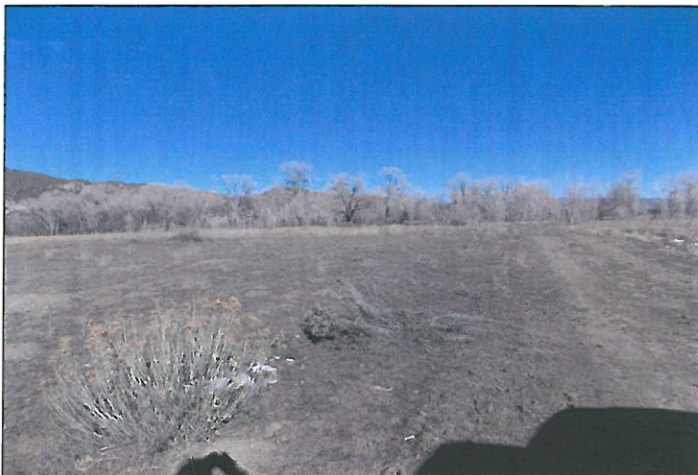
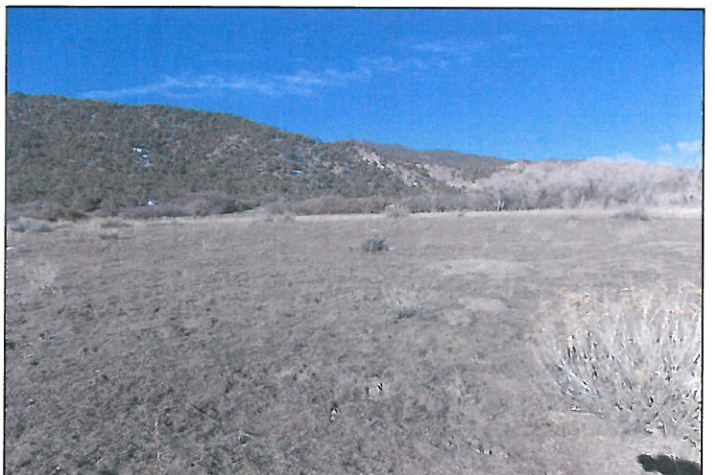
PHOTOGRAPHS

This inspection was conducted as a pre-operational inspection for a 112c permit application. The proposed site contains an already active 111 permit (M-2013-037) held by Skanska USA Civil West Rocky Mountain District, Inc. The 111 permit area is fully active with mining and stockpiles filling essentially the entire 111 permit area and beyond.

The proposed 112 site is larger and consists to two areas connected by an access road. There are oil and gas sites located within the area of the proposed permit. The proposed area of the permit includes a boundary that runs parallel to the Piedra River. The plan includes setbacks from the river aimed at reducing impacts to the river and its corridor. Vegetation within the undisturbed portion of the proposed permit includes Pinon Juniper and open grassy areas.
