RE: HOMESTAKE PITCH RECLAMATION PROJECT
2013 ANNUAL GEOTECHNICAL REPORT (M-1977-004113)

Homestake Pitch Reclamation Project
2013 Geotechnical Observations
Indian Creek and Tie Camp Creek Waste Rock Dumps

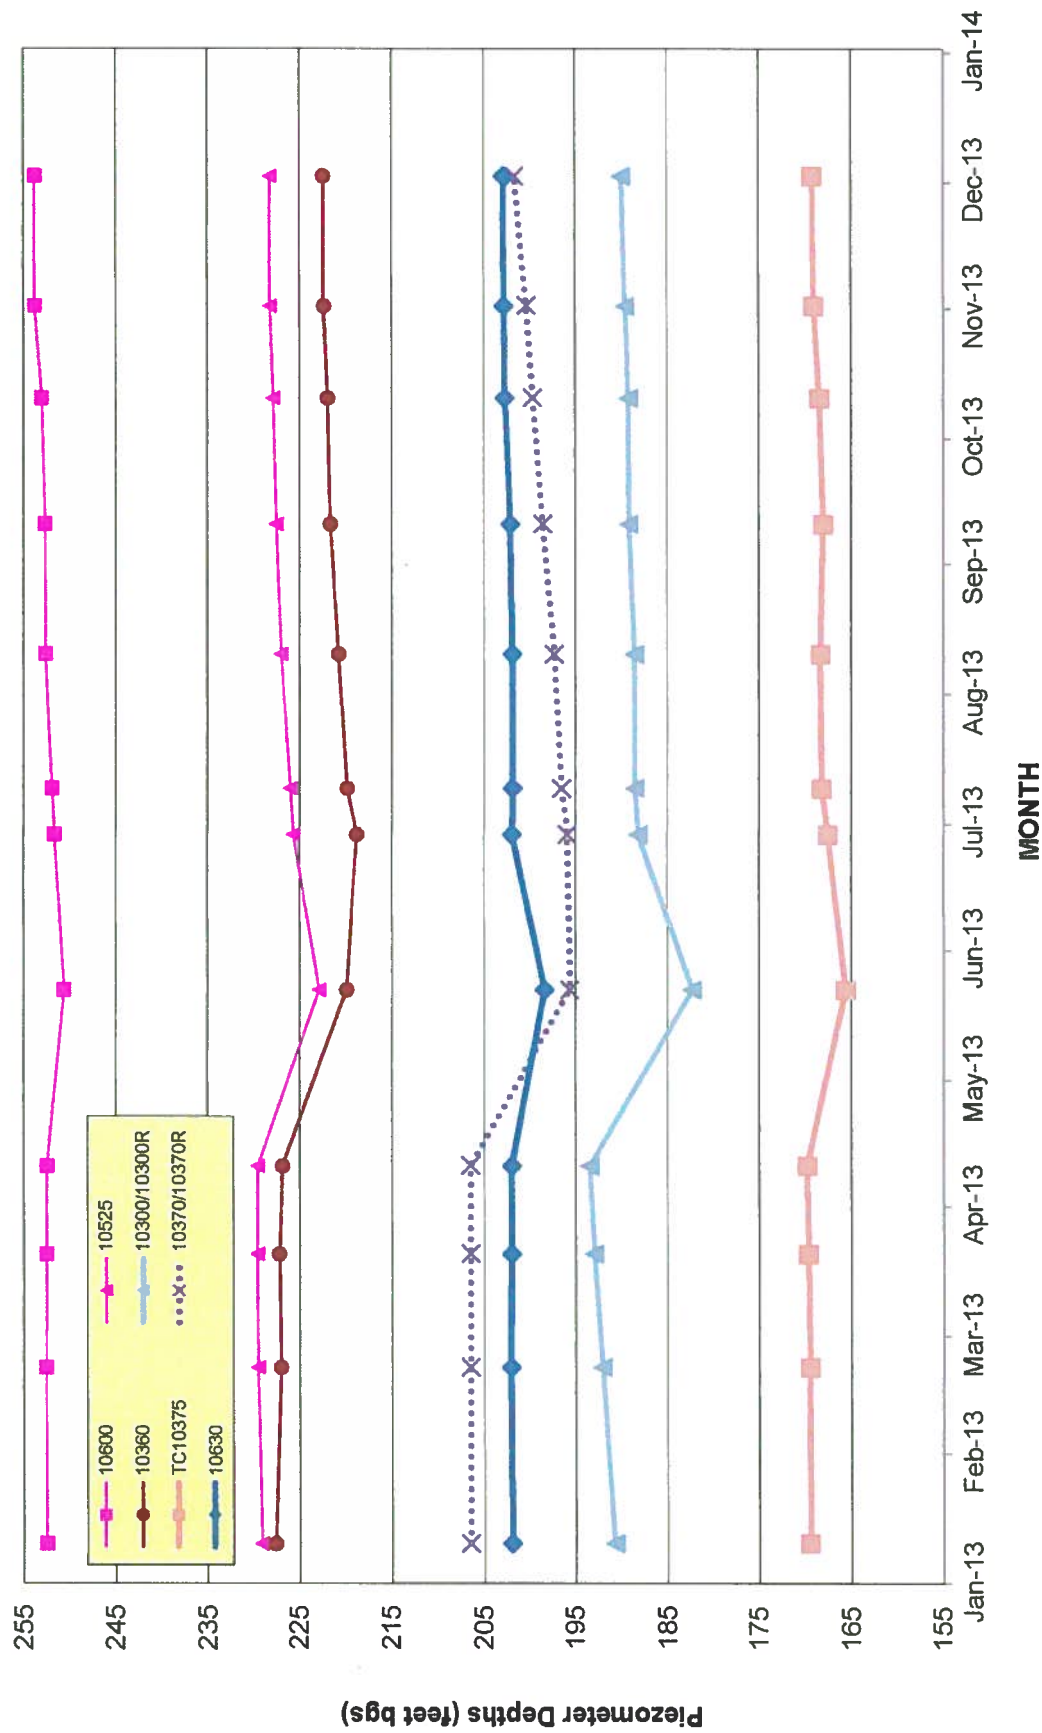
Figure 3: 2013 Water Levels in Indian Creek and Tie Camp Creek Waste Rock Dump Piezometers

2013 Observations: Unlike 2012 when the water in Piezometer IC10630 rose only 0.2 feet following snowmelt and summer precipitation events, in 2013 the water elevation in this piezometer rose by approximately 3.5 feet between January and May, and then fell back to its normal range by the end of June. This piezometer rarely has shown more than a foot of water rise following snow melt and it normally dries up by mid-summer. The maximum differential for Piezometer IC10630 during 2013 was 4.4ft.

2013 Observations: Piezometers IC10600 and IC10525 bound this area and similar to piezometer IC10600, the 2012 water level in Piezometer IC10525 rose by 6.7 feet. This compares with a 2.1 feet rise in 2012, 11.0 feet in 2011, 6.5 feet in 2010 and 8.6 feet in 2009. The small rise in the water level in 2012 and 2013 reflected a significantly reduced snow pack after several years with heavier snow pack. Even with the greater rise in more recent years, the water level in Piezometer IC10525 fell back by late summer to what be considered a normal operating range.

In 2013, the water level in Piezometer IC10300R rose by 11.1 feet compared with 2012, when the water level rose by only 0.2 feet. The average depth to water for the two year period increased by 4.3 feet, reflecting an increased snow back and heavier summer precipitation in the area in 2013. However, the water levels dropped back to normal levels after the spring snow melt.

2013 Observations: Piezometer TC10375 monitors the Tie Camp Creek Rock Dump. In 2013, water levels averaged 168.6 feet bgs, with a maximum observed seasonal fluctuation of 4.2 feet between May and June. The maximum fluctuation was higher than the 2.4 feet recorded in 2012, but well below the 2008 rise of 12.3 feet, when the site incurred heavy snow pack. This is deemed a normal and acceptable seasonal variation. Field observations indicate that the repairs performed in 1995 were successful and no new areas of surficial instability were observed from 1996 through 2013. In 2012, grading was performed on the second and third benches from the top of the rock dump to control rill erosion that had become apparent over the past couple of years due to the benches filling with silt. This repair work was described in the 2012 Annual Reclamation Report. In 2014, we will continue to monitor the surface conditions of the rock dump after the spring snow melt.

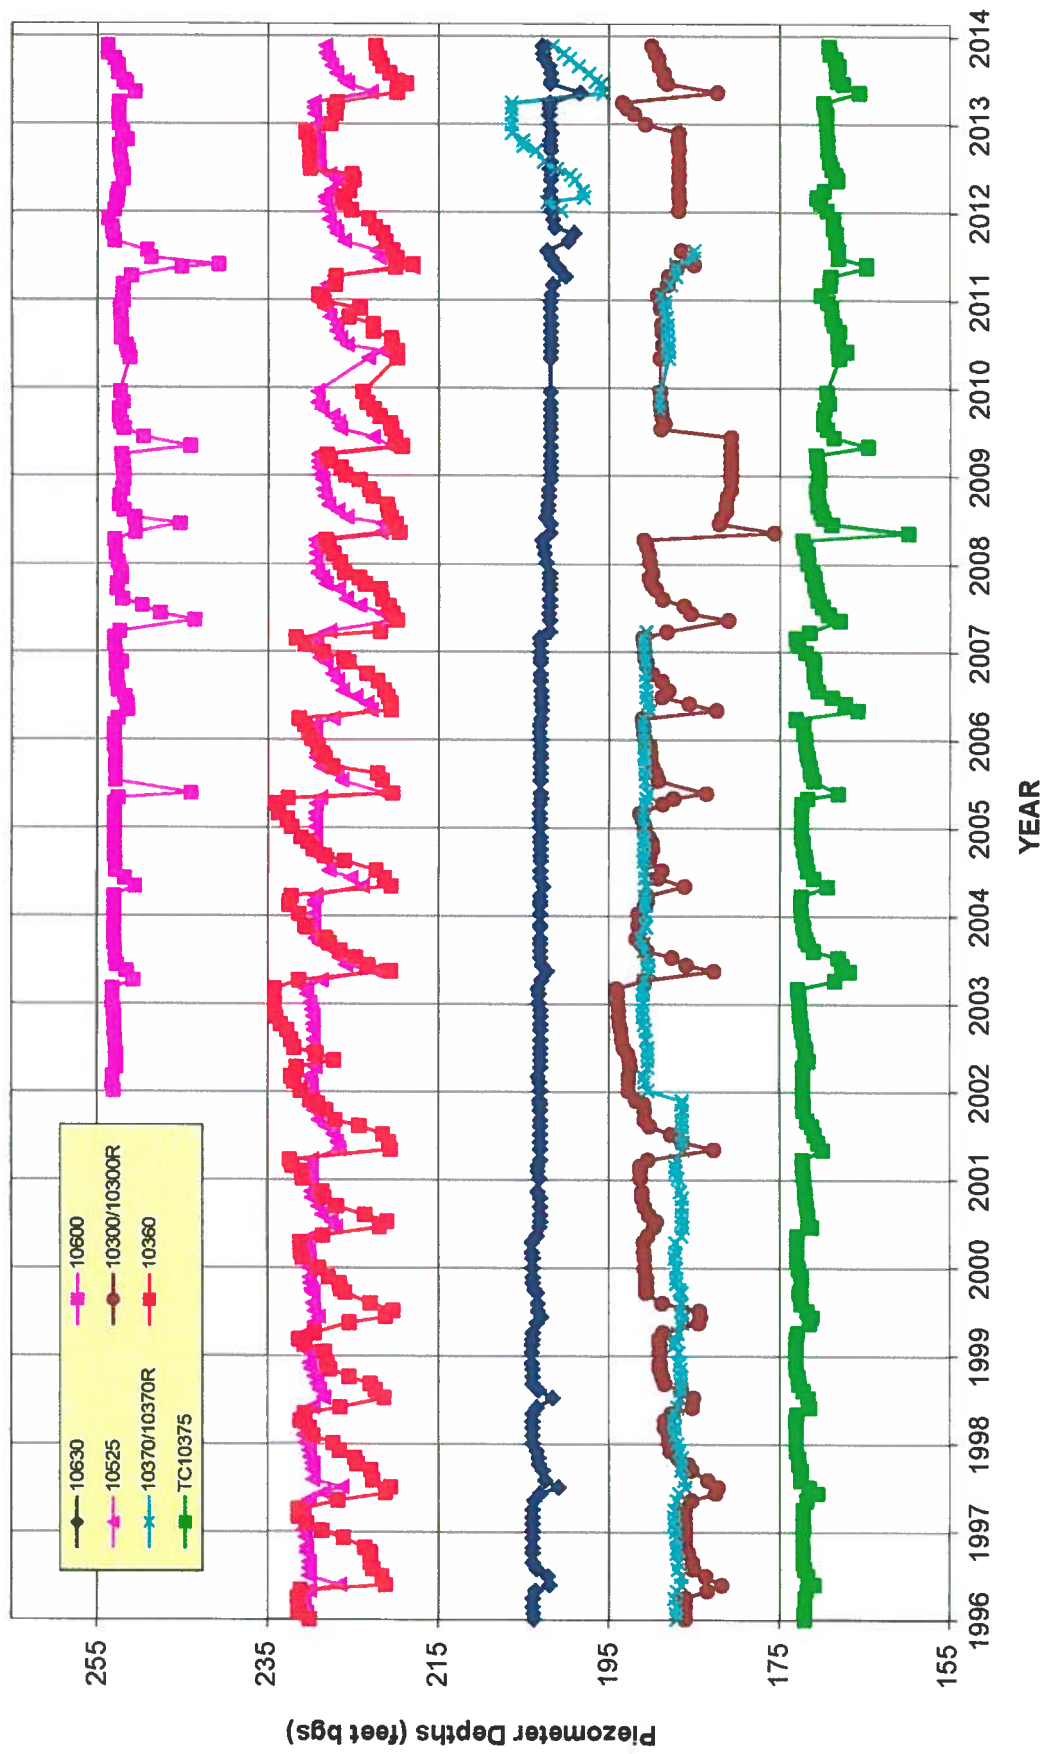
**Figure 4: Historical Water Levels in Indian Creek and Tie
Camp Creek Waste Rock Dump Piezometers**

Historically, the water levels in rock dump piezometers show little fluctuation in the winter months with a temporary rise in response to the spring snow melt. They usually return to normal levels in mid to late summer. Two of the piezometers in the Indian Creek rock dump were replaced in 2011 after several years of issues associated with corrosion and silt buildup in the well casing making it difficult to get an accurate reading of the phreatic surface in the rock dump. All of the piezometers are now functioning as required to provide accurate water level information. The 2013 monthly water level measurements are provided on Table 1 of the attached report. The piezometer readings in 2013 were indicative of the reduced snow pack the past two years and heavier summer precipitation. The water level readings in 2013 are plotted as Figure 3 and a graph with piezometer water levels since 1996 is provided as Figure 4. The Y-axis on these plots is labeled as depth to water from the ground surface.

The 2013 water level measurements showed a maximum differential following snow melt above the 2012 measurements, but below that of the previous five years due to differences in snow pack and summer precipitation. Following the dry conditions of 2001 through 2003, the seasonal variations had increased in recent years as heavier snow packs had occurred, with 2012 being a relatively dry year. The replacement of two piezometers in the Indian Creek rock dump in 2011 has alleviated issues in monitoring the phreatic surface in the Indian Creek rock dump. We will continue to monitor and evaluate the cause and effect of any seasonal spikes in the piezometric water levels, observe any changes in surface features of the rock dumps and repair as needed. There continues to be no indication of concern related to slope or foundation instability or elevated phreatic surfaces in either the Indian Creek or Tie Camp Creek rock dumps.
