**COLORADO DIVISION OF RECLAMATION, MINING AND SAFETY**  
**MINERALS PROGRAM INSPECTION REPORT**  
**PHONE: (303) 866-3567**

<b>MINE NAME:</b> Revenue Mine	<b>MINE/PROSPECTING ID#:</b> M-2012-032	<b>MINERAL:</b> Lead, silver and gold	<b>COUNTY:</b> Ouray
<b>INSPECTION TYPE:</b> Monitoring	<b>INSPECTOR(S):</b> Bob Oswald	<b>INSP. DATE:</b> January 9, 2014	<b>INSP. TIME:</b> 10:00
<b>OPERATOR:</b> Star Mine Operations, LLC	<b>OPERATOR REPRESENTATIVE:</b> LJ Trujillo	<b>TYPE OF OPERATION:</b> 112d-1 - Designated Mining Operation

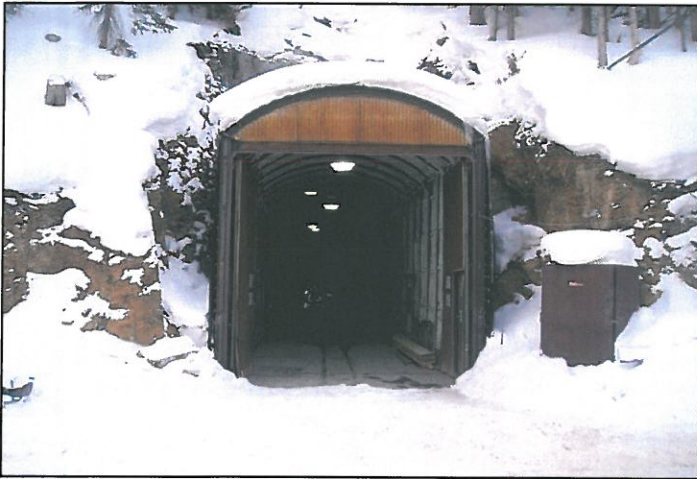
The portal structures at the underground shop are complete and stable, and appear to provide secure closures. The shop space is completed, with overhead lighting and rails set into the concrete floor. The backup generator trailer has been moved to a location between the filter building and the propane tanks. Most mine parts and equipment are now stored on the pad just north of the filter building.

Shop portal

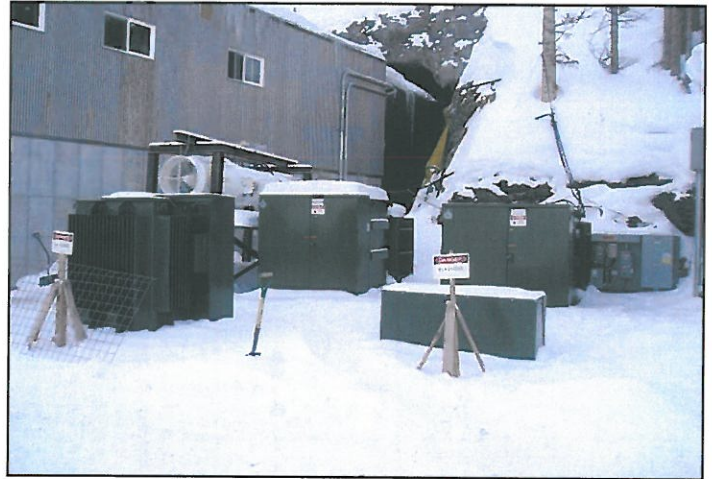
Transformers and vent fan at filter building

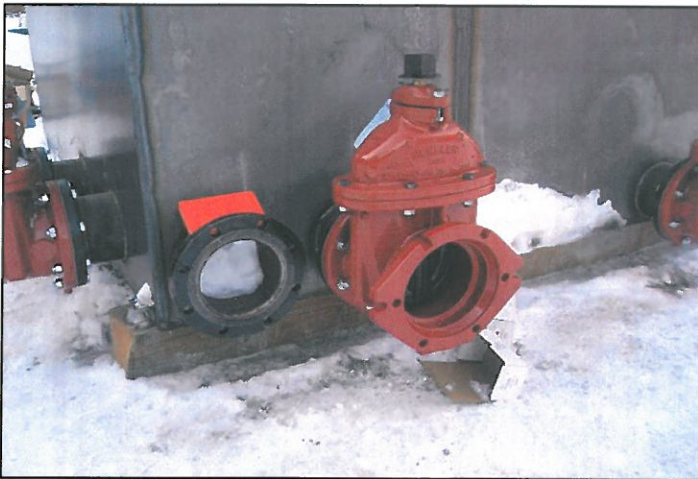
The inspection did not include inspection of significant portions of the surface areas of the permit, since most of the site was covered in snow that has not been plowed away. One of the few surface features inspected was the location where the recently-approved mine water handling valve box will be installed near the Revenue tunnel portal. The valve box will be used to house the valves needed to control and direct mine discharge to perforated pipes and/or to the lined leach field. The box to be installed was observed; it was fabricated from heavy steel plate and contains several chambers for sediment deposit, cleanout and energy dissipation. It has a 16-inch diameter inlet and 8-inch diameter outlet bulkheads with control valves. The valve box may be installed fairly soon. The piping and liners will be installed in the spring.

Valve on mine water valve box

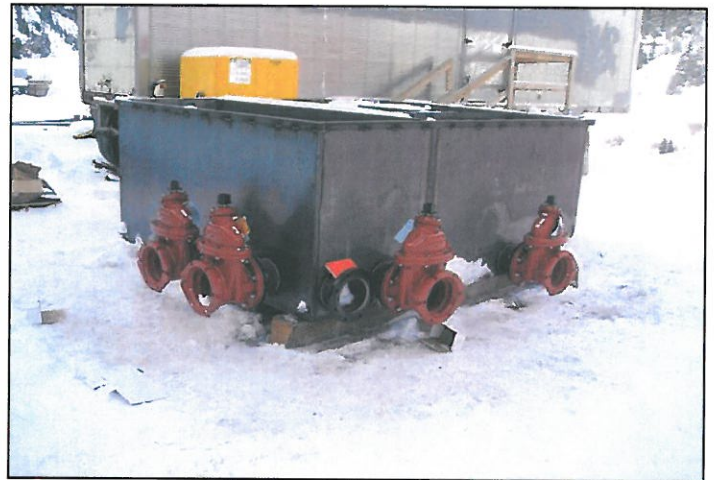
Outlets of mine water valve box

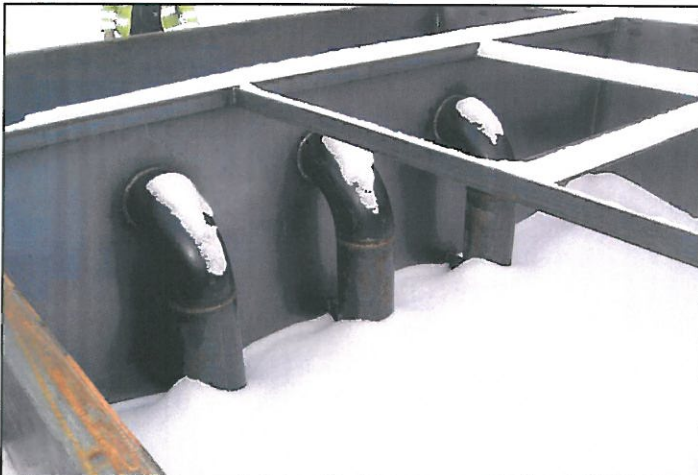
Interior of valve box

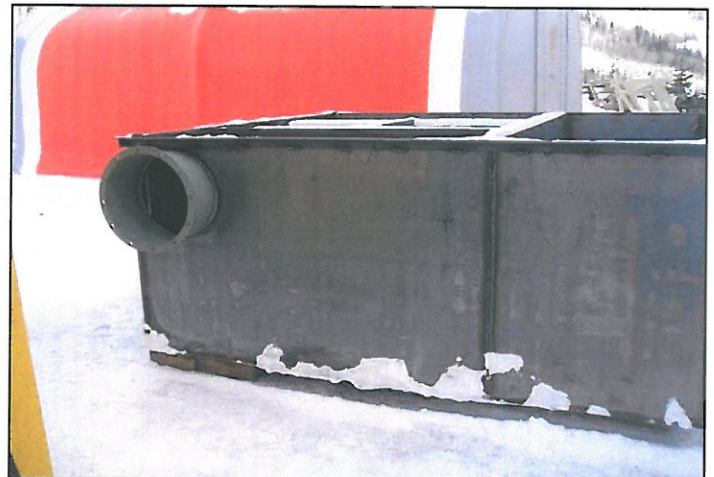
Inlet of mine water valve box

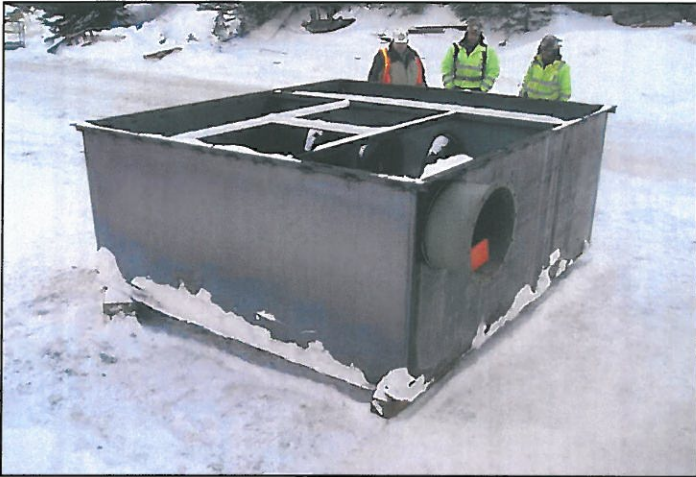
Valve box, inlet side

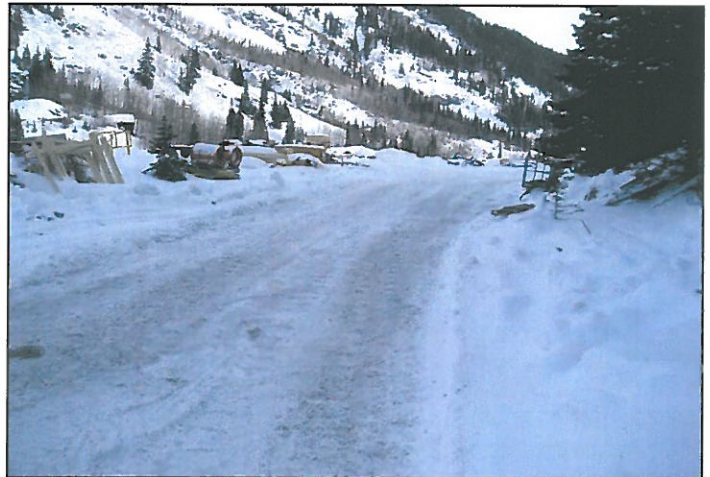
Parts storage area north of filter building

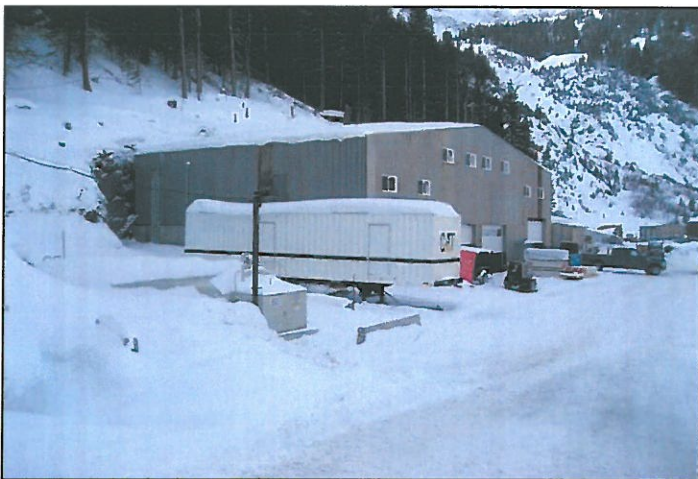
Filter building and backup generator (white trailer)

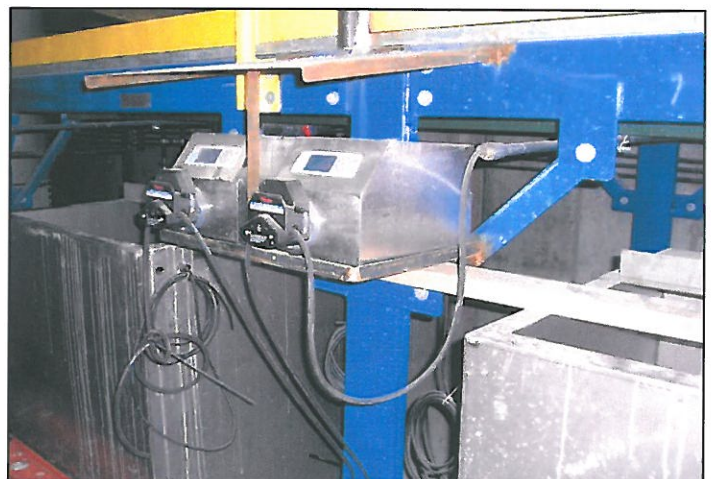
Reagent mixer

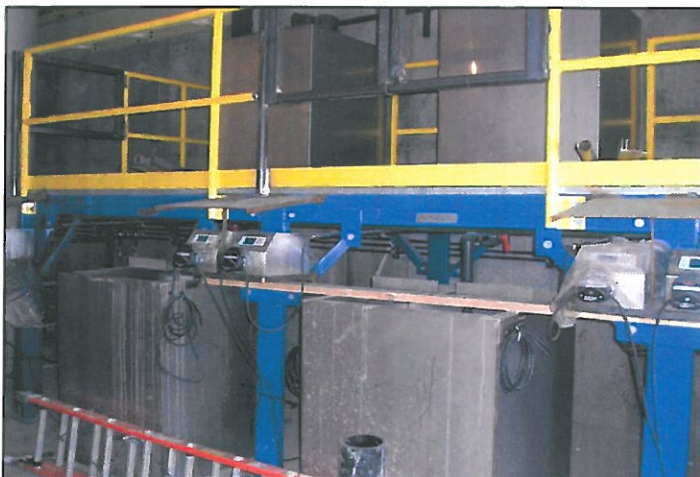
Reagent mixing tanks

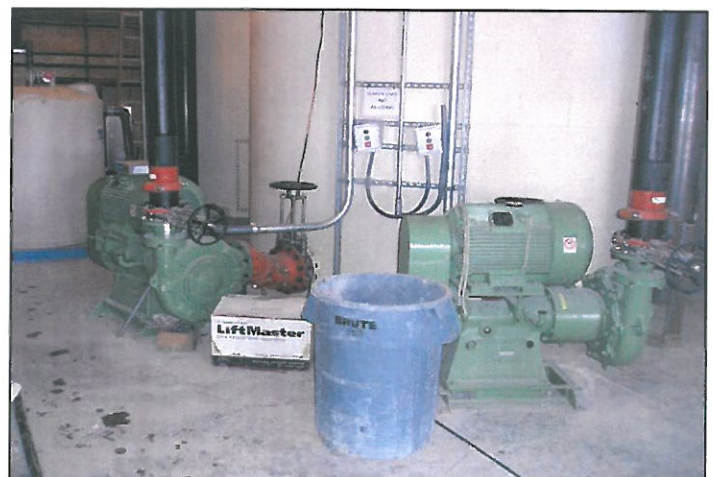
Mill water storage tanks and pumps

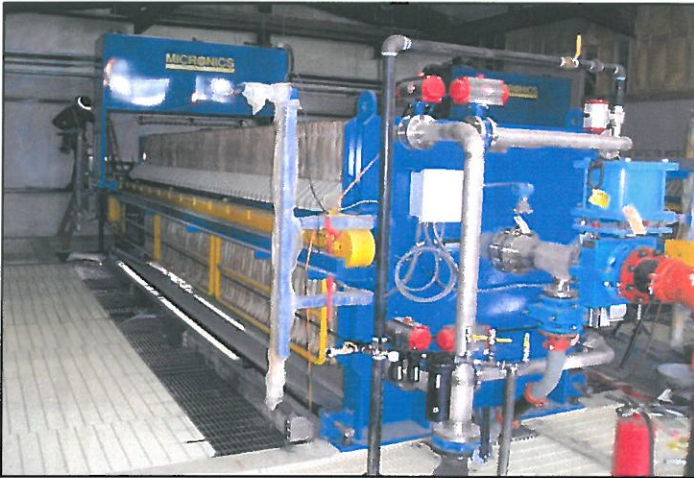
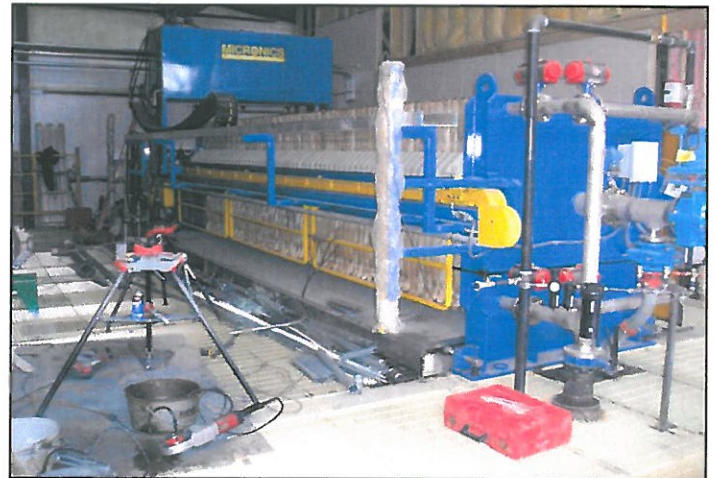
The filter building at the mill tunnel portal is nearing completion. The outside bay doors are installed, the water tanks and pumps are in place, and reagent mixing tanks are connected. Upstairs the two filter presses are nearly completely installed, and the offices, control room and assay lab are close to completion. There are no chemicals stored at the site presently.

Filter press

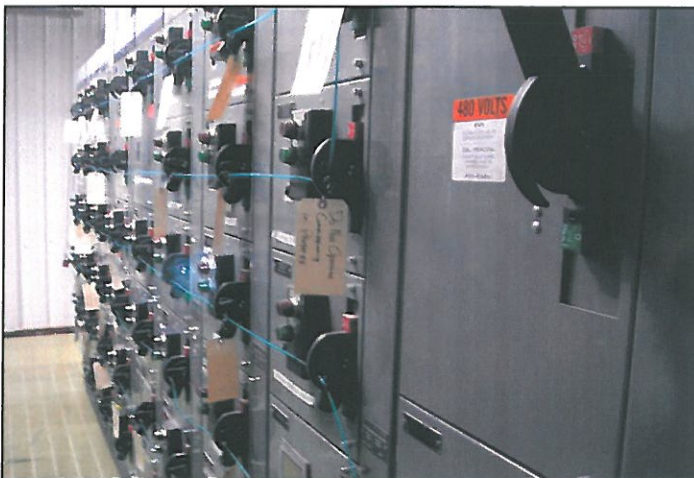
Locked-out switch gear in mill facility

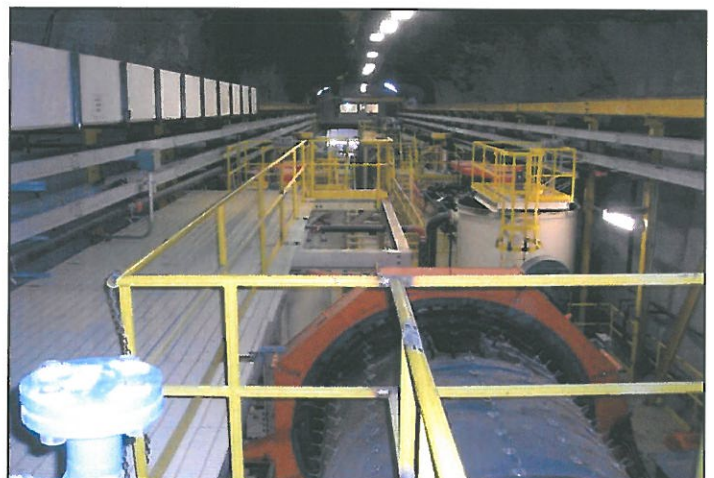
The mill space is close to completion also. Previous inspection reports have described the lighting, electric switch gear and cable installation, concrete floor and sumps, and mill circuit equipment in the main mill space. The mill was inspected again, and the tanks, piping, cabling, and controls were found to be more complete. Delivery of crushed ore to the ball mill is the first stage in the main mill space.

View of ball mill and mill circuits, from 3<sup>rd</sup> level deck

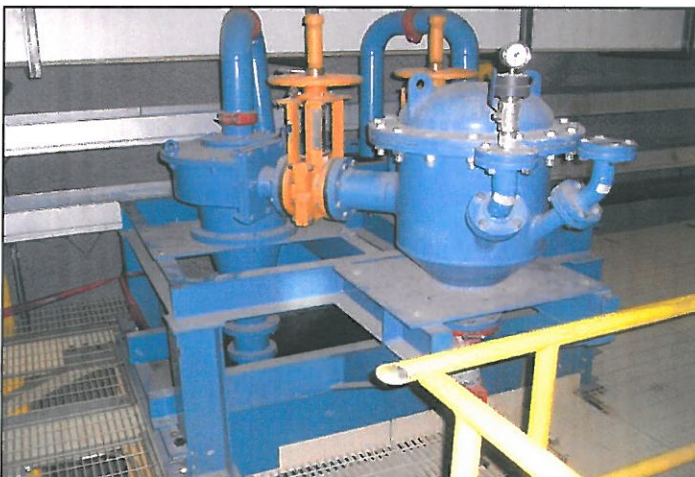
Other new items observed in the mill included the first process circuit for extracting gold from the ore, immediately after it leaves the ball mill. Significant changes have been made since the last inspection (on 11/1/13) to the system of conveyors and crushers for delivering the ore to the ball mill. The tunnels housing the conveyors and crushers that lead off from the mill tunnel are now largely completed. They have been provided with lighting, ventilation, concrete floors and containment sumps, and adequate massive concrete foundations for the elevated crushers and conveyor equipment. There is a secondary escapeway to the ore haulage tunnel, connected to the main Revenue tunnel.

Gold extraction equipment, mill 3<sup>rd</sup> level
