COLORADO DIVISION OF RECLAMATION, MINING AND SAFETY
MINERALS PROGRAM INSPECTION REPORT
PHONE: (303) 866-3567

MINE NAME: Korinek #1 Pit	MINE/PROSPECTING ID#: M-1979-131	MINERAL: Sand and gravel	COUNTY: Crowley
INSPECTION TYPE: Monitoring	INSPECTOR(S): Tyler V. O'Donnell	INSP. DATE: November 26, 2013	INSP. TIME: 10:00
OPERATOR: Korinek Sand & Gravel	OPERATOR REPRESENTATIVE: Gerald Korinek	TYPE OF OPERATION: 112c - Construction Regular Operation

Korinek #1 Pit

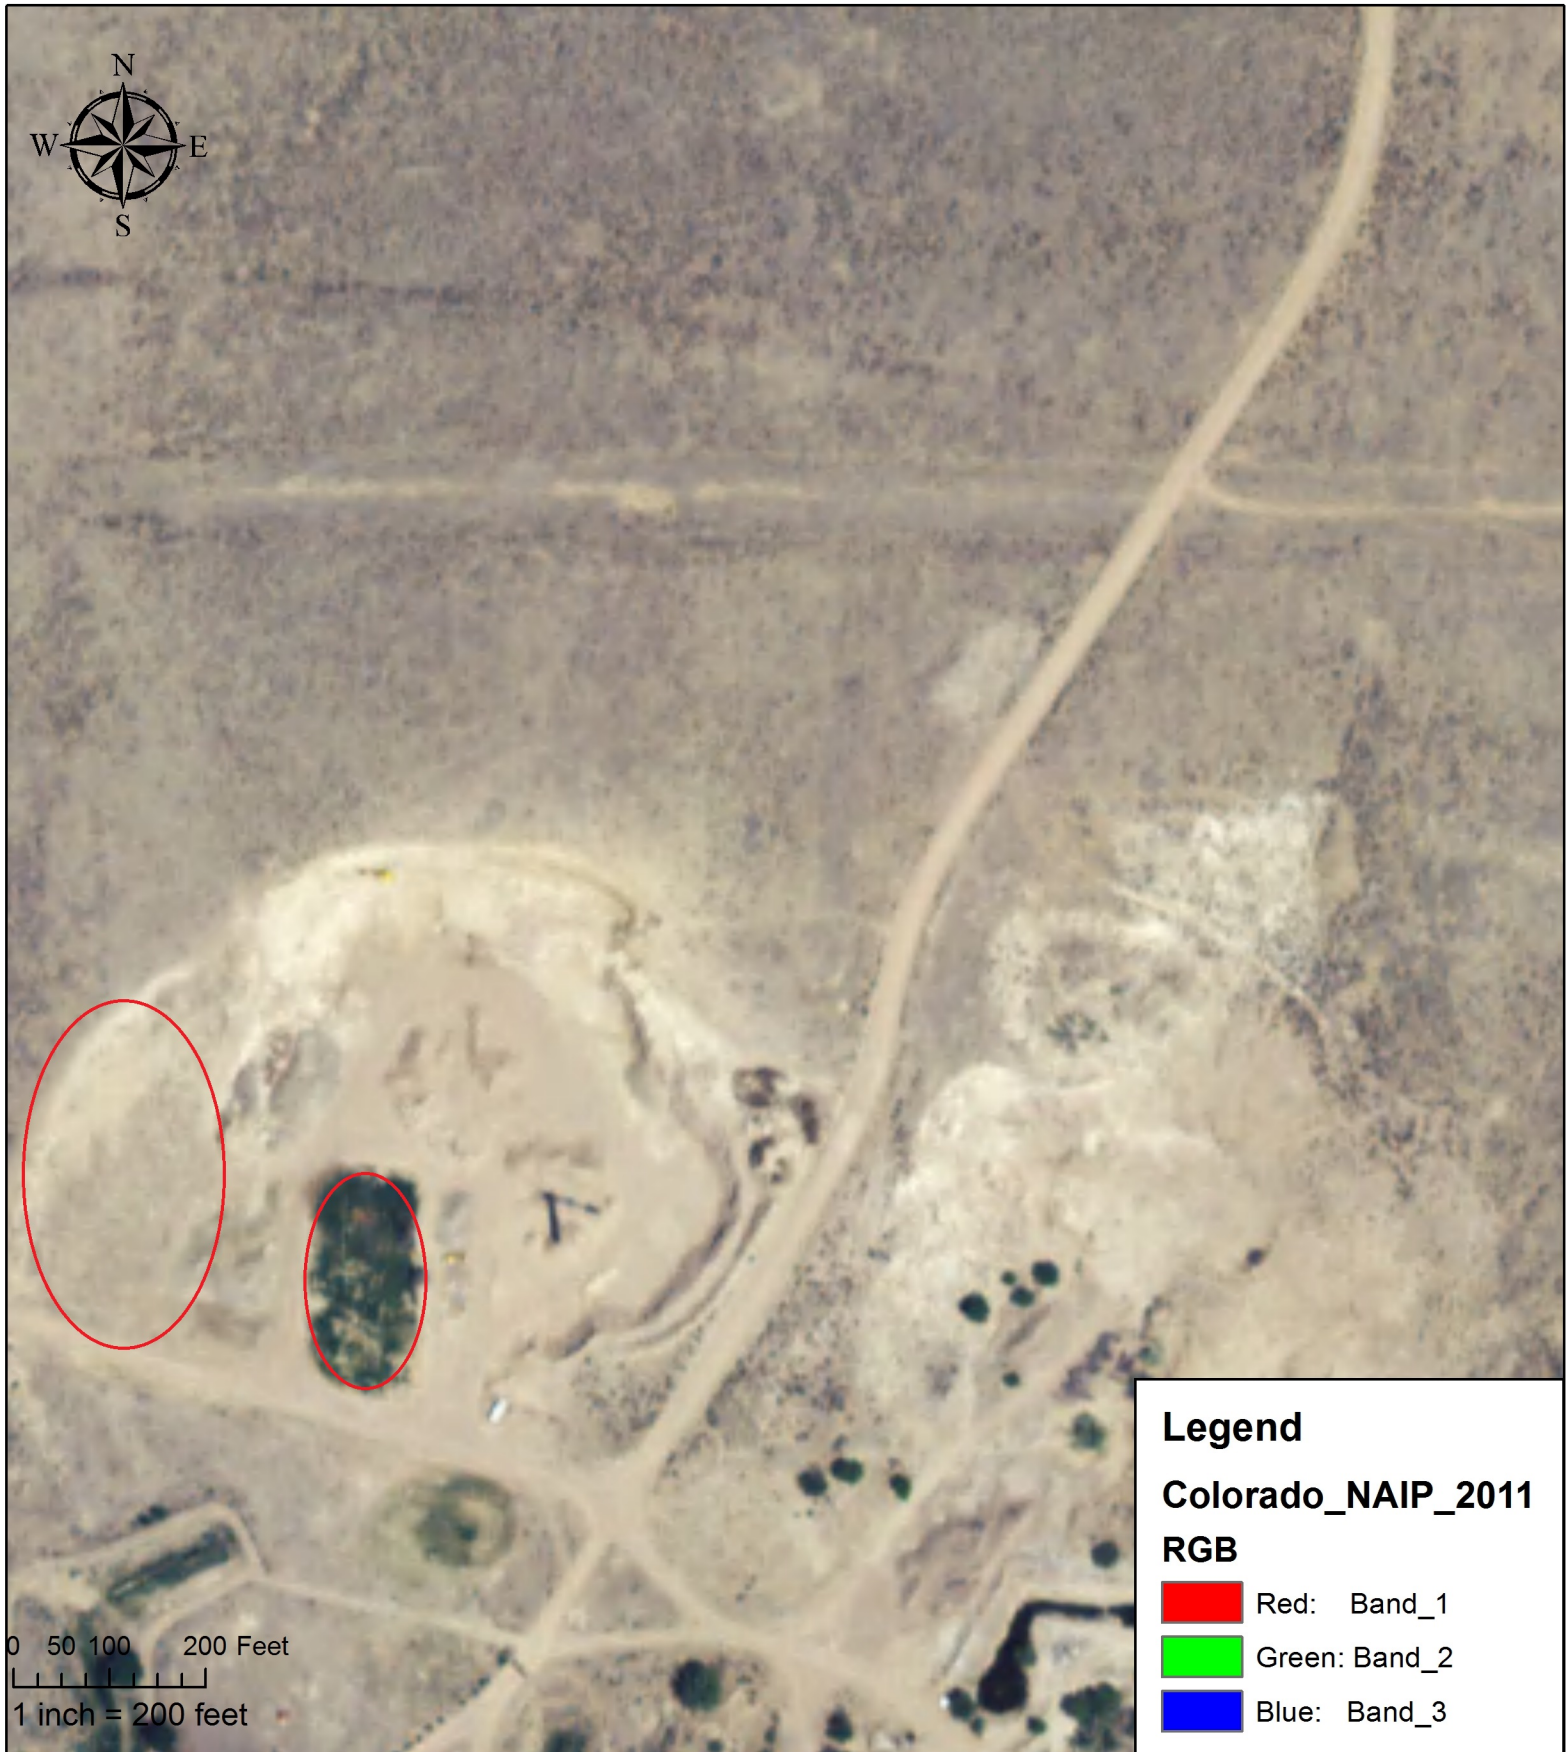
It appears the Operator is in the process of reclaiming two portions of the site totaling approximately 1.75 acres (see Figure # 1). Both areas have been graded to a slope of 3H:1V or flatter and have been seeded. The Operator indicated that they have had difficulty establishing vegetation, in both locations.

Figure 1: Map of the Korinek #1 Pit, areas of ongoing reclamation circled in red (Colorado NAIP 2011 Imagae)

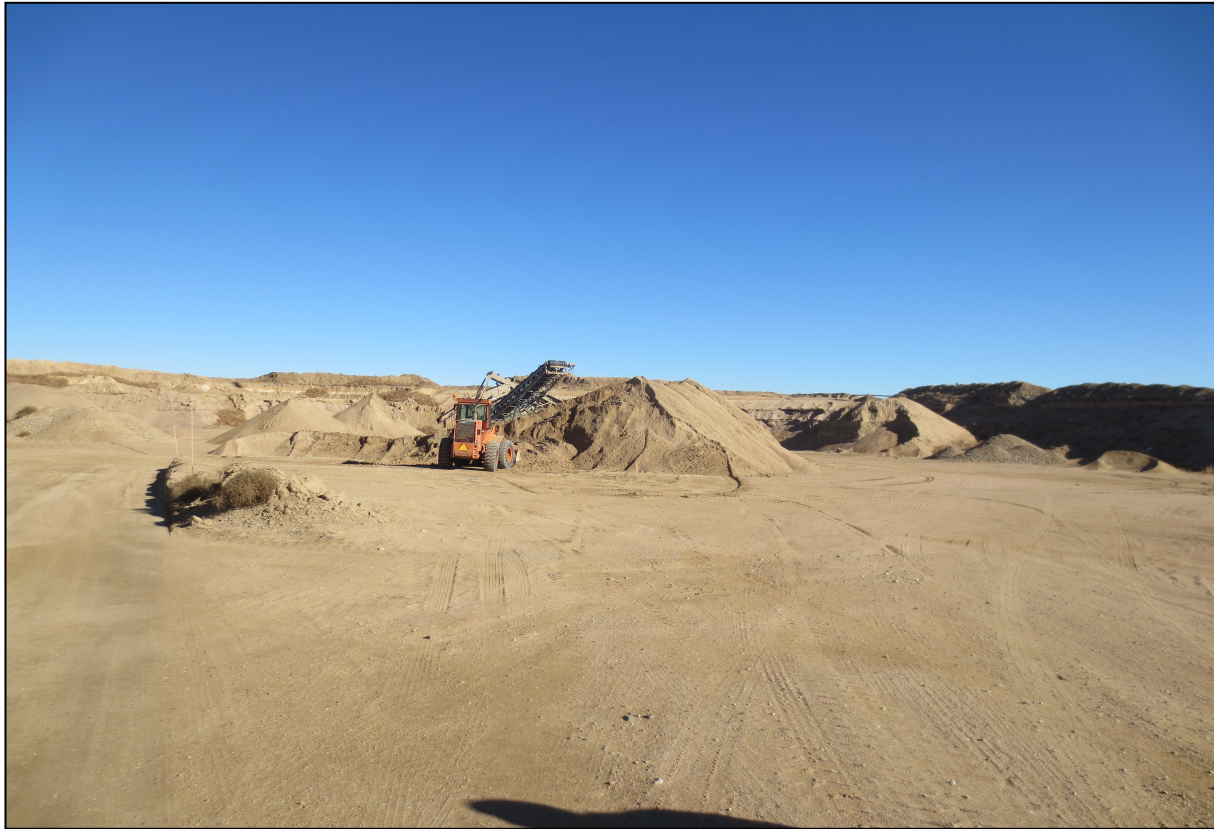
Photo 1: Processing plant with product stockpiles.

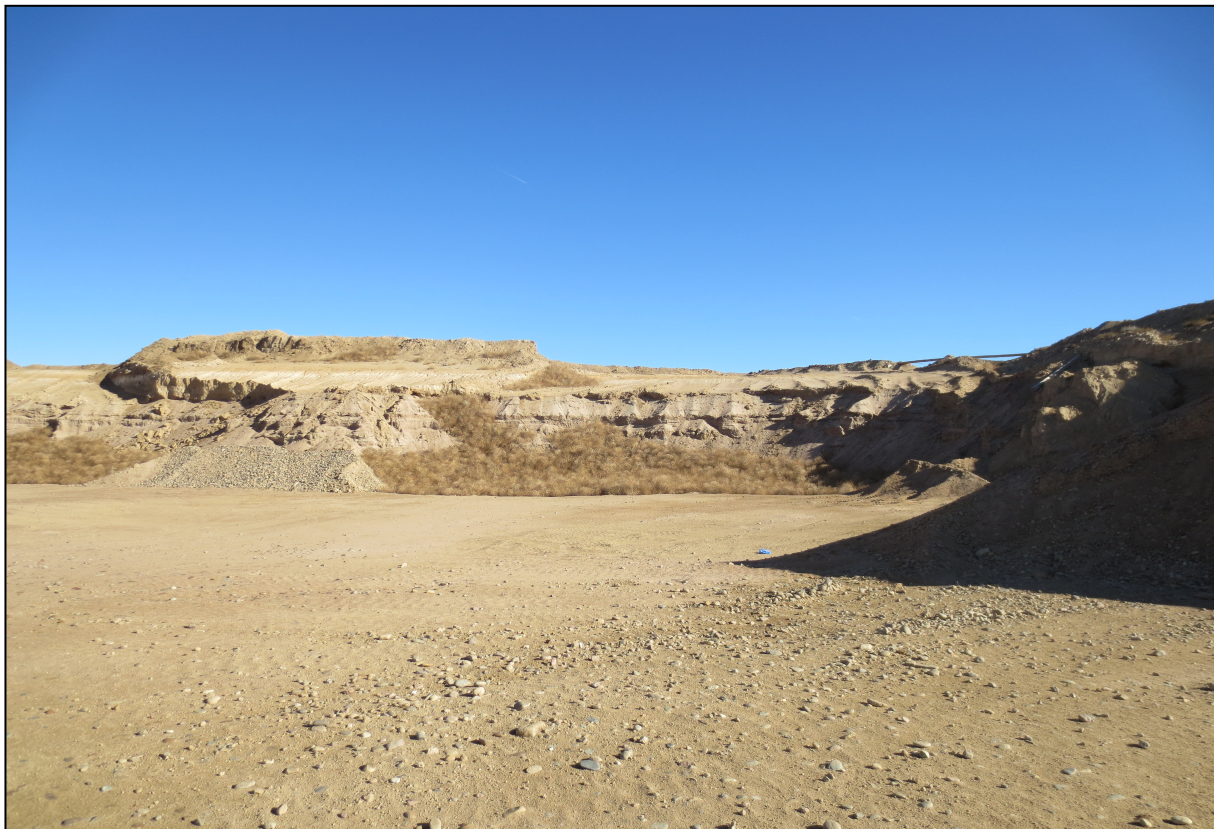
The site currently has a highwall that is approximately 1500 to 2000 feet long with an average height between 15 and 20 feet. The highwall has an approximate slope of 0.5H:1V.

Topsoil was stockpile along the top of the Highwall. There appeared to be enough topsoil for the reclamation of the disturbed area.

Photo 2: Highwall, topsoil stockpile circled in red.

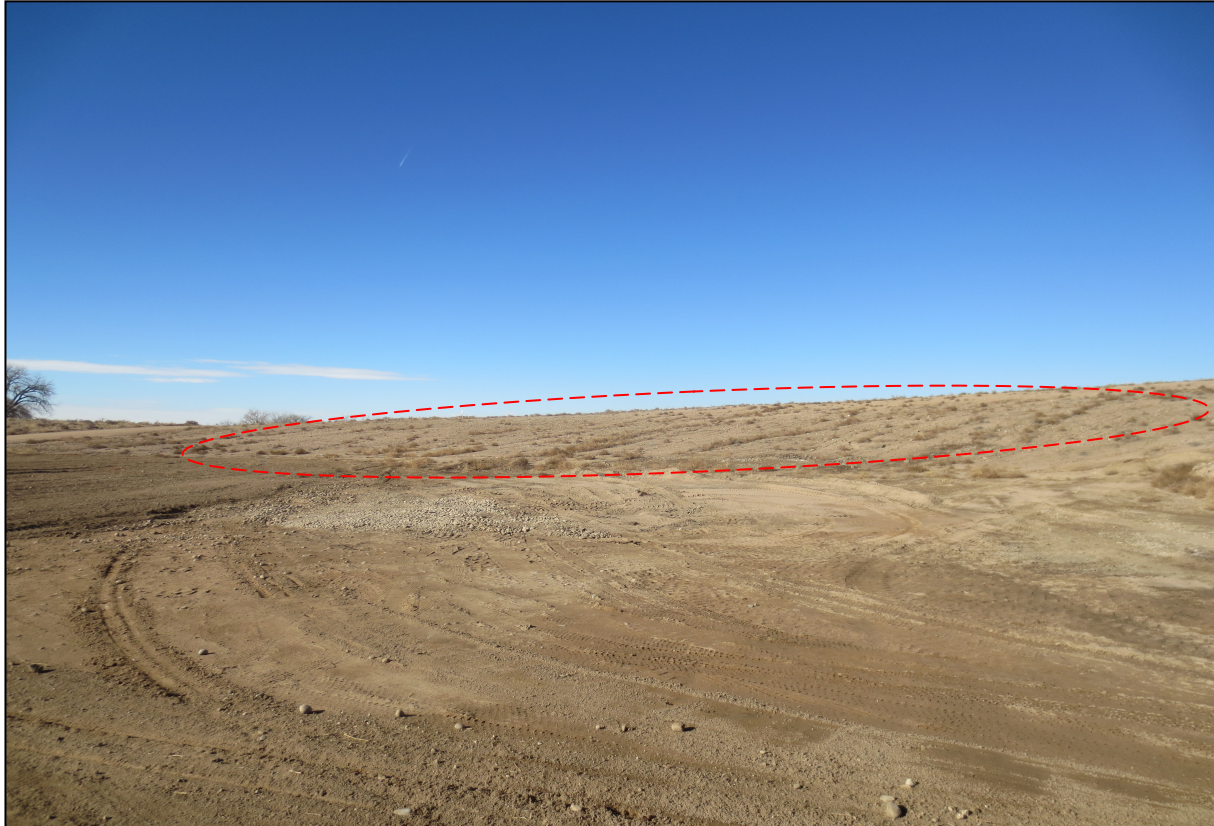
Photo 3: Southwest pit wall circled in red, reclamation ongoing progress.

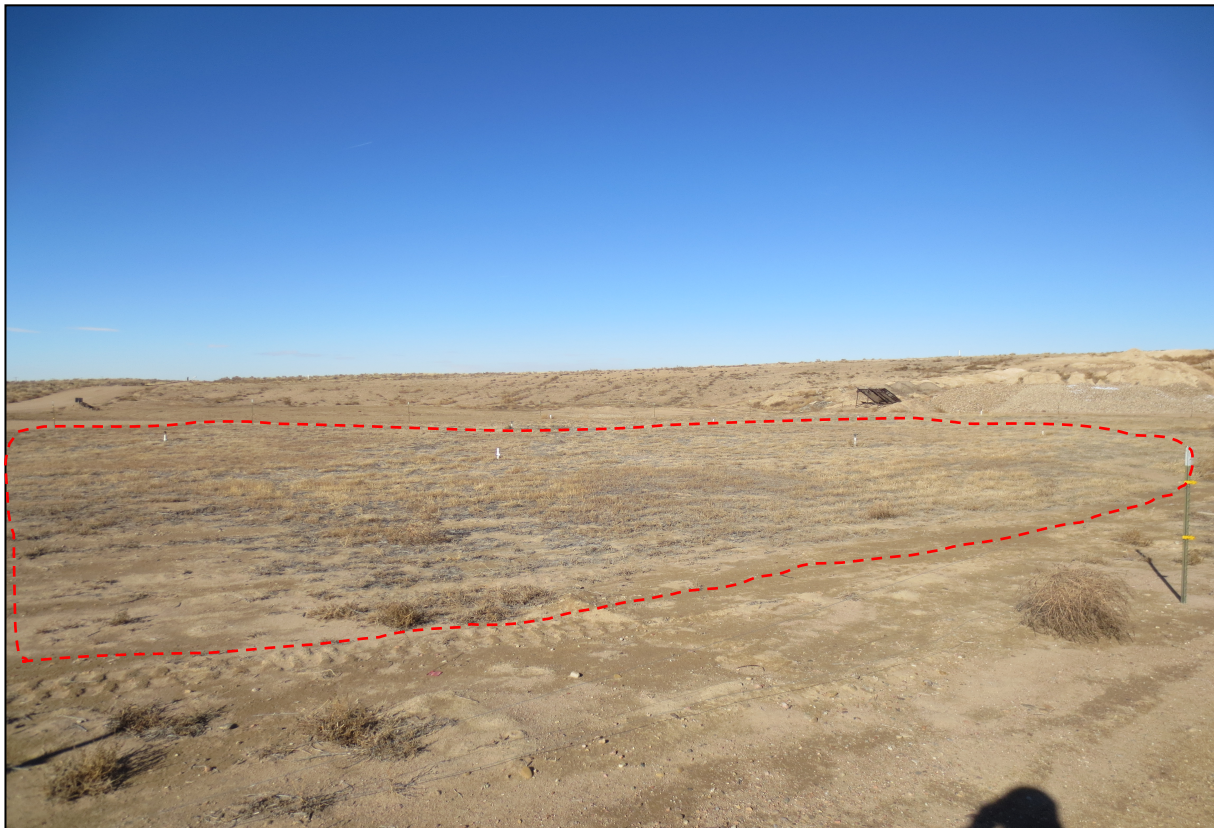
Photo 4: Pit floor, ongoing reclamation outlined in red.
