COLORADO DIVISION OF RECLAMATION, MINING AND SAFETY MINERALS PROGRAM INSPECTION REPORT

| MINE NAME: | MINE/PROSPECTING ID#: | MINERAL: | COUNTY: |
|---|---|---|---|
| Hertzog Pit | M-1981-276 | Sand and gravel | Moffat |
| Monitoring | Stephanie J. Mitchell | January 14, 2014 | 12:30 |

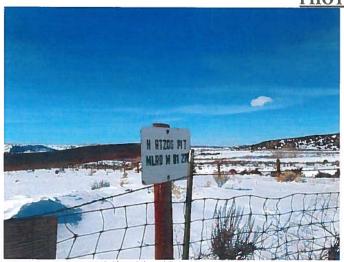
Mine Identification Sign

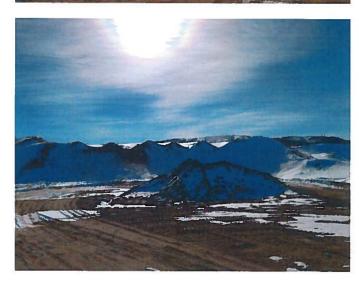
The side slopes of the pit excavation appear to be at a 2:1 horizontal to vertical ratio or less. The southern portion of the site has been revegetated with native grass and forbs.

Area (background) to the South, reclaimed

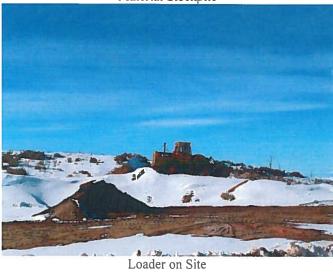
Material Stockpile
