Reference: Cripple Creek & Victor Gold Mining Company,
Cresson Project Squaw Gulch (VLF), Hwy 67 Realignment

Subject: Weekly Construction Quality Assurance ("CQA") Report:
AMEC: Squaw Gulch (VLF), Hwy 67 Realignment - Week ending 01/04/14.

CRIPPLE CREEK & VICTOR GOLD MINING Co.
Squaw Gulch (VLF), HWY 67 Realignment Field Monitoring Summary Weekly Report

Reporting Period: 12.29.13 thru 1.4.14

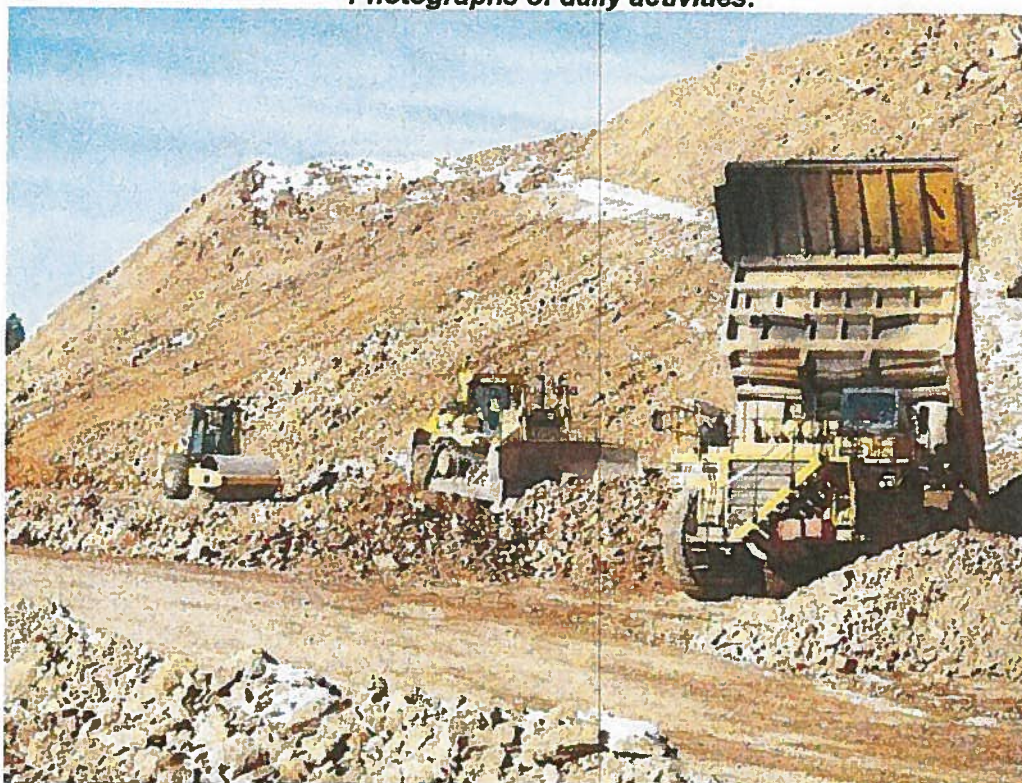
Photo 1: Fill placement at the ADR road.

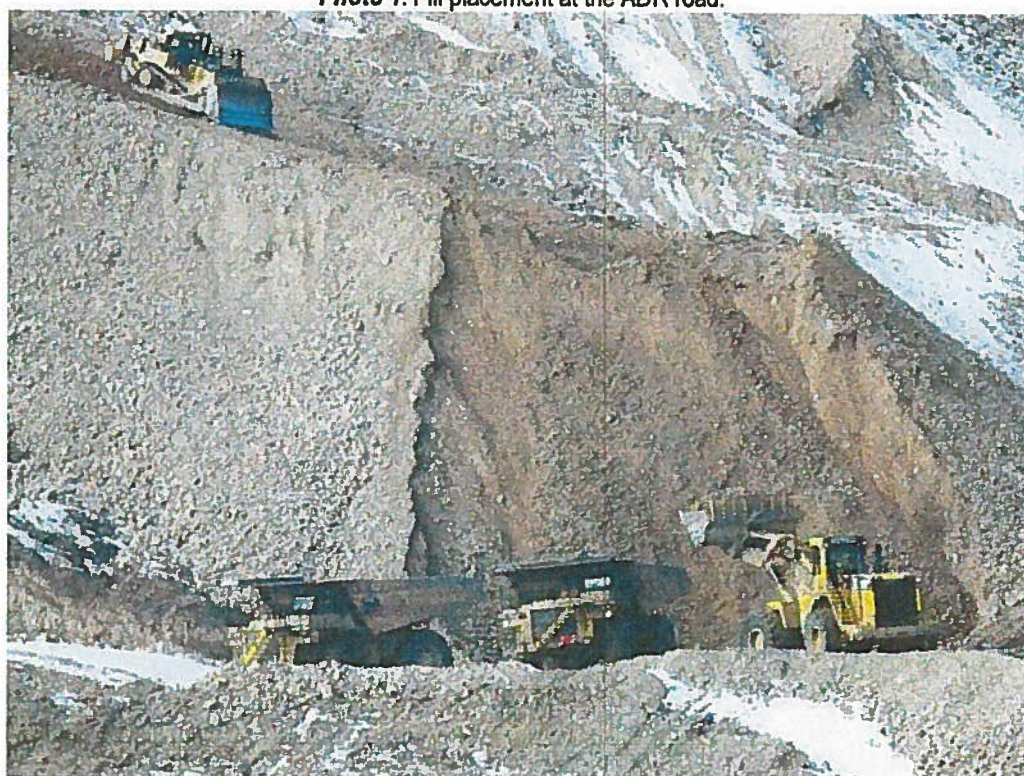
Photo 2: Cut operations between stations Q6+00 and A6+00.

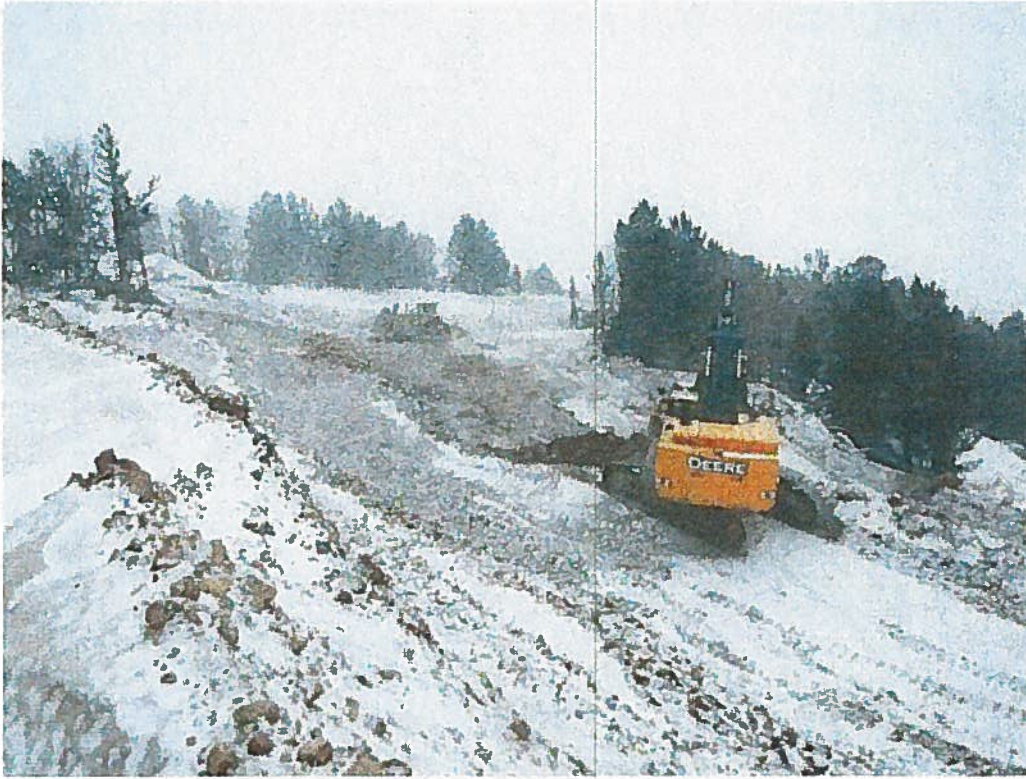
Photo 3: Cut operations in the Phase 2 Diversion Channel area.

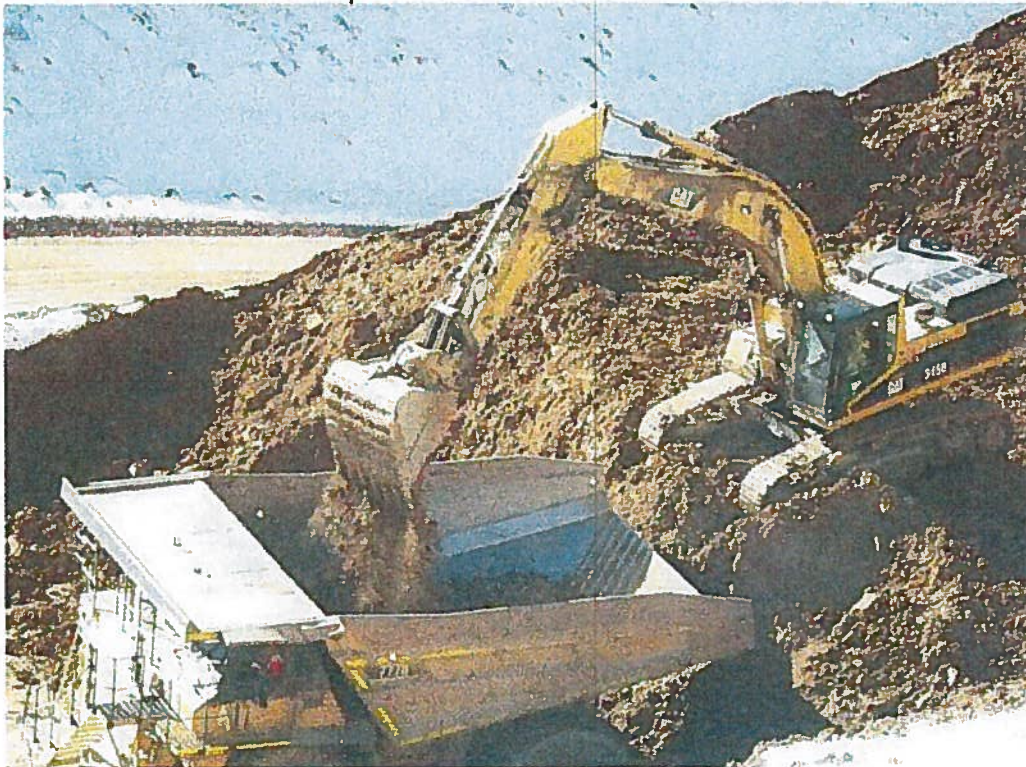
Photo 4: Loading out clay till for the Squaw Gulch clay processing plant.
