STATE OF COLORADO

DIVISION OF RECLAMATION, MINING AND SAFETY

**RE: Response to Continuation of Complaint,
Battle Mountain Resources, Inc., San Luis Project, Permit No. M-1988-112**

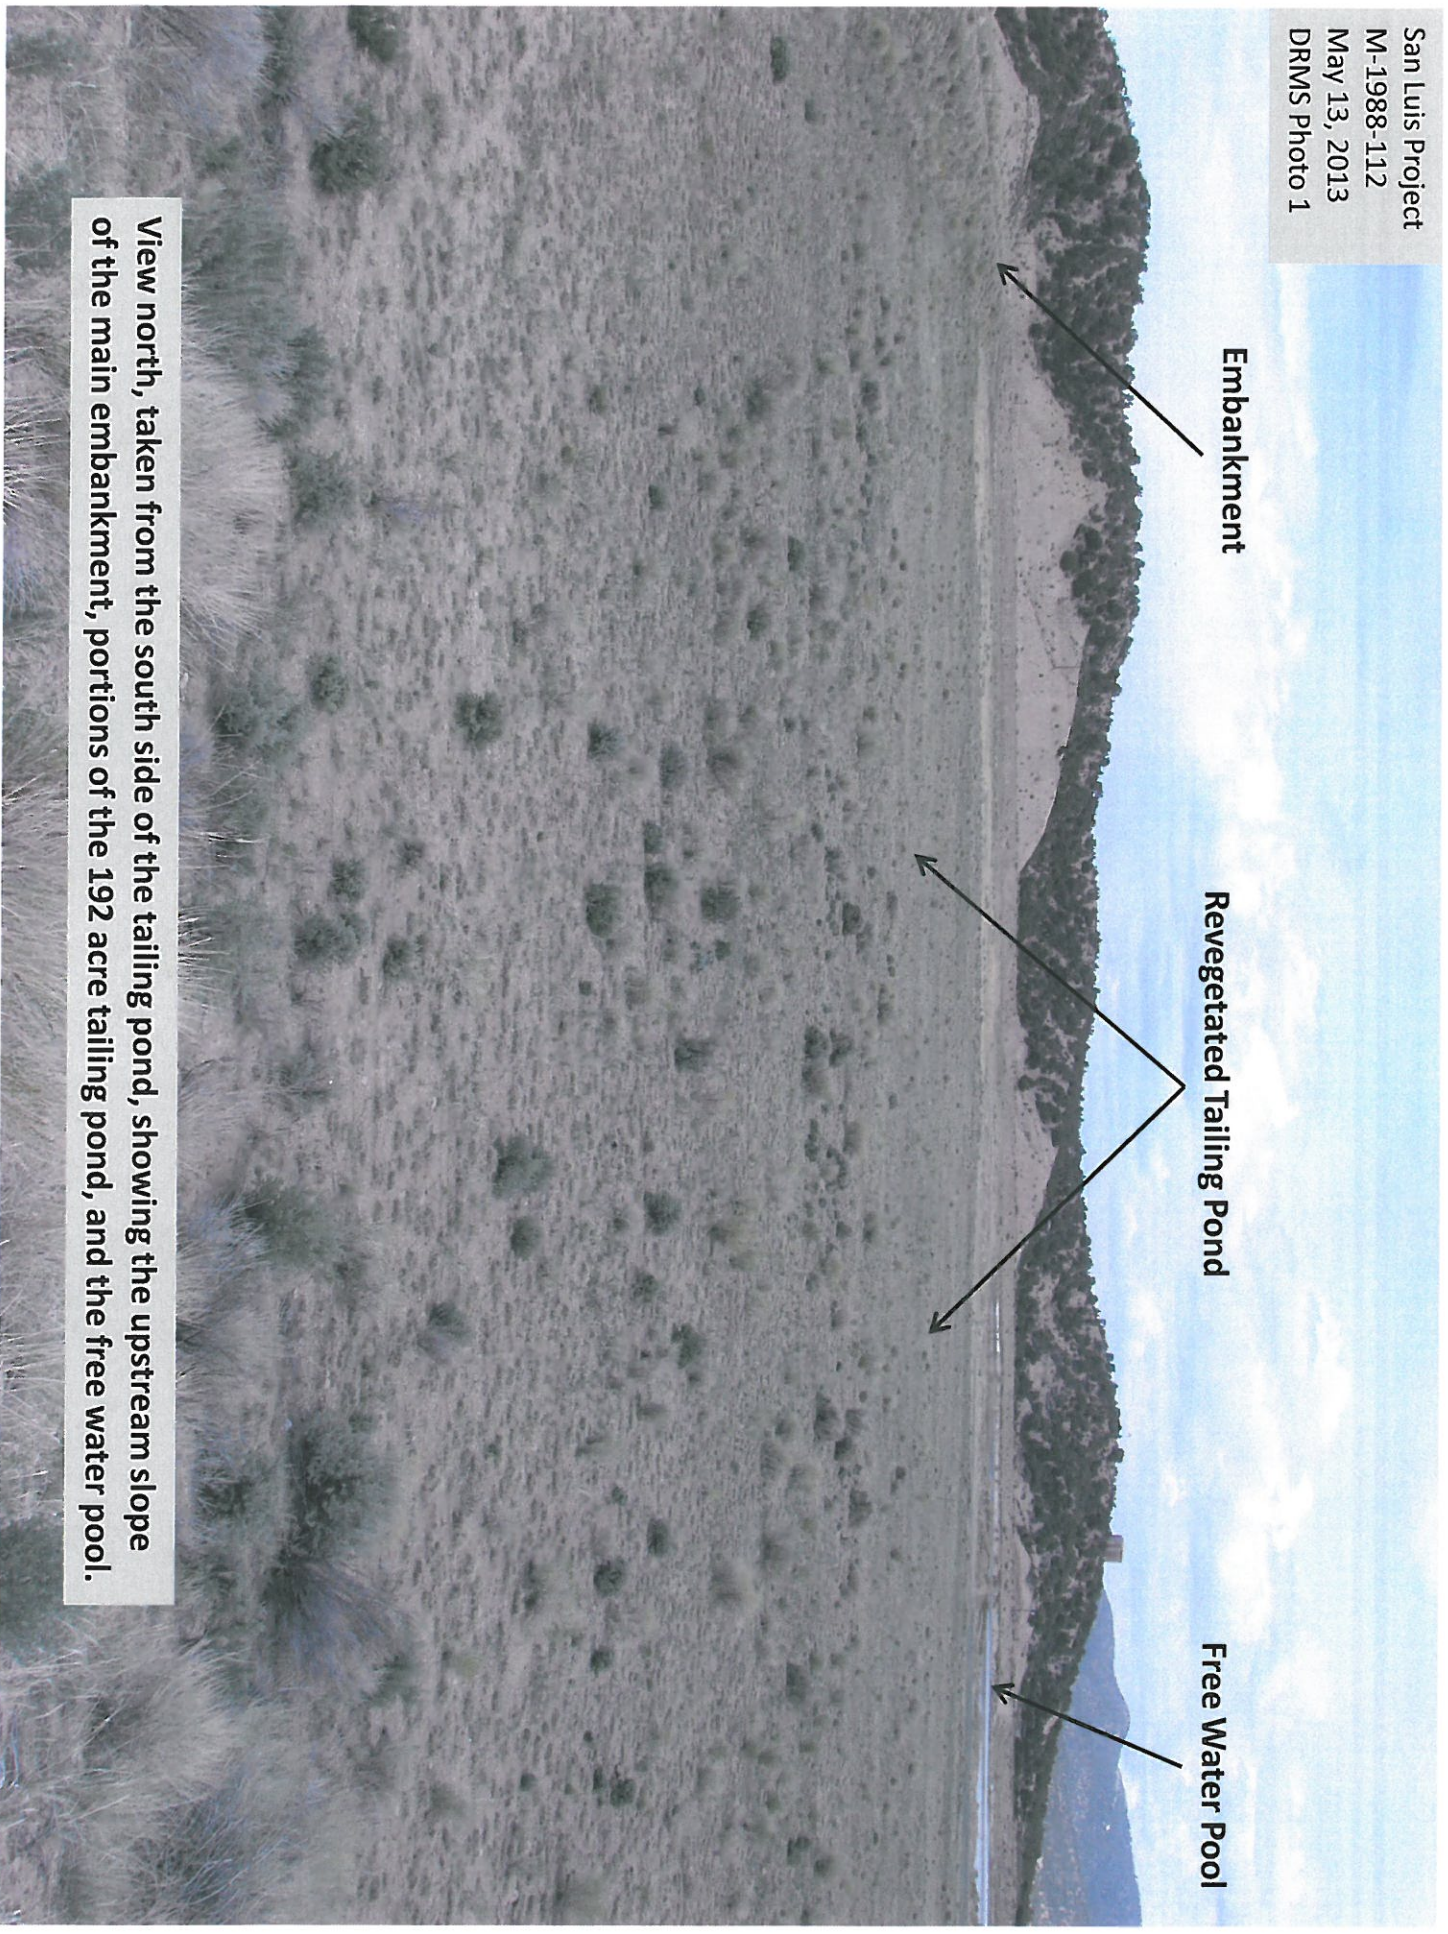
As shown in DRMS Photo 1, the upstream slope of the main embankment of the tailing pond was well vegetated and appeared stable; evidence of slumping, settling or excessive erosion was not observed. The surface area of the tailings is approximately 192 acres, which includes an approximate 20-acre area for the free water pool. The Operator identified markers at approximately 200 feet upstream from the embankment, which delineate the setback distance for the free water pool from the embankment. During the time of this inspection the free water pool was visually estimated at greater than 500 feet distance from the main embankment. The Operator indicated the current depth of the free water pool to be approximately 2 feet. The free water pool contains drainage from precipitation, fluids pumped from the collection pond, and brine and untreated West Pit water pumped from the water treatment plant.

View north, taken from the south side of the tailing pond, showing the upstream slope of the main embankment, portions of the 192 acre tailing pond, and the free water pool.

As noted in the enclosed Engineer's Inspection Report from Mr. Perry, a small excavation was observed in the upstream slope of the embankment at the location of the pump-back pipeline from the collection pond. As recommended by Mr. Perry, the excavation must be appropriately backfilled, compacted, and the vegetative cover re-established in accordance with the approved designs. Alternate designs for the pump-back pipeline may be recommended through the engineering inspection and reporting program of TR-33. However, any alteration to previously approved designs must be submitted for review and approval through the Technical Revision or Amendment process defined under Rules 1.9 and 1.10.

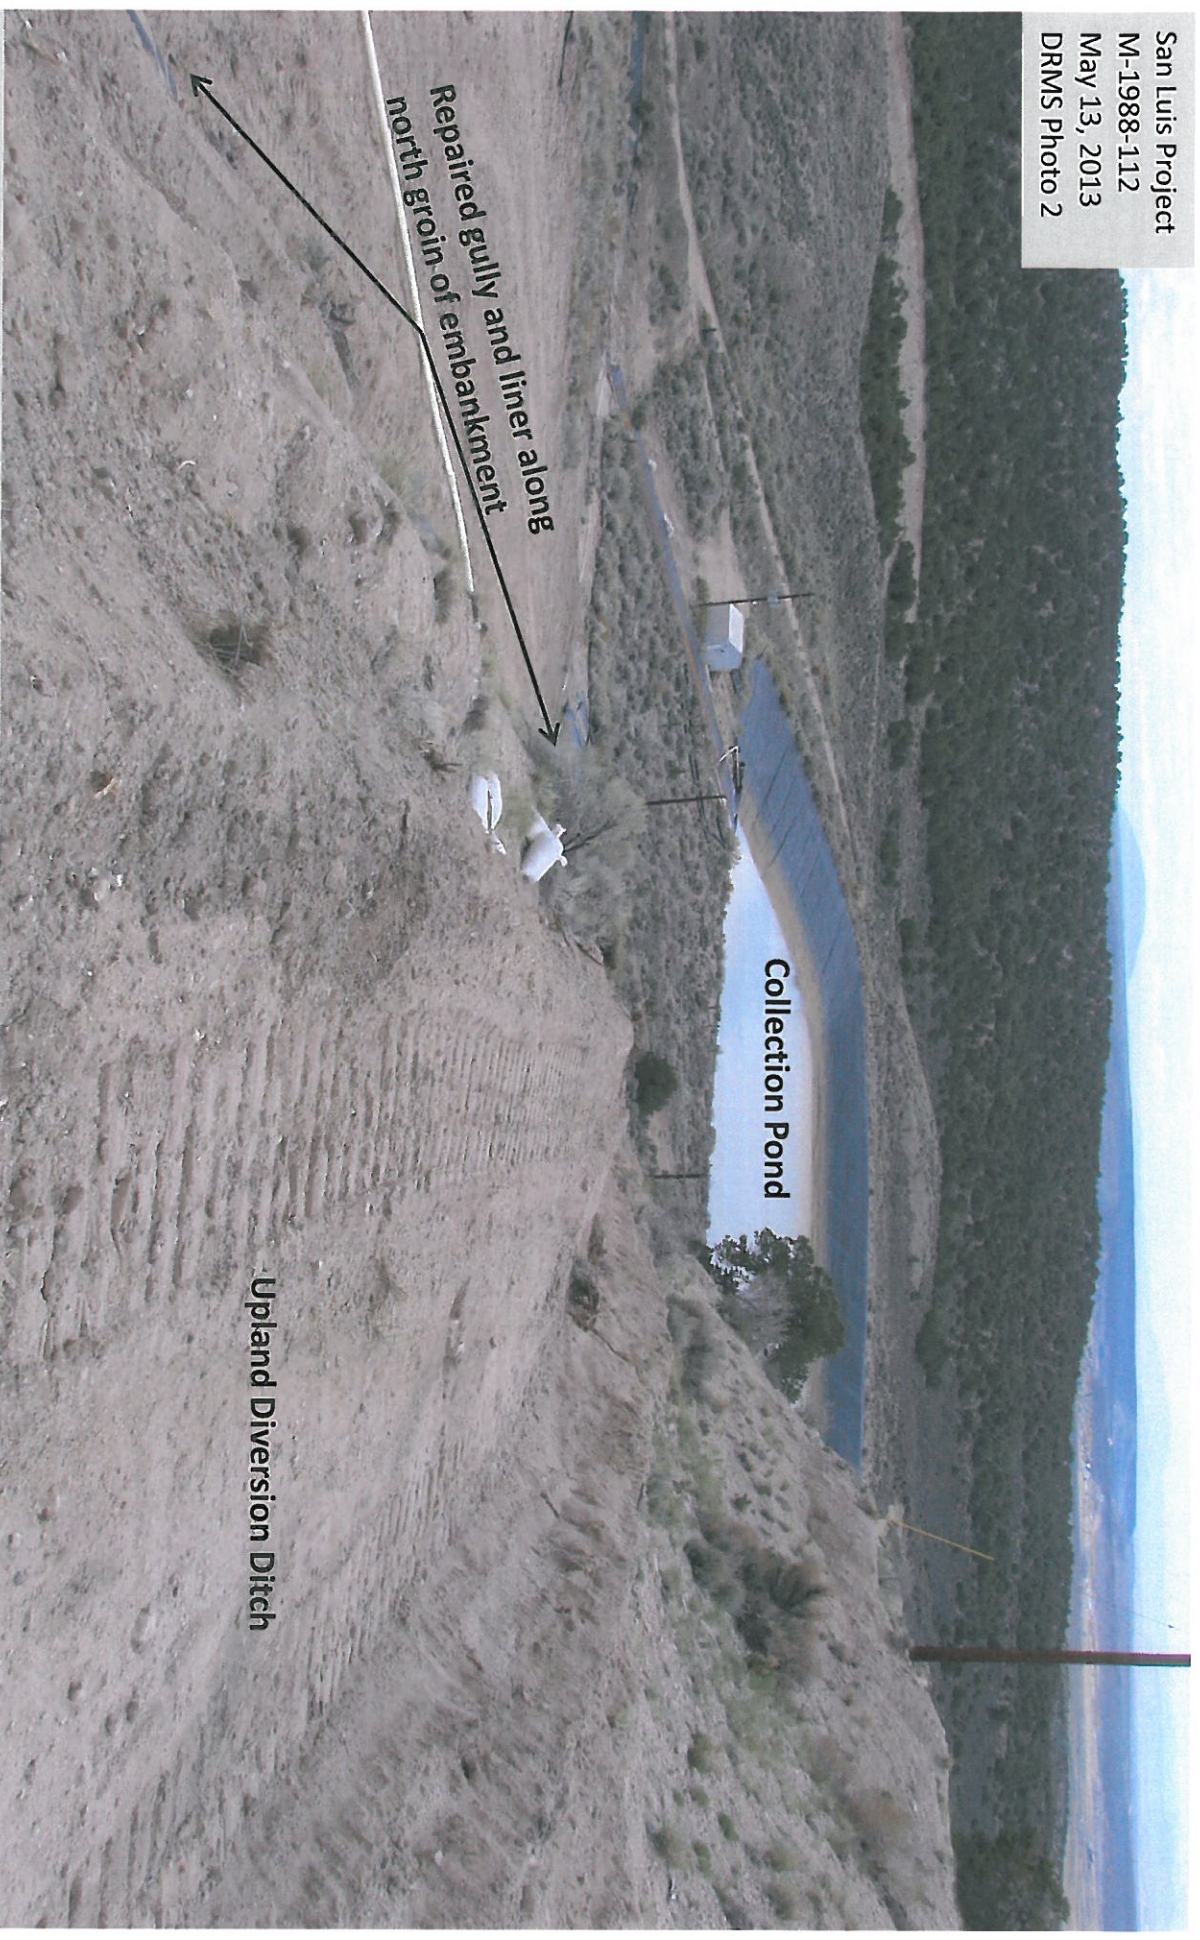
As shown in DRMS Photo 2, the Operator has recently completed routine maintenance and repair of minor erosion features on the downstream slope of the main embankment of the tailing pond. The area shown in photo 2 is located at the north end of the embankment, at the transition of the earthen embankment with the geosynthetic liner covering the native slope. The repairs included surface grading and reseeding, installation of new liner material to replace eroded liner, and excavation of a diversion ditch to intercept upland drainage

and thereby minimize potential for future erosion to the embankment. The recently disturbed area was visually estimated at 200 feet long by 50 feet wide, or approximately 0.23 acres. The downstream slope of the embankment was not steeper than 3H:1V, as indicated in the approved plans and as-built certifications for the embankment. The downstream slope of the embankment appeared well vegetated and stable; evidence of slumping, settling or excessive erosion was not observed.

View west, taken nearby the crest and north end of the main embankment of the tailings pond, showing portions of the downstream slope of the embankment and the collection pond of the tailings repository. The Operator had recently conducted routine maintenance to control erosion. Erosion control methods employed by the Operator included surface grading along the transition of the earthen embankment with the liner, replacement of eroded sections of the liner, and installed a diversion ditch to intercept upland drainage and minimize potential for future erosion to the embankment.

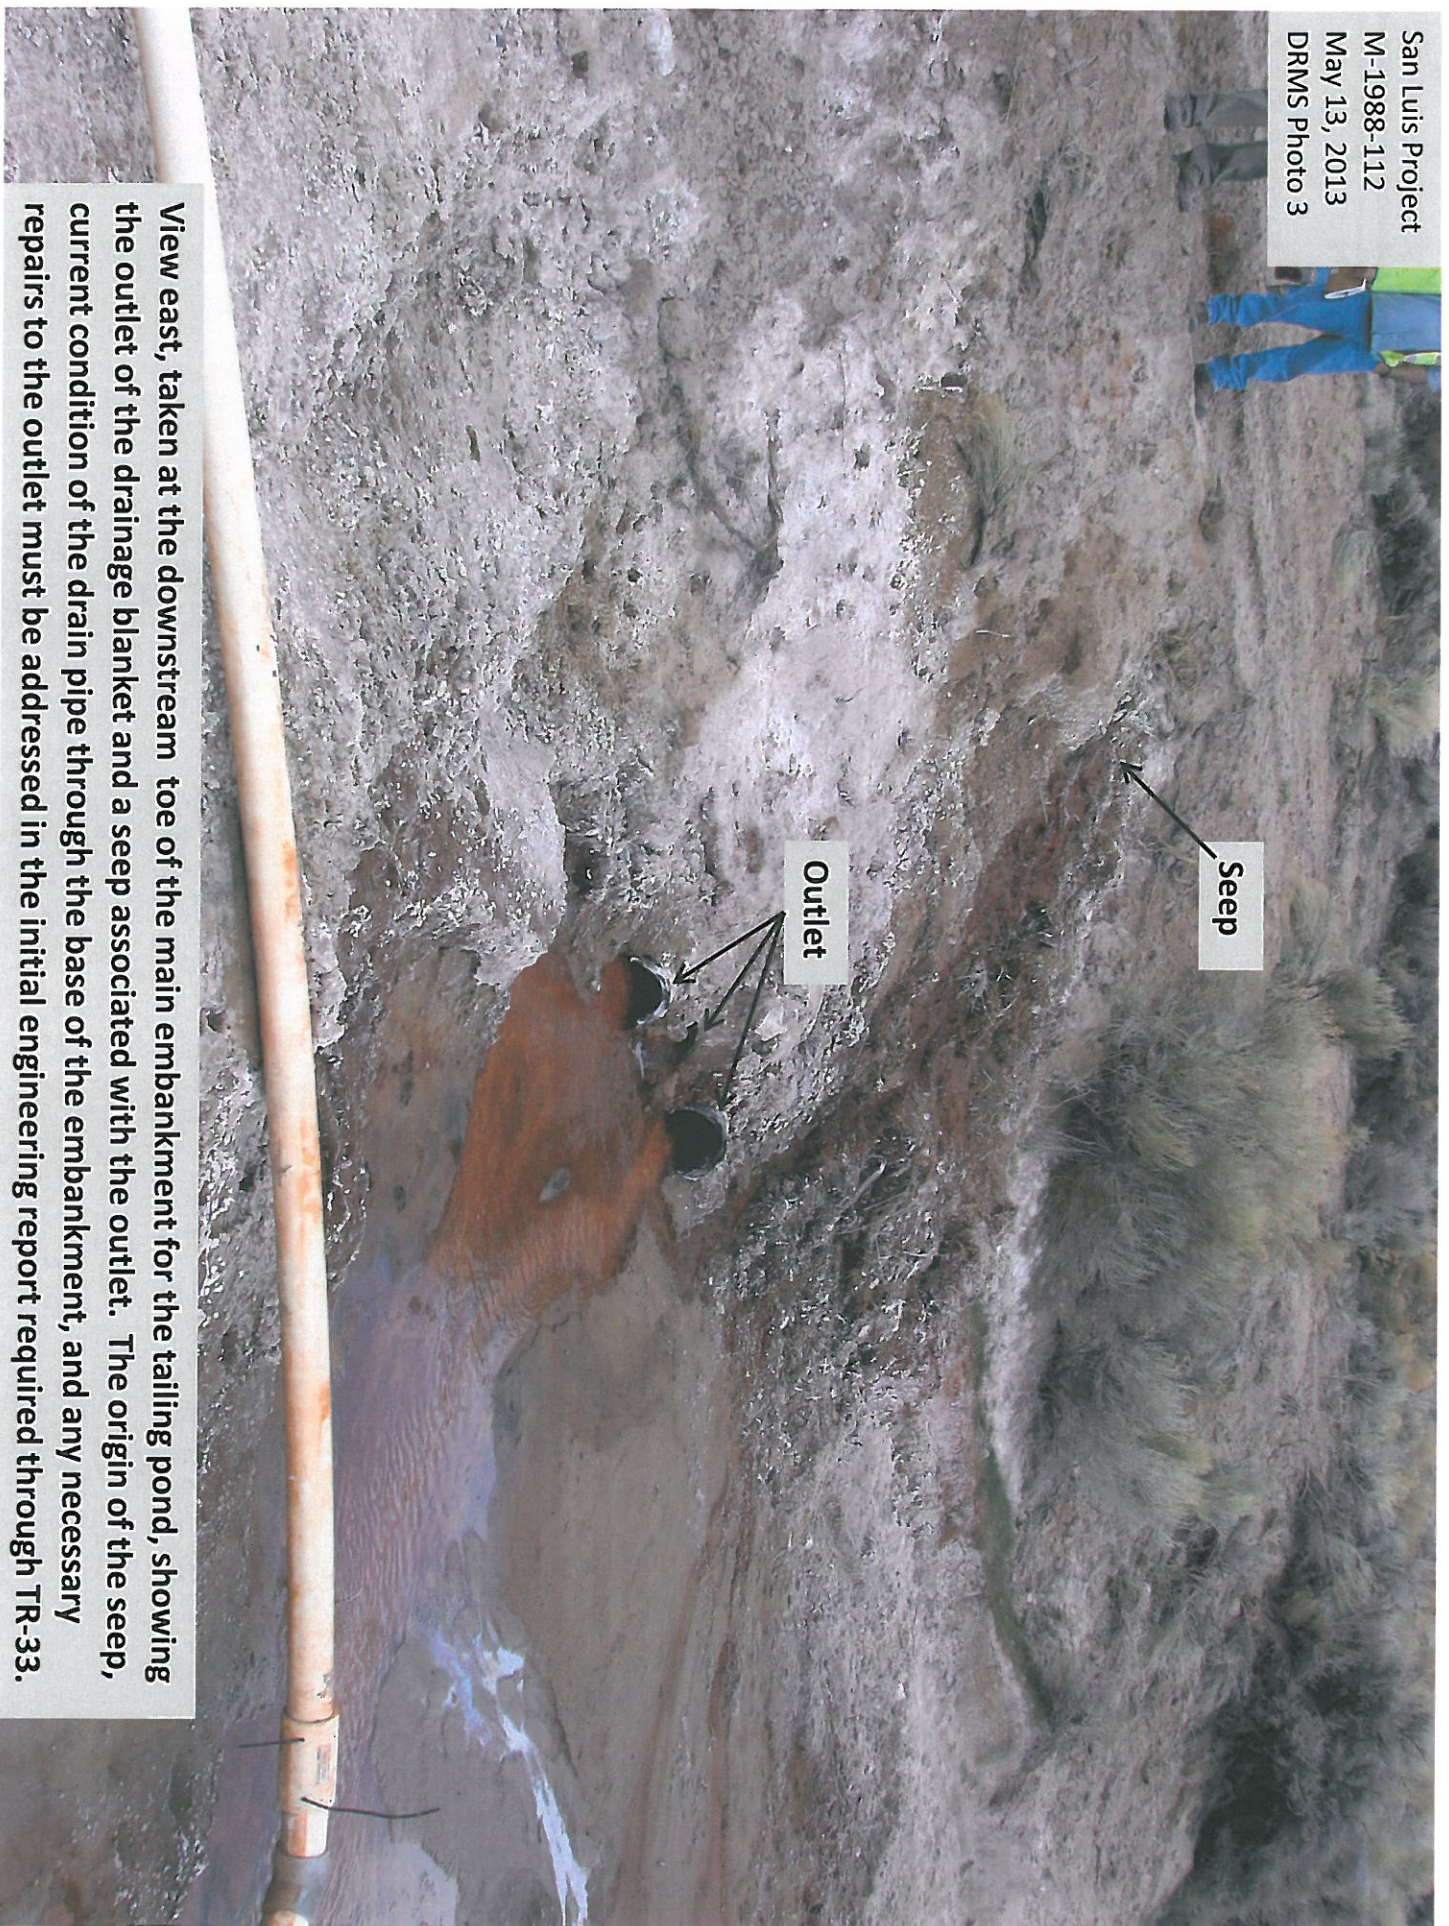
San Luis Project
M-1988-112
May 13, 2013
DRMS Photo 3

The drainage blanket for the tailing pond and its associated outlet through the embankment are essential components of the tailings repository. As recommended in the enclosed Engineer's Inspection Report from Mr. Perry, the configuration of the existing drain-pipe upstream of the outlet, and the origin of the seep shown in photo 3, must be verified. Such investigations shall occur through the inspection and reporting program approved through TR-33. Any alteration to previously approved designs must be submitted for review and approval through the Technical Revision or Amendment process defined under Rules 1.9 and 1.10.

View east, taken at the downstream toe of the main embankment for the tailing pond, showing the outlet of the drainage blanket and a seep associated with the outlet. The origin of the seep, current condition of the drain pipe through the base of the embankment, and any necessary repairs to the outlet must be addressed in the initial engineering report required through TR-33.

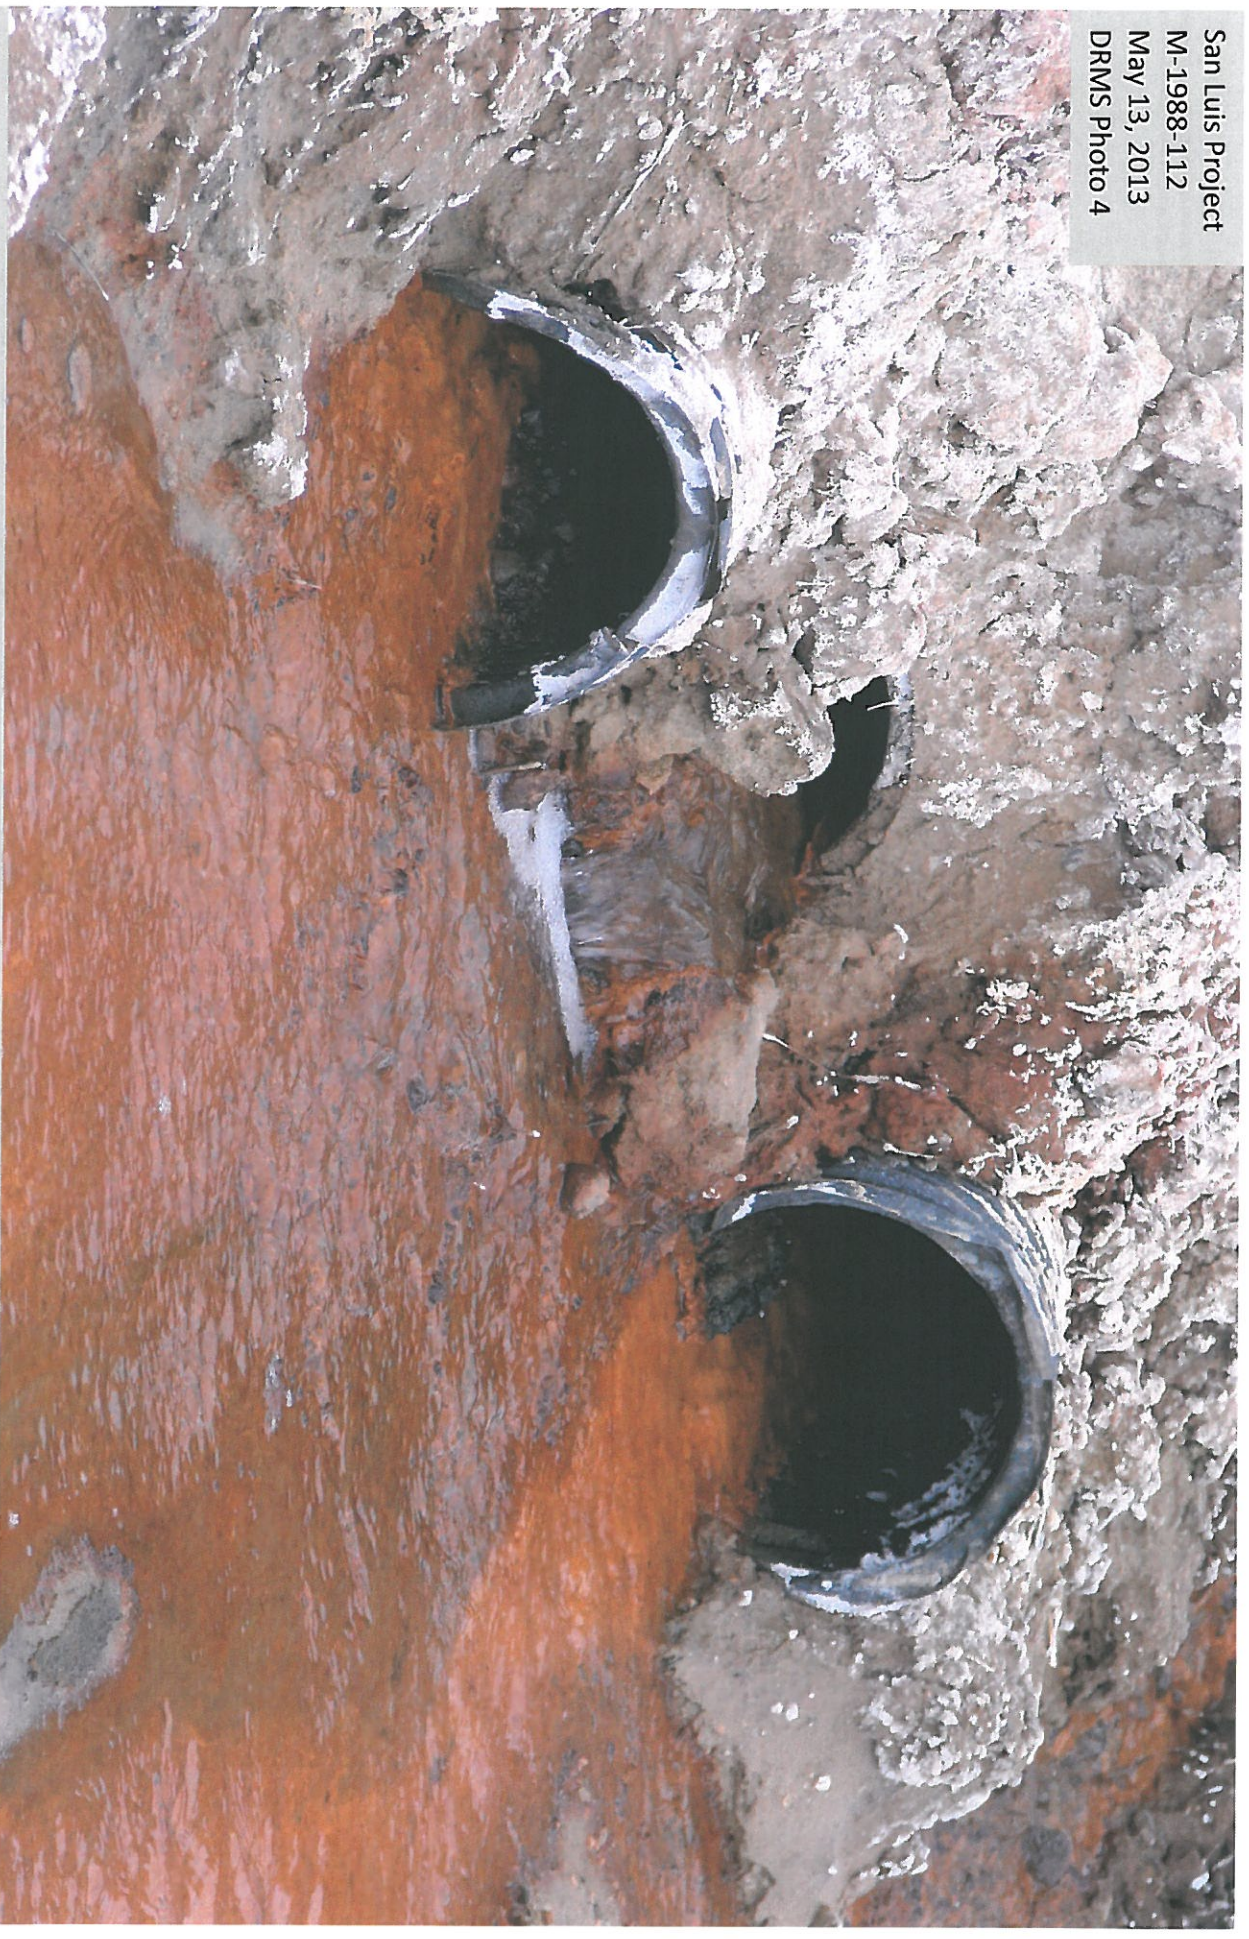
San Luis Project
M-1988-112
May 13, 2013
DRMS Photo 4

Detail photo of the drainage blanket outlet, shown in photo 3. Discharge from the outlet is contained at the collection pond and recycled to the free water pool for disposal by evaporation. Flow rate was estimated at 30 gpm. Routine maintenance to the outlet, to include sediment removal from the culverts and stabilization of the slope immediately above the culverts, appears necessary to ensure the outlet continues to function in accordance with approved designs.

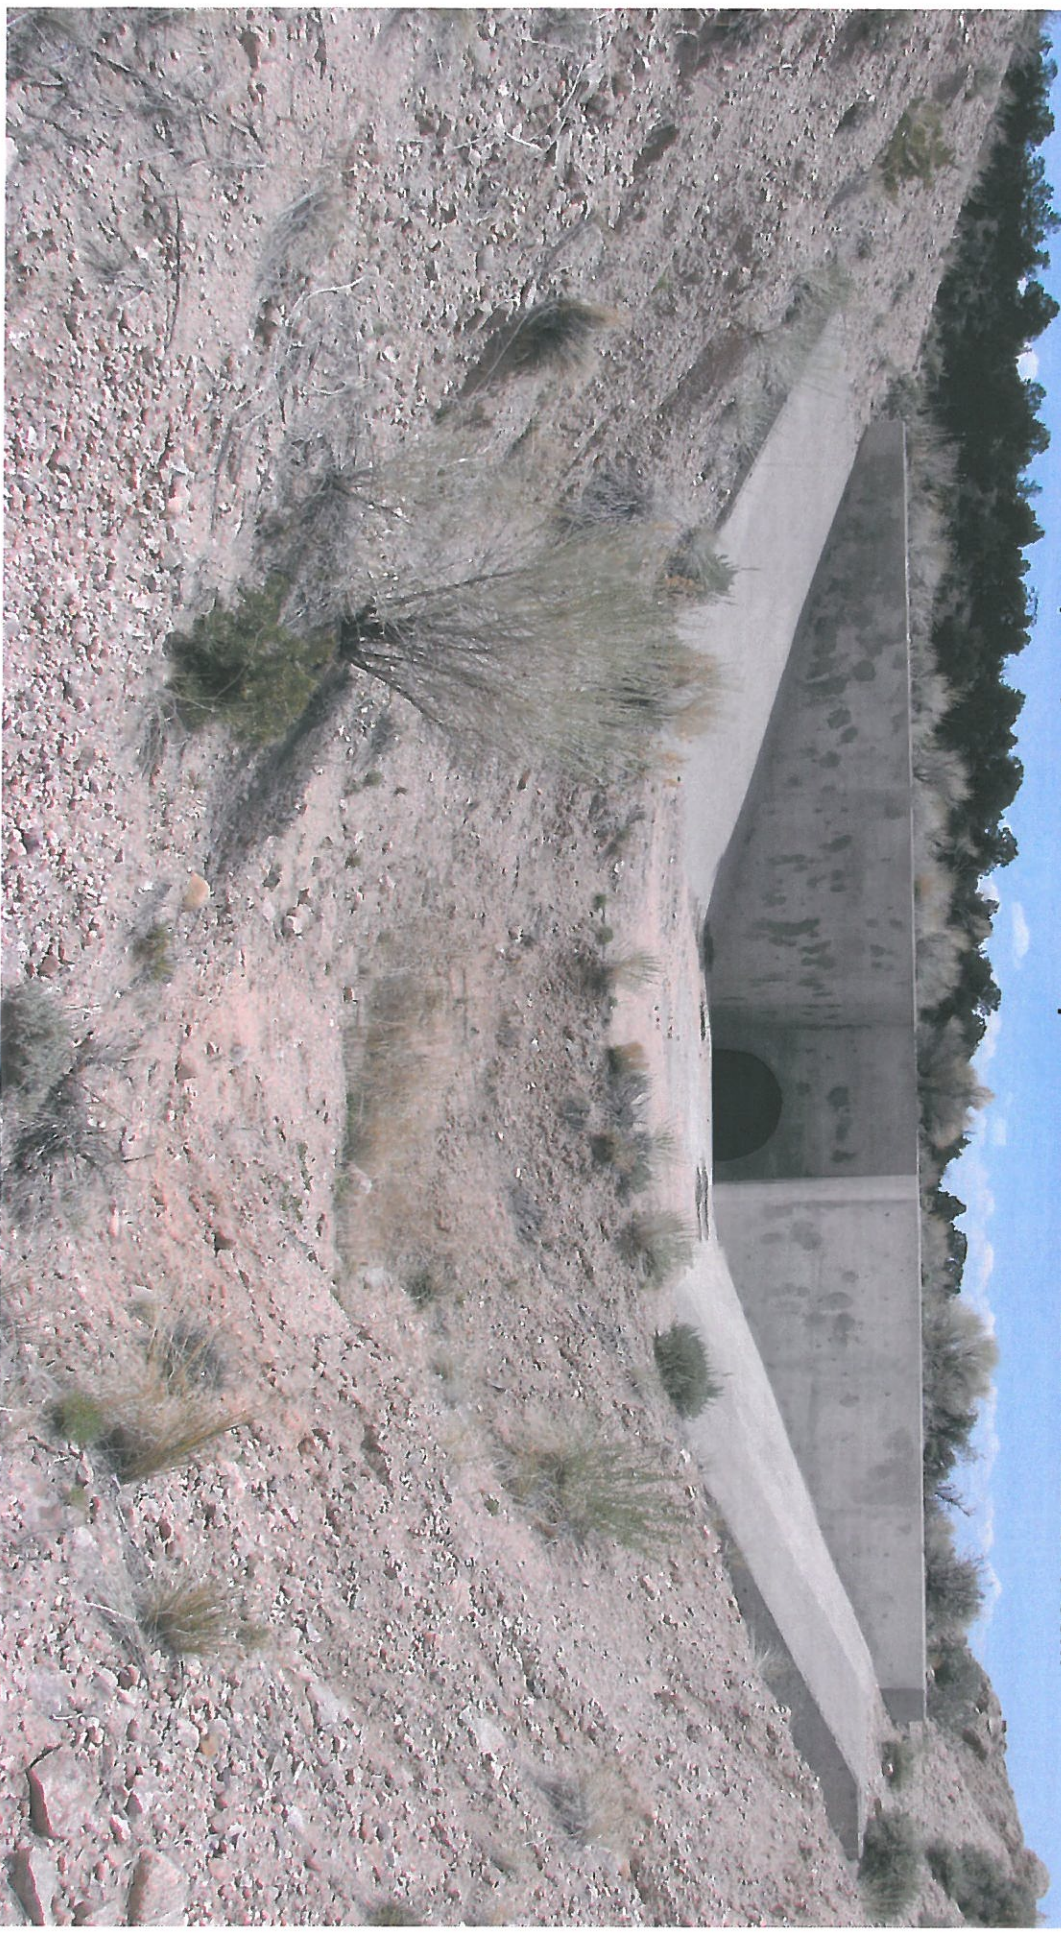
As shown in DRMS Photos 5 and 6, all portions of the south diversion ditch proximal to the embankment of the tailing pond appeared stable; evidence of erosion/sedimentation was not observed. However, as shown in photo 5, the inlet for the drop structure was not protected by a debris screen. As recommended by Mr. Perry, a properly designed debris screen appears essential to ensure the continued function of the drop structure. Please ensure the initial engineer inspection and report, required through TR-33, addresses the issue. If the engineer inspection and report recommends a debris screen, such plans must be submitted for review and approval through either the Technical Revision or Amendment process, described under Rules 1.9 and 1.10, prior to construction.

View west, showing portions of the upland diversion ditch for the south side of the tailings repository, and the inlet of its associated drop structure located at the crest of the embankment. The south upland diversion structure is designed to safely convey flows up to and including the 100 year, 24 hour storm event. Permit documents define the 100 year, 24 hour storm event at 2.9 inches precipitation and calculate storm runoff from the south drainage area at 292 cfs. As shown in this photo, the inlet of the drop structure did not include a debris screen.

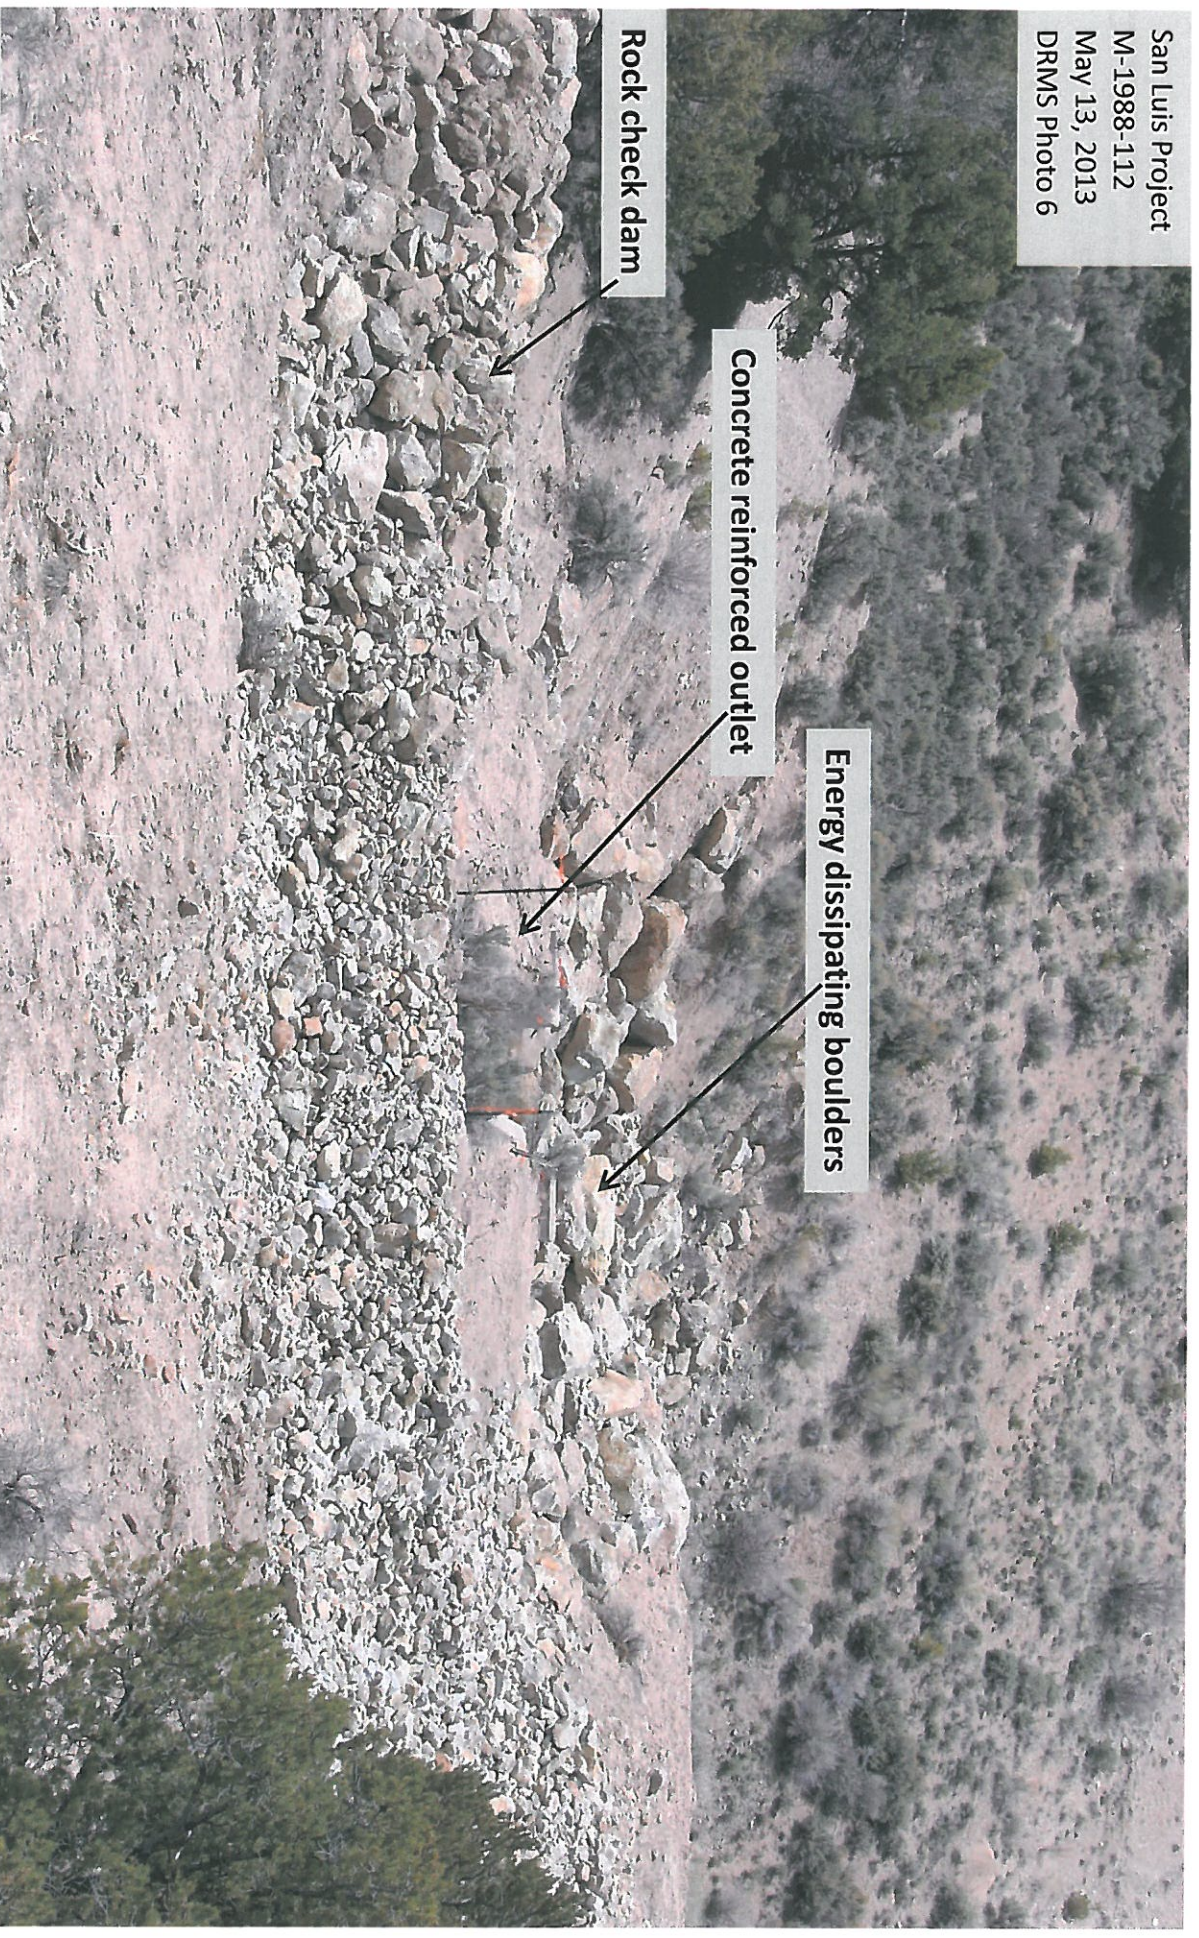
View west, taken nearby the crest and south end of the main embankment of the tailing pond, showing the drop structure outlet for the south diversion ditch. The Operator had recently conducted routine maintenance to control erosion. Erosion control methods employed by the Operator included surface grading, placement of riprap armoring, installation of rock check dam, and placement of energy dissipating boulders at the drop structure outlet. The outlet of the south diversion ditch appeared well maintained and stable; evidence of excessive erosion was not observed.

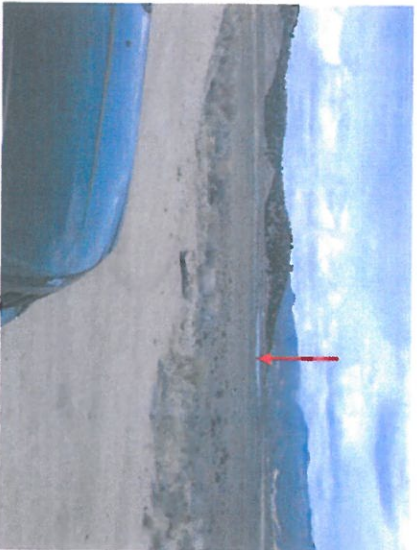
Photo 1 - Looking upstream at the tailings containment area from the left abutment of the main dam. During normal operations there is only a small pool of water.

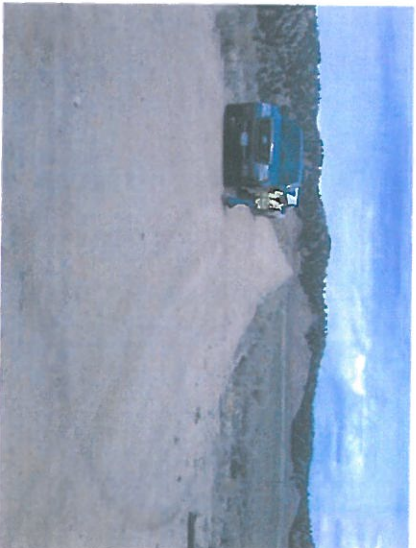
Photo 2 - Dam crest looking right from the left abutment.

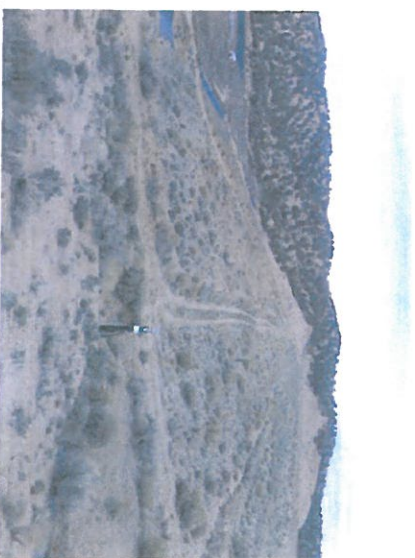
Photo 3 - Downstream slope looking right from the left abutment.

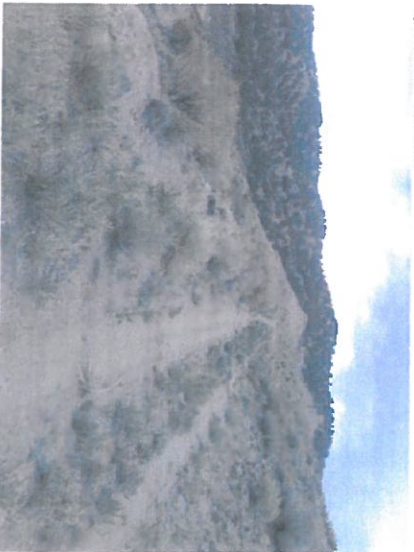
Photo 4 - Looking across one of two benches on the downstream slope.

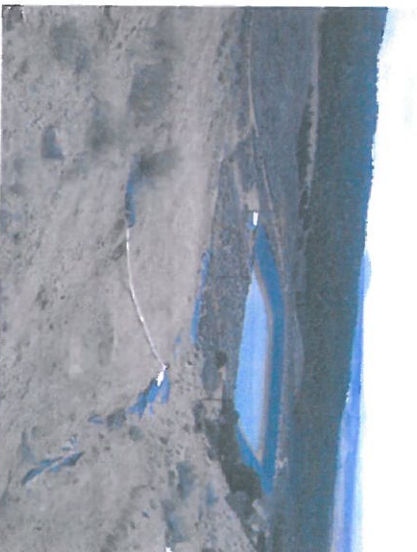
Photo 5 - Foreground shows right groin where liner and erosion damage was recently repaired. Background: seepage collection pond at the downstream toe of the main dam.

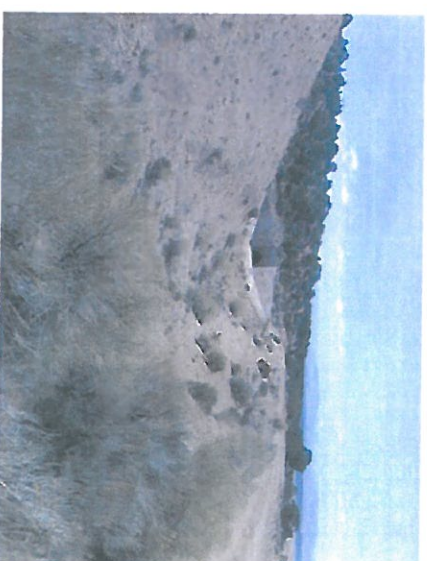
•We observed that there is no trash rack on the drop structure intake. The SEO typically recommends a self-cleaning type trash rack for the intake of a closed conduit spillway in order to prevent clogging.

Photo 6 - South diversion ditch and drop structure inlet located on the left side (south) of the main dam.

- ☒ (97) OTHER: **Consider installing a trash rack at the south diversion drop structure inlet.**
- ☒ (98) OTHER: **Perform an internal inspection of the south diversion drop structure conduit. ALSO we recommend evaluating how the Maximum Normal water level is controlled in both the main tailings dam and the seepage collection pond (See spillway sect. of this report).**

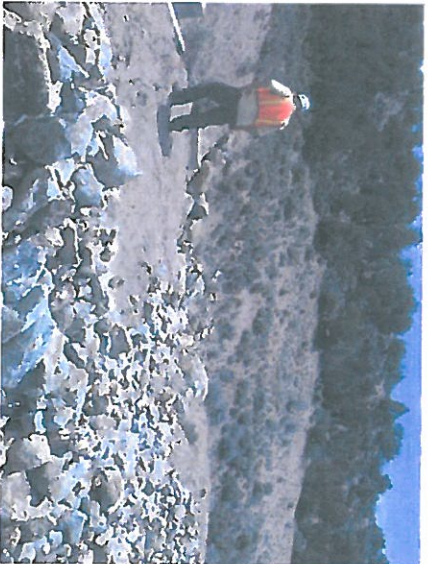
Photo 7 – Recent erosion repairs performed around the south diversion drop structure outfall.

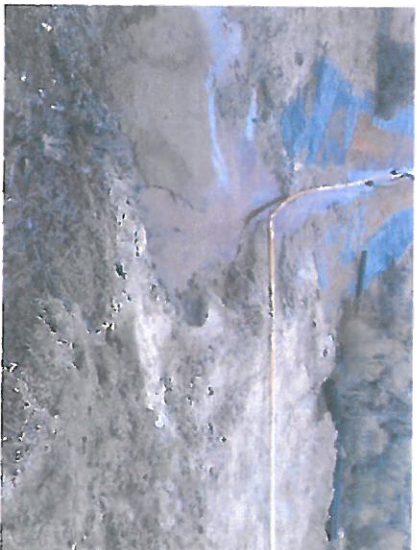
Photo 8 – Seepage at toe of the main dam. Majority of seepage comes through collection drain, but some seepage appears to be uncontrolled (see Photo 9).

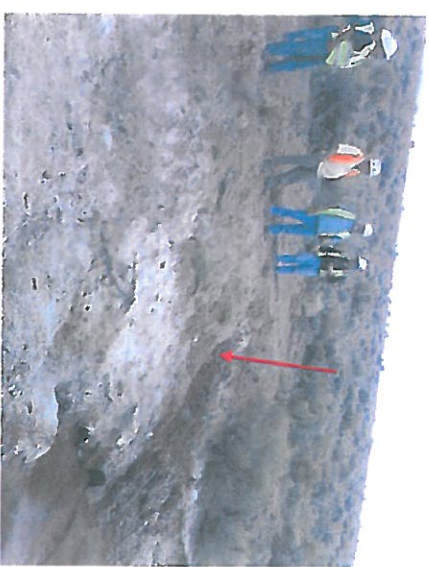
•Three 12" diameter HDPE pipes outfall at the downstream toe of the main embankment into an open channel to the seepage collection pond. The owner reports that the three pipes may be short extensions of what they believe is a larger (36"-48" dia.) HPDE seepage collection pipe under the main embankment. Again, no details of the collection pipe system were found by us on the Phase I as-built plans.

•Uncontrolled seepage was observed exiting ~6-ft above the 12" HDPE drain outfalls on the downstream slope of the main embankment.

Photo 9 – Seepage drain outfall at the downstream toe (3x12' HDPE pipes). There is reportedly a large seepage collection pipe under the dam. NOTE: Uncontrolled seepage exiting higher on the slope above the drain outfalls (red arrow).

(1) research to determine the design of the seepage collection pipe system under the embankment, and (2) after determining the design of the pipe collection system, determine if it is feasible to video inspect the pipes. The SEO recommends that internal outlet conduit video inspections be performed at least every 10 years for SEO-regulated High and Significant Hazard dams.
