Reference: Cripple Creek & Victor Gold Mining Company,
Cresson Project Squaw Gulch (VLF), Hwy 67 Realignment

Subject: Weekly Construction Quality Assurance ("CQA") Report:
AMEC: Squaw Gulch (VLF), Hwy 67 Realignment - Weeks ending 01/11/14 and
1/18/14.

CRIPPLE CREEK & VICTOR GOLD MINING Co.
Squaw Gulch (VLF), HWY 67 Realignment Field Monitoring Summary Weekly Report

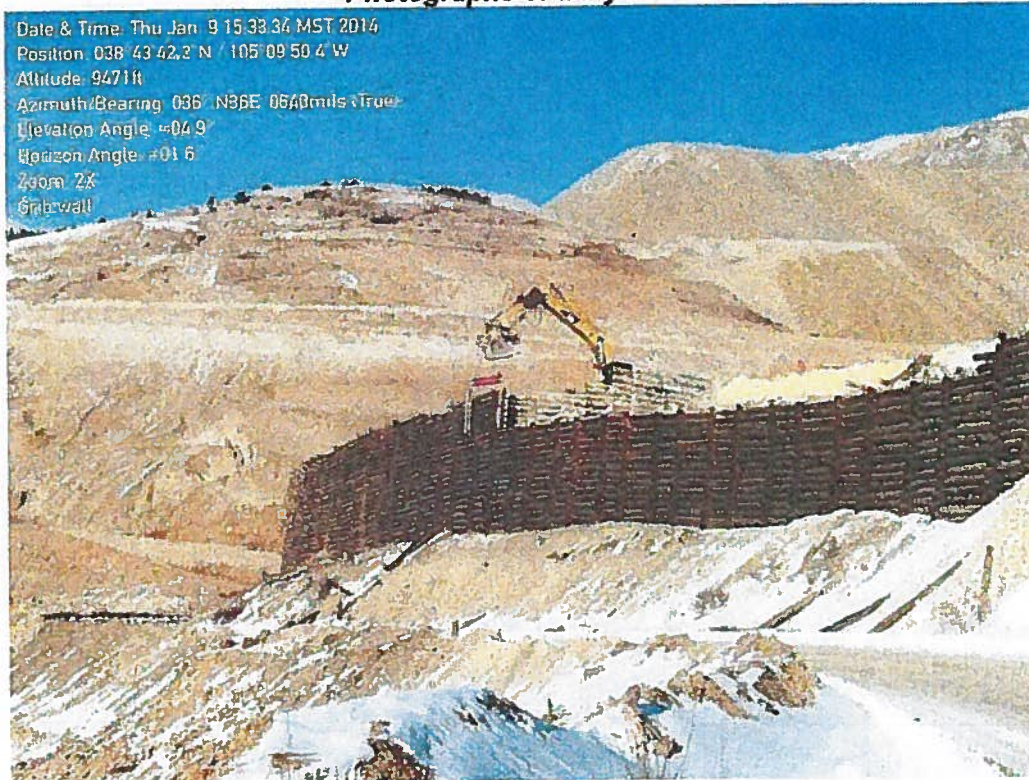
Photo 1: Historical Crib Wall dismantling.

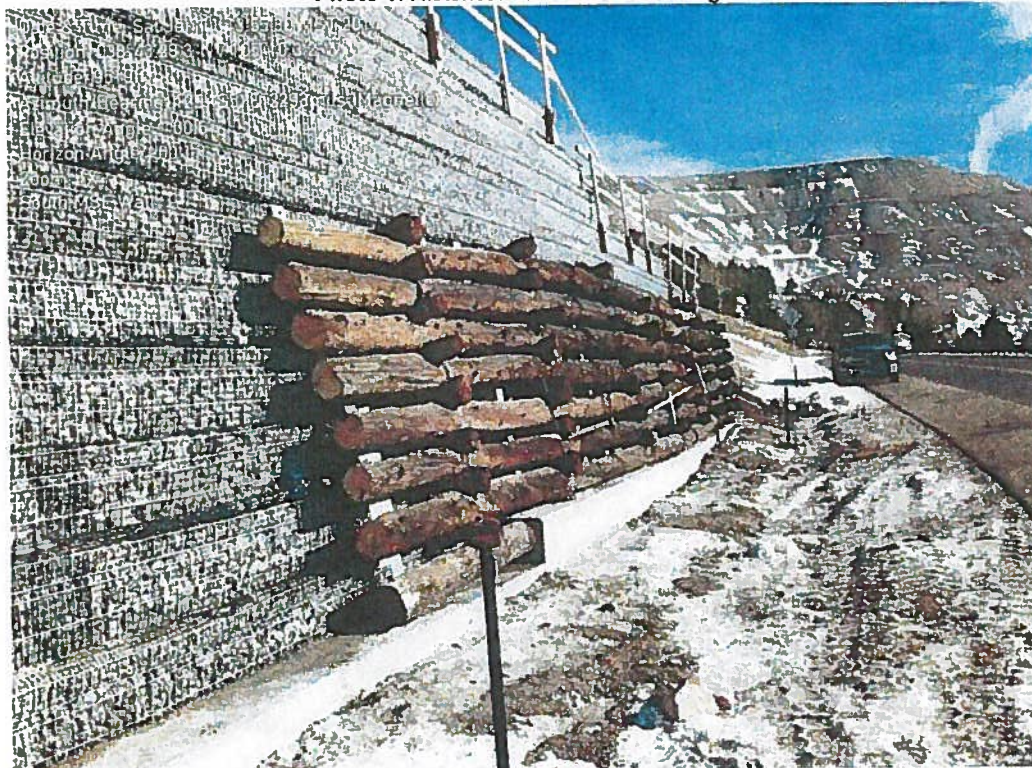
Photo 2: Installed timber panels at the South MSE Wall.

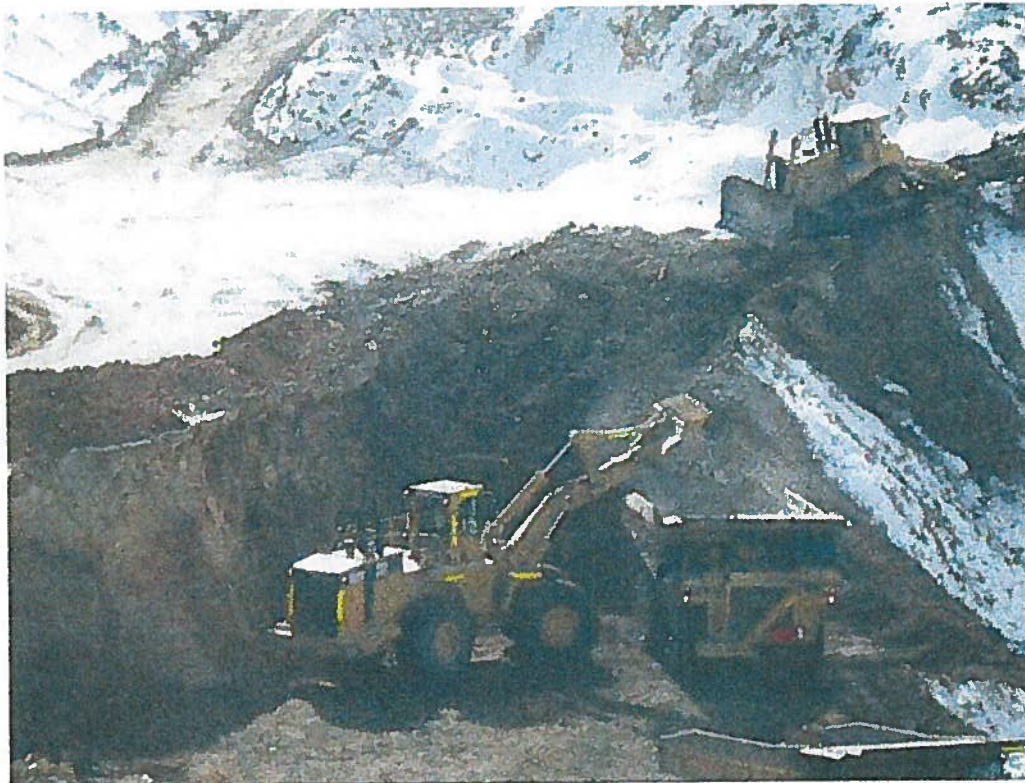
Photo 3: Cut operations near station A20+00.

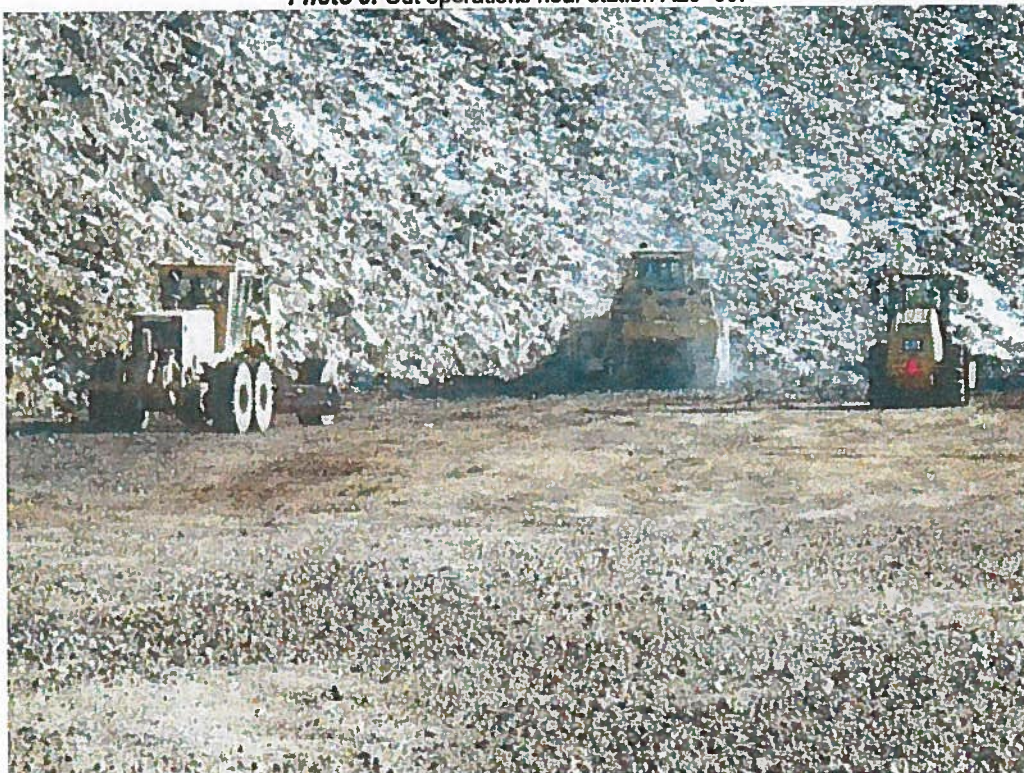
Photo 4: Fill placement at the Buttress Fill area.

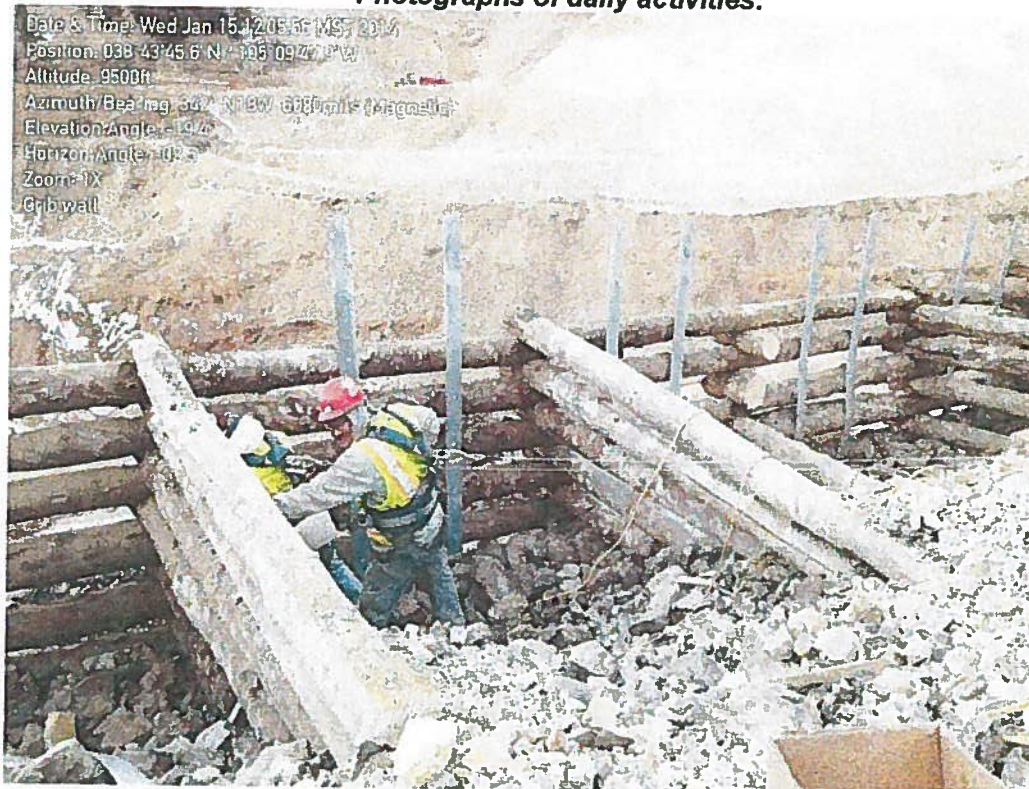
Photo 1: Historical Crib Wall dismantling.

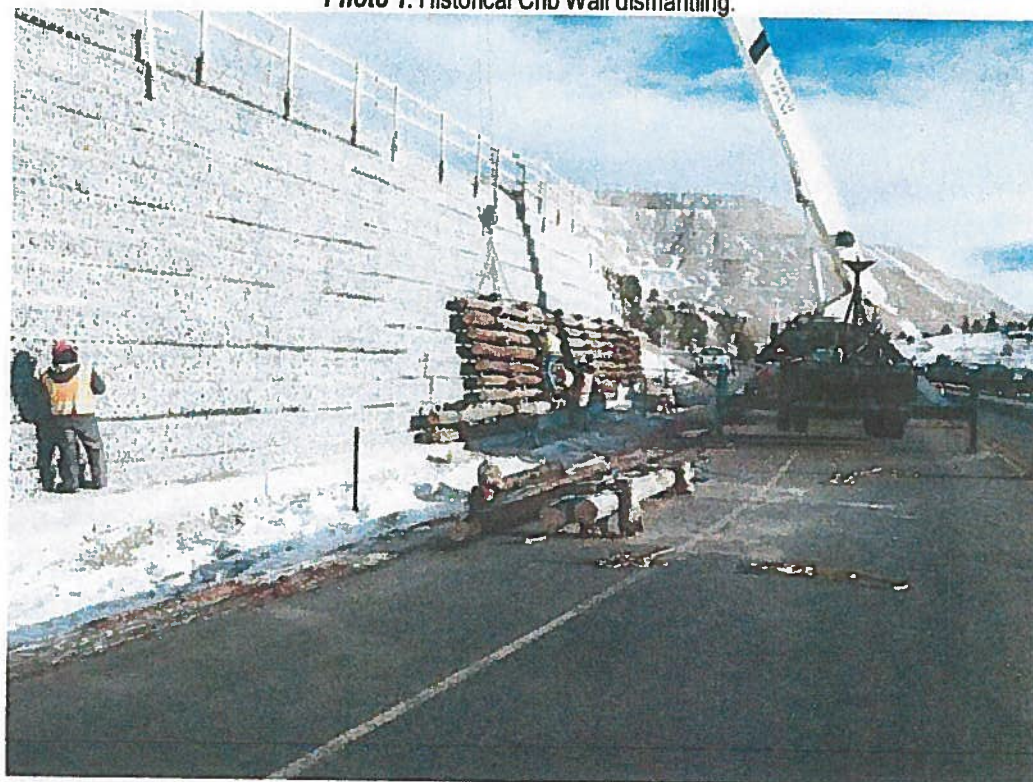
Photo 2: Installed timber panels at the South MSE Wall..

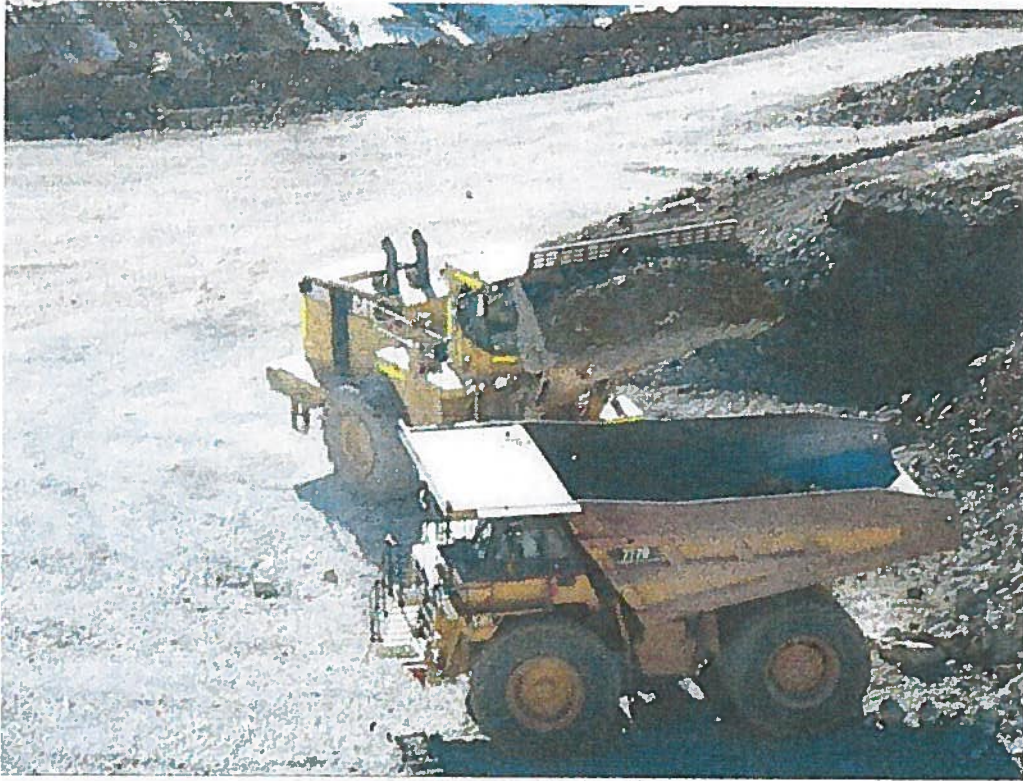
Photo 3: Cut operations near station A14+00.

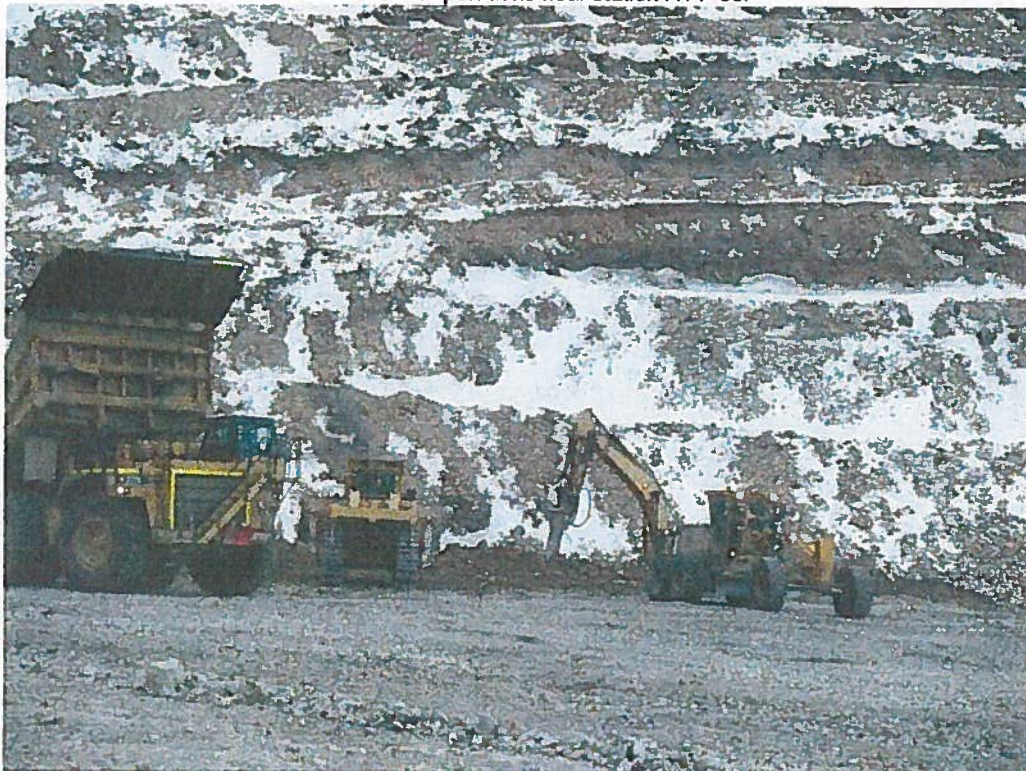
Photo 4: Fill placement at the Butress Fill area.
