**COLORADO DIVISION OF RECLAMATION, MINING AND SAFETY
MINERALS PROGRAM INSPECTION REPORT
PHONE: (303) 866-3567**

MINE NAME: North Farm Road Gravel Pit	MINE/PROSPECTING ID#: M-2000-110	MINERAL: Sand, gravel and borrow material	COUNTY: Rio Grande
INSPECTION TYPE: Monitoring	INSPECTOR(S): Bob Oswald	INSP. DATE: January 21, 2014	INSP. TIME: 15:00
OPERATOR: Mario Bassi and Josephine Bassi	OPERATOR REPRESENTATIVE: None	TYPE OF OPERATION: 112c - Construction Regular Operation

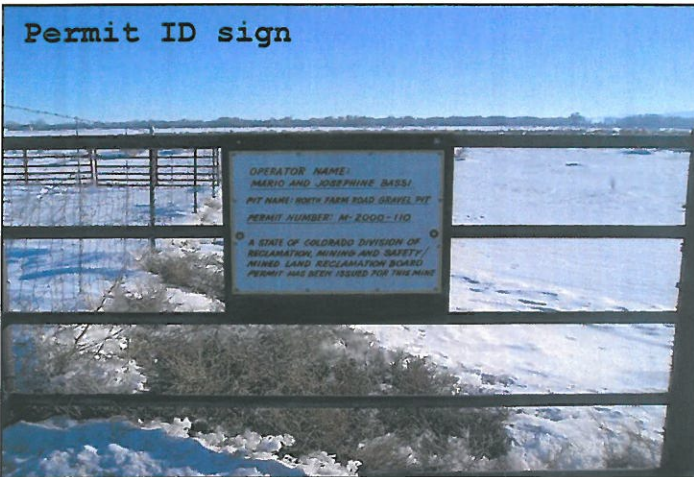
The required permit ID sign was observed posted at the northern entrance gate to the permitted area. The gate and sign are present at the edge of the county road, but there is no onsite roadway from the gate to the pit. The pit has only been accessed to-date from its western side, where it adjoins the neighboring permitted area. This is not a problem, since the amount of disturbance is less, and no unpermitted land is crossed. Permit boundary markers, consisting of fencelines, were installed along the permit boundary. The operation is approved to be carried out in phases, termed "cells" in the permit file, and this operation is still in Cell 1.

Permit ID sign

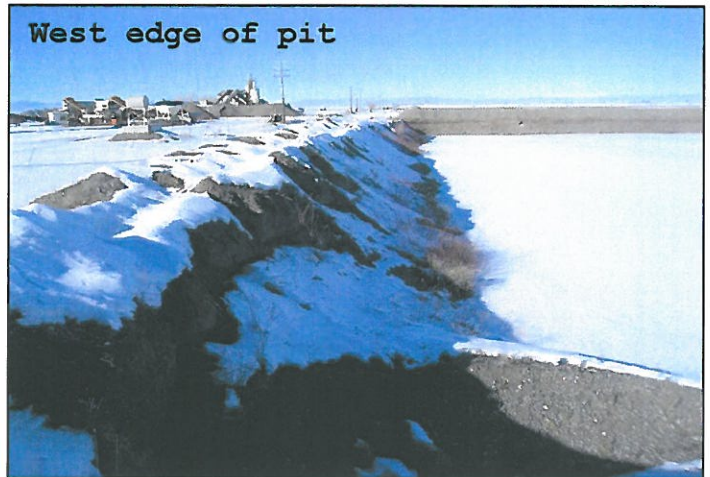
West edge of pit

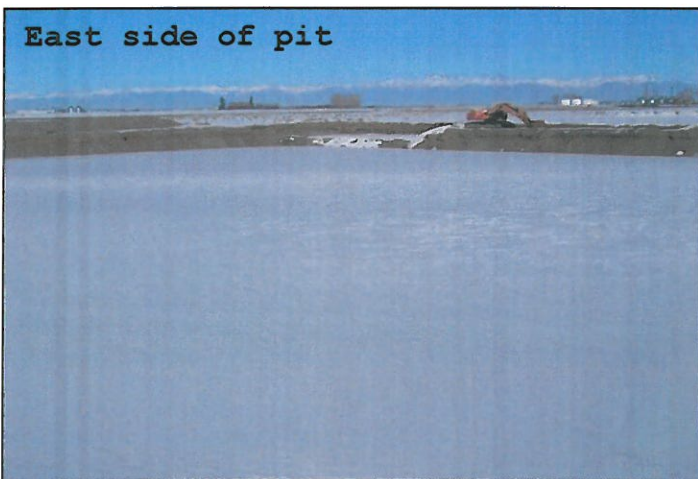
There was a tracked excavator on the east side of the pit. Excavation of the pit has exposed the shallow groundwater, creating a pond; the pond was ice-covered on the day of the inspection. The operator is also the landowner, who holds senior water rights, and the pond is approved by CDWR and this permit. There will be more ponds created as additional cells are mined.

East side of pit

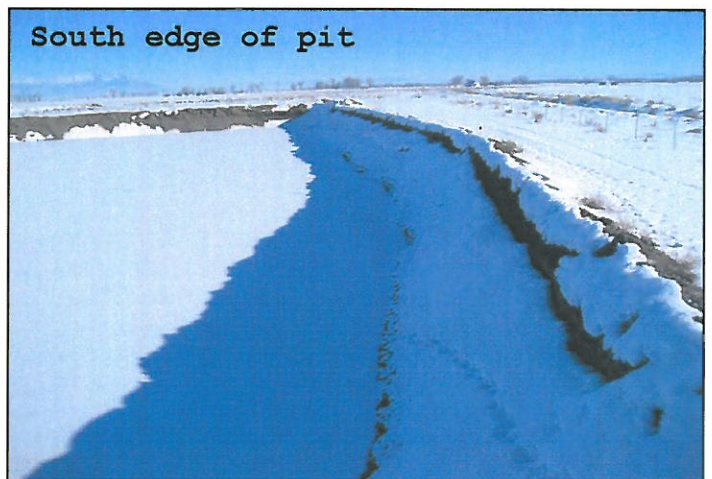
South edge of pit

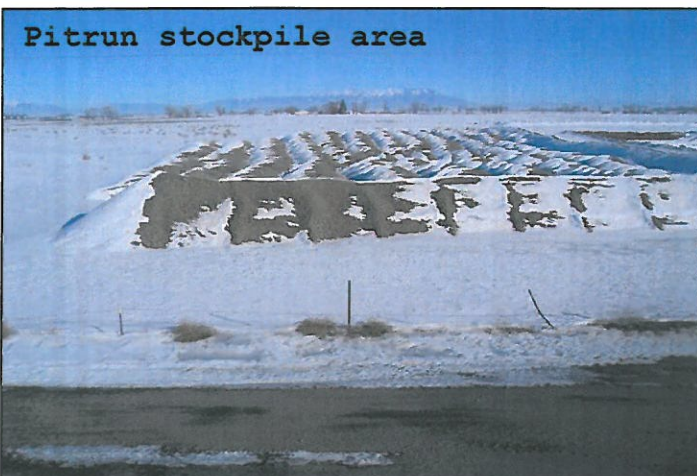
Pitrun stockpile area

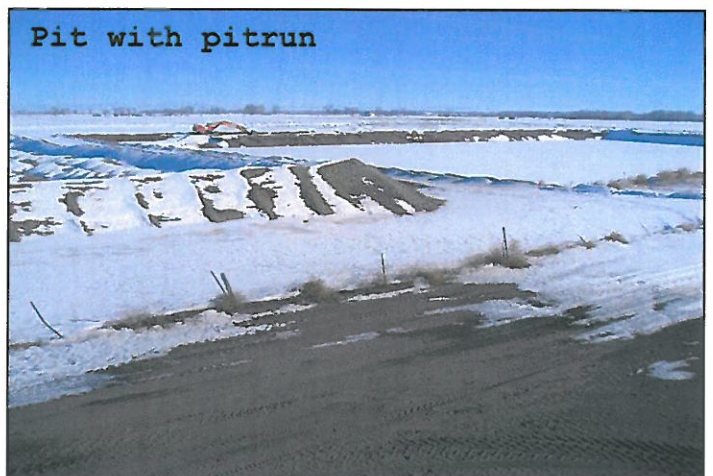
Pit with pitrun
