Reference: Cripple Creek & Victor Gold Mining Company,
Cresson Project Squaw Gulch (VLF), Hwy 67 Realignment

Subject: Weekly Construction Quality Assurance ("CQA") Report:
AMEC: Squaw Gulch (VLF), Hwy 67 Realignment - Week ending 01/25/14.

CRIPPLE CREEK & VICTOR GOLD MINING Co.
Squaw Gulch (VLF), HWY 67 Realignment Field Monitoring Summary Weekly Report

Reporting Period: 1.19.14 thru 1.25.14

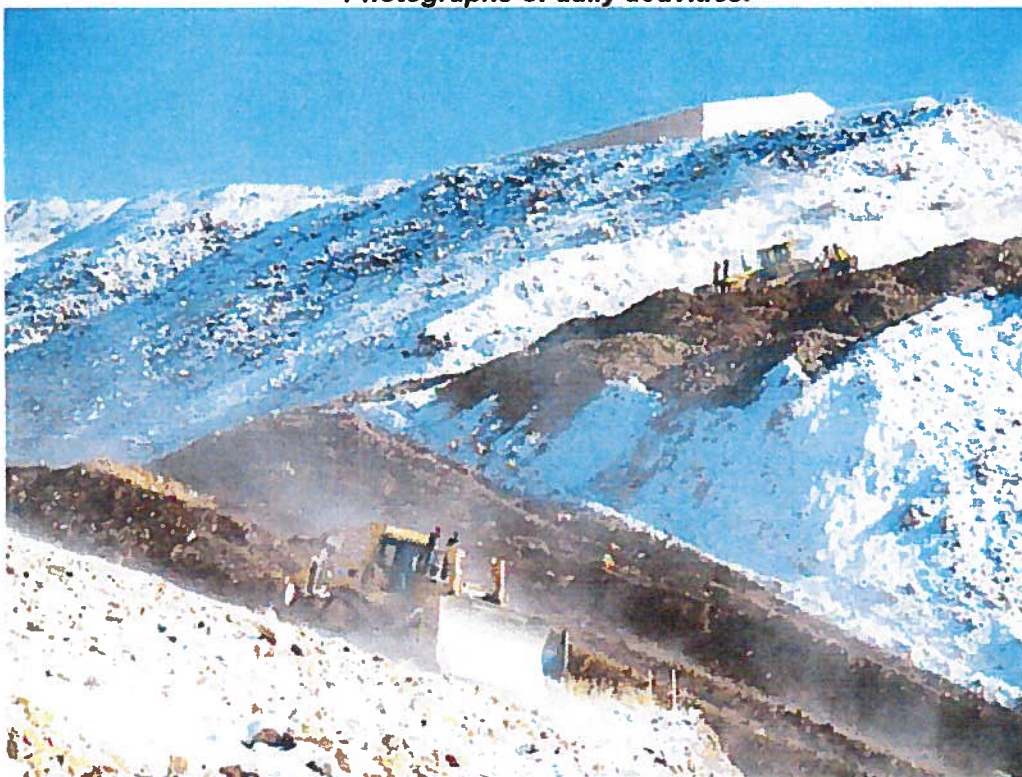
A Cat D10 pushed material downslope from Dump 4 east of the Phase 2 Diversion Channel area where it was placed as fill in approximately 3 foot lifts by a Cat dozers. The lifts were compacted per method specification by a Cat vibratory smooth drum roller.

Photo 1: Cut and fill operations east of the Phase 2 Diversion Channel adjacent to Dump 4.

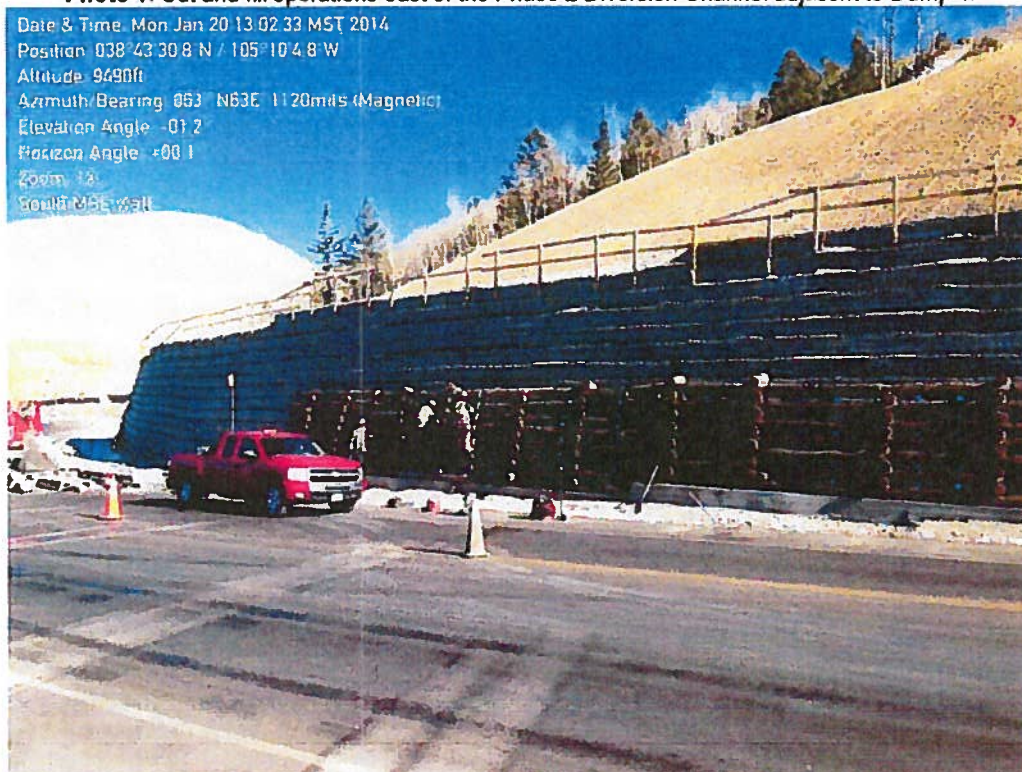
Timber-panel installation continued at the South MSE wall.

Photo 2: Installed timber panels at the South MSE Wall.

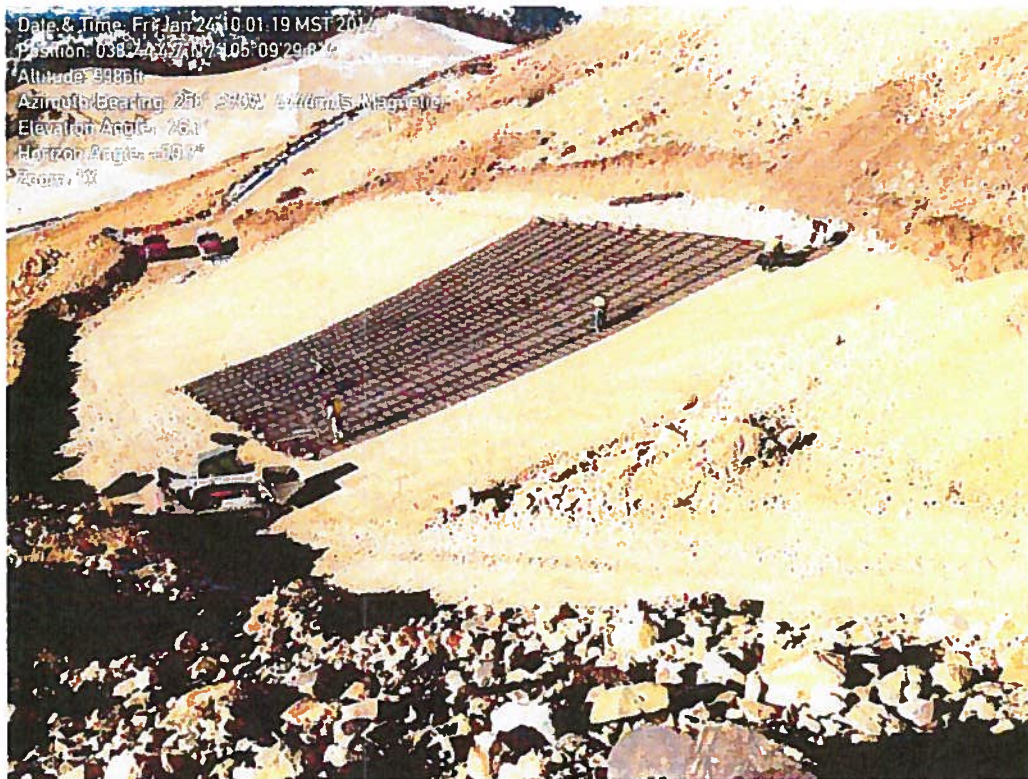
Two layers of geogrid and select structural fill were installed at Working UG # 6123. Work is to continue.

Photo 3: Placement of the second layer of geogrid at Underground Working UG 6123.

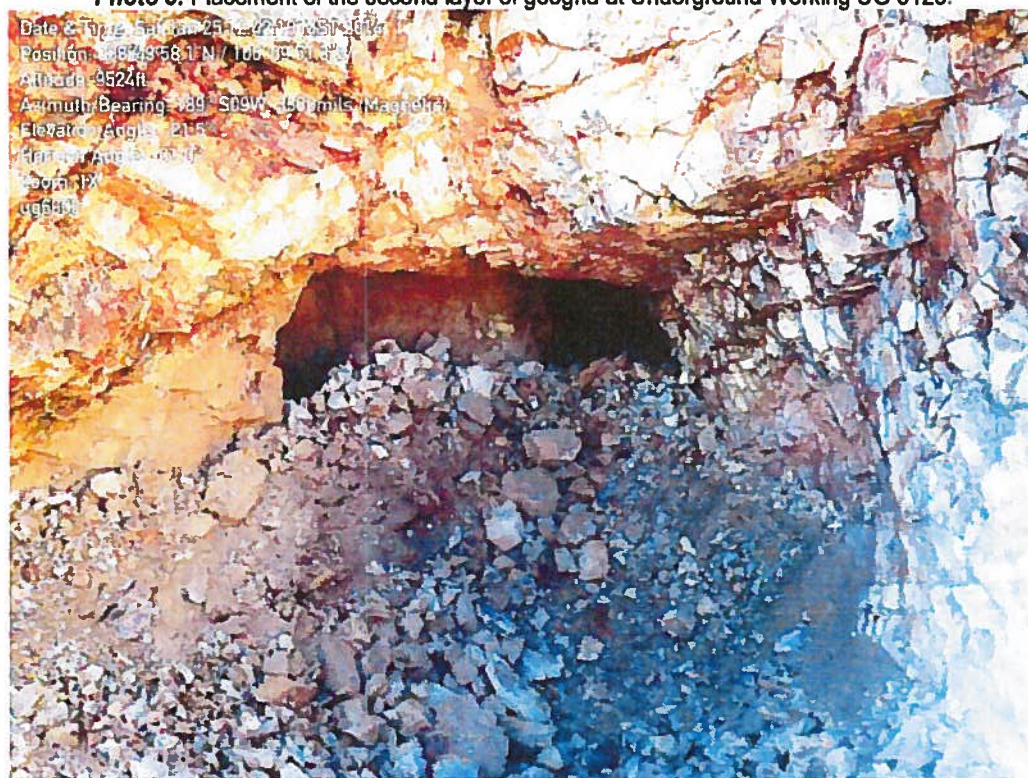
A Cat 345 excavator removed shot rock from the adit at UG #6003. Two additional adits were located and will require confirmatory drilling to isolate them.

Photo 4: Newly discovered adits at Underground Working UG 6003.
