Reference: Cripple Creek & Victor Gold Mining Company,
Cresson Project Squaw Gulch (VLF), Hwy 67 Realignment

Subject: Weekly Construction Quality Assurance ("CQA") Report:
AMEC: Squaw Gulch (VLF), Hwy 67 Realignment - Week ending 02/1/14.

CRIPPLE CREEK & VICTOR GOLD MINING Co.
Squaw Gulch (VLF), HWY 67 Realignment Field Monitoring Summary Weekly Report

Reporting Period: 1.26.14 thru 2.01.14

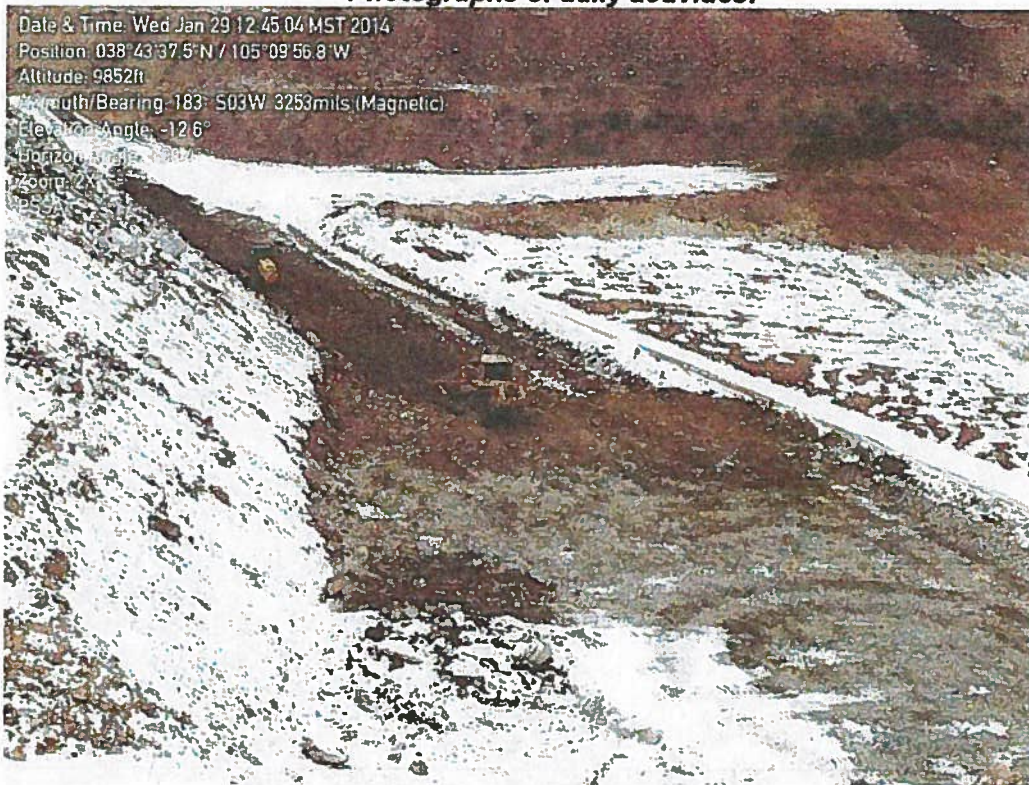
A John Deere excavator loaded out structural fill from the base of the PSSA into Cat 740 haul trucks. The structural fill was hauled to the PSSA toe embankment and placed in approximately 36 inch lifts. A Cat D8 dozer also placed cut material used as structural fill at the PSSA west sliver fill. The structural fill came from the west slope of the PSSA and was placed in approximately 24 inch lifts. A Cat vibratory smooth drum roller compacted both fill areas at the PSSA per method specification. A John Deere 1050J dozer was also used to grade the bottom of the PSSA to provide access for closure drain drilling.

Photo 1: Fill placement at the PSSA toe embankment.

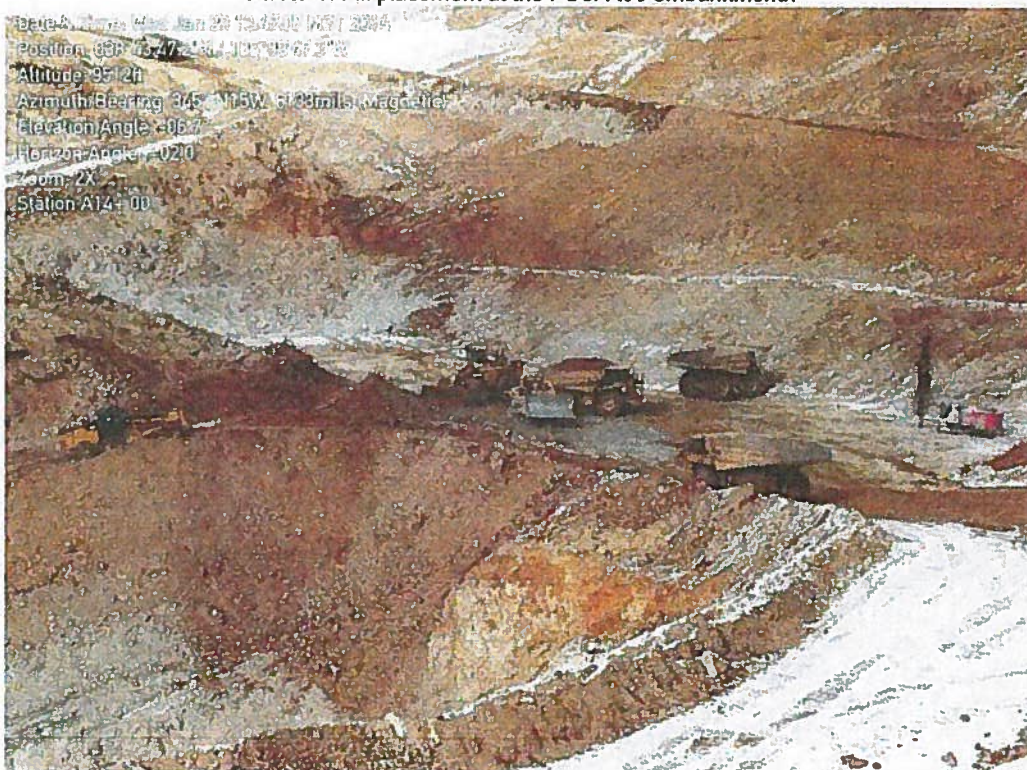
Photo 2: Cut removal near station A14+00.

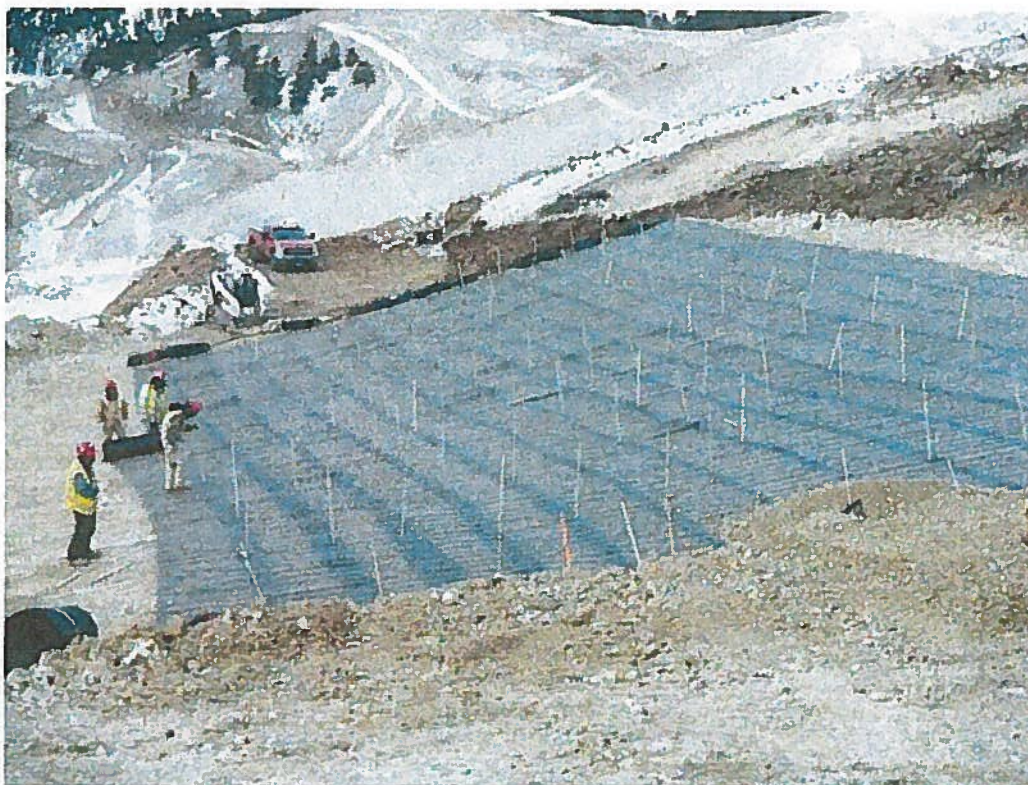
The third layer of geogrid and select structural fill were started at Working UG # 6123. Work is to continue.

Photo 3: Placement of the final layer of geogrid at Underground Working UG 6123.

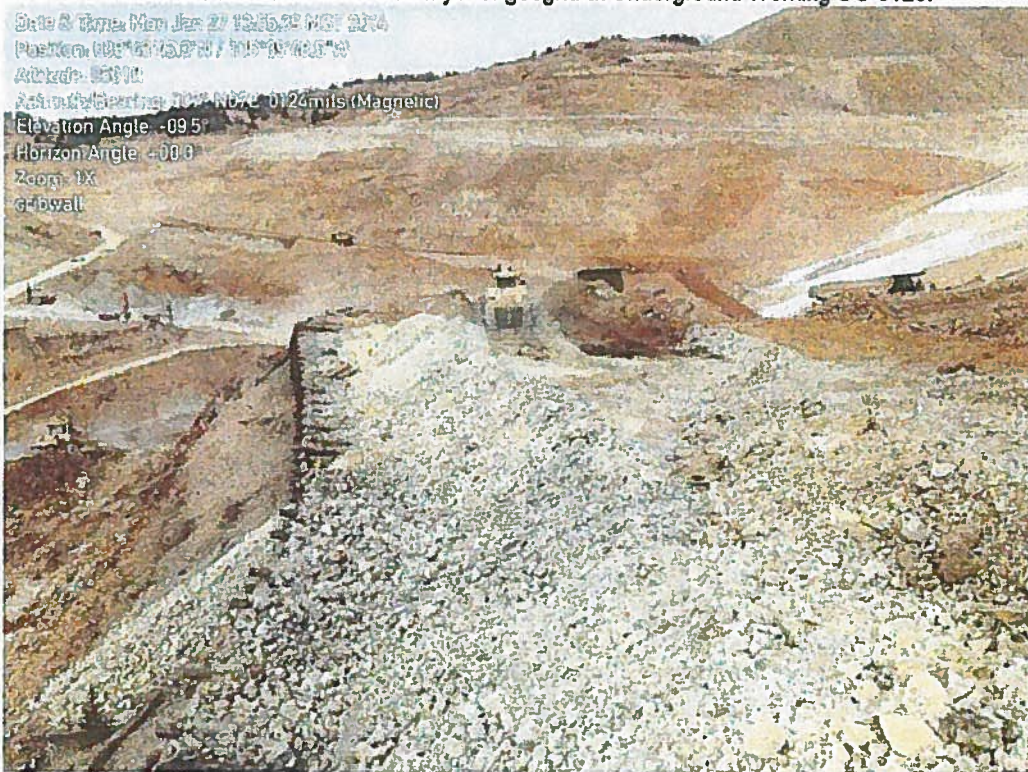
A Cat 320 excavator was used to remove tailings from behind the timbers at the historic crib wall. The tailings were pushed down hill near station B16+00 where they were loaded out and used as fill. A Cat 320 excavator was also used to remove timber panels from the historic crib wall that were fastened together with steel backing straps and spikes.

Photo 4: Tailings removal at the Crib Wall.
