**To COLORADO DIVISION OF RECLAMATION, MINING AND SAFETY
MINERALS PROGRAM INSPECTION REPORT
PHONE: (303) 866-3567**

MINE NAME: Velarde Pit	MINE/PROSPECTING ID#: M-2002-118	MINERAL: Sand and gravel	COUNTY: Huerfano
INSPECTION TYPE: Monitoring	INSPECTOR(S): Tyler V. O'Donnell	INSP. DATE: January 27, 2014	INSP. TIME: 09:30
OPERATOR: APC Southern Construction Co., LLC	OPERATOR REPRESENTATIVE: Richard Pounds	TYPE OF OPERATION: 112c - Construction Regular Operation

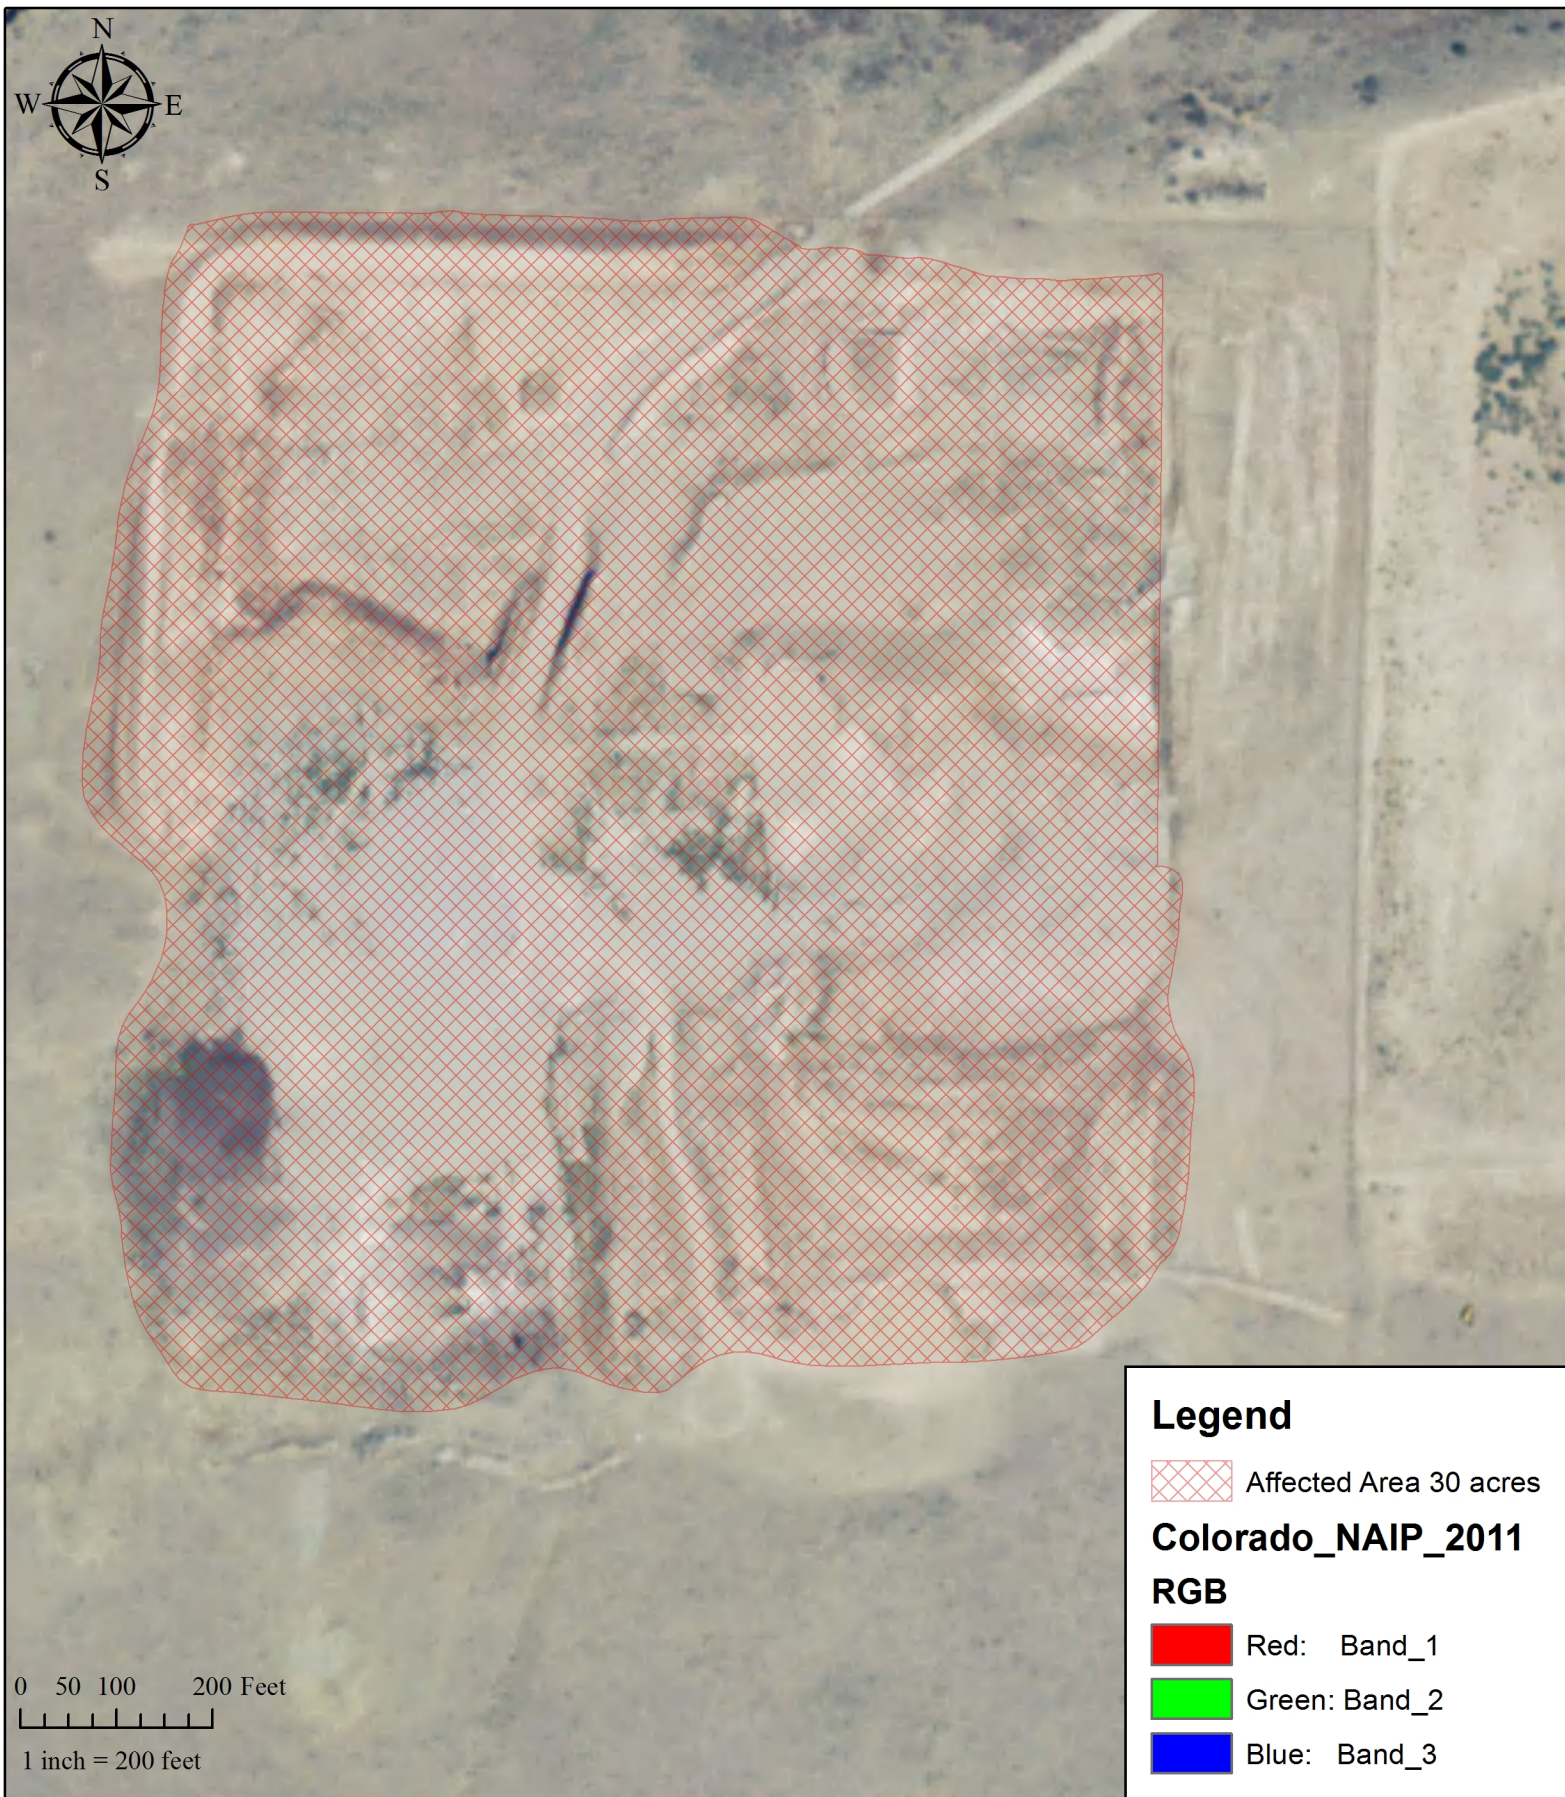
Velarde Pit

PROBLEM/POSSIBLE VIOLATION: Problem: The Operator has failed to comply with the approved mine plan, the Operator has disturbed more acres than the maximum allowed disturbance of 20 acres. The current mine plan shall updated and clarified pursuant to C.R.S. 34-32.5-112 (1)(c)(VI). The operator must provide sufficient information to describe or identify how the Operator intends to conduct the operation.

The mining operation has commended in the eastern part of Phase 1 and is progressing westward. The Operator appears to be observing the required 25 foot power line offsets. All mining activity appeared to be within the approved permit boundaries. The Operator indicated in the last annual report that 34 acres were currently affected by mining operations. During the inspection, the disturbed area was measured with a hand held GPS unit and was found to be approximately 30 acres (see figure #1). The Operator committed to disturbing no more than 20 acres at one time. This will be cited as a problem and will require a corrective action.

Figure 1: Affected area boundary (marked by the red lines on this 2011 NAIP image) encloses approximately 30 acres.

CORRECTIVE ACTIONS: The Operator shall submit a Technical Revision, with the required \$216 revision fee, to update and clarify the current approved mine plan and Exhibit L (Rule 6.4.12) Reclamation Cost Estimate to reflect existing and proposed activities by the corrective action date.

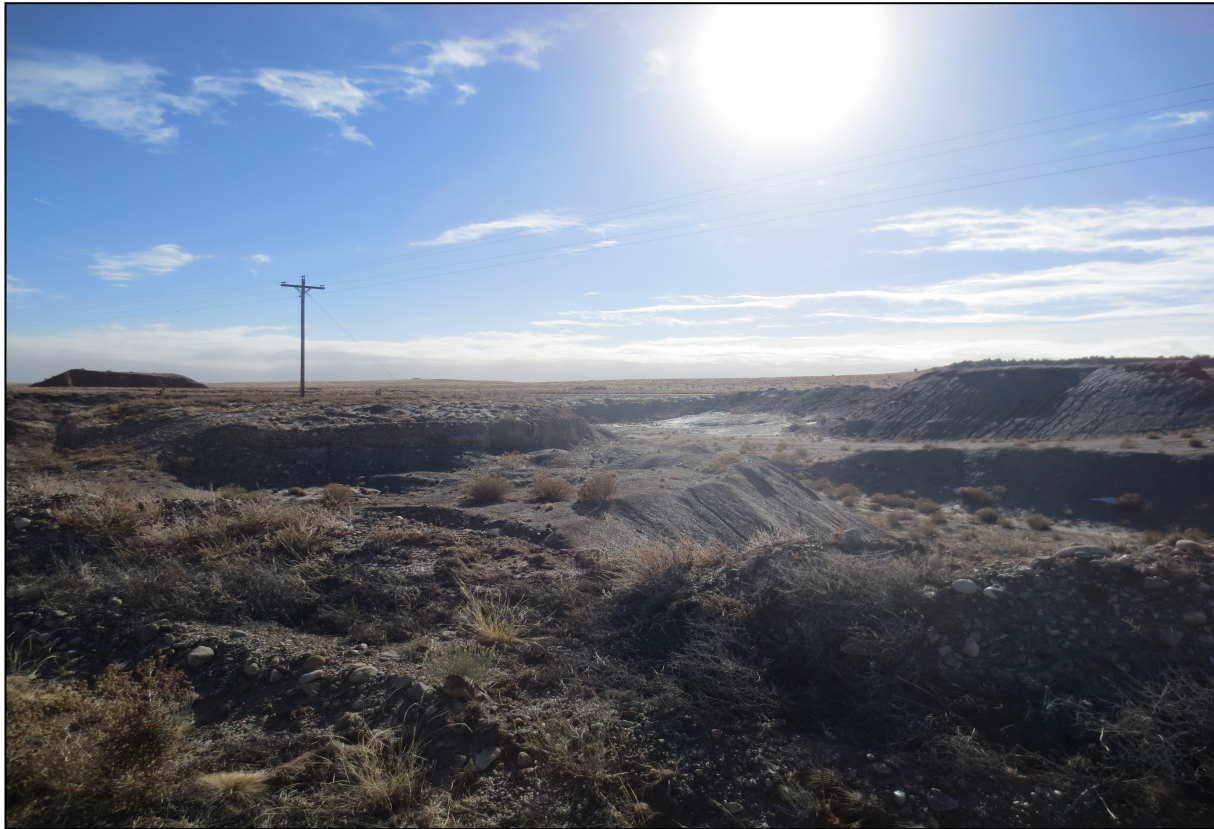
The pit has portions of the highwalls that have been graded to an approximant slope of 3H:1V and other portions of the pit walls are near veridical (see Photos 1 and 2).

Photo 1: View looking southeast into the pit from the access road.

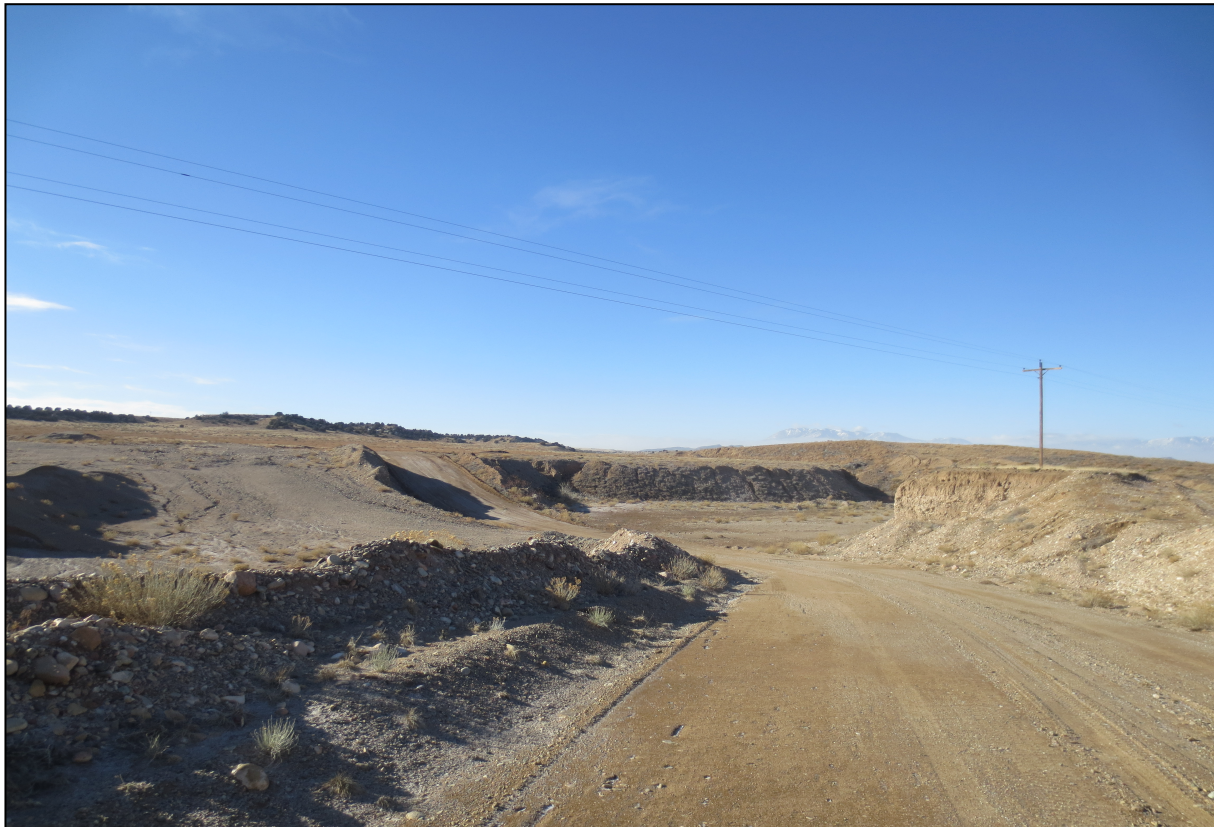
Photo 2: View looking southwest into the pit from the access road.

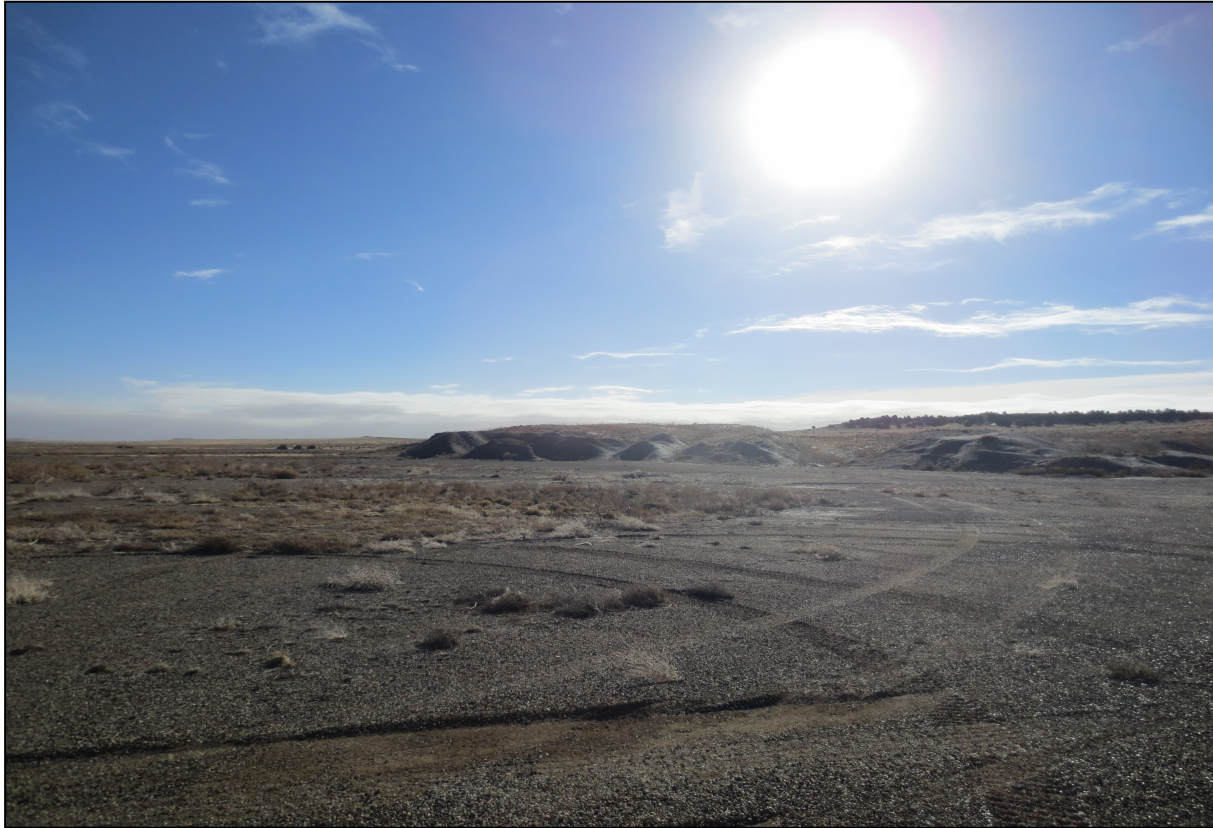
Photo 3: View looking southeast, where the processing plant was, and product stockpile in the background.

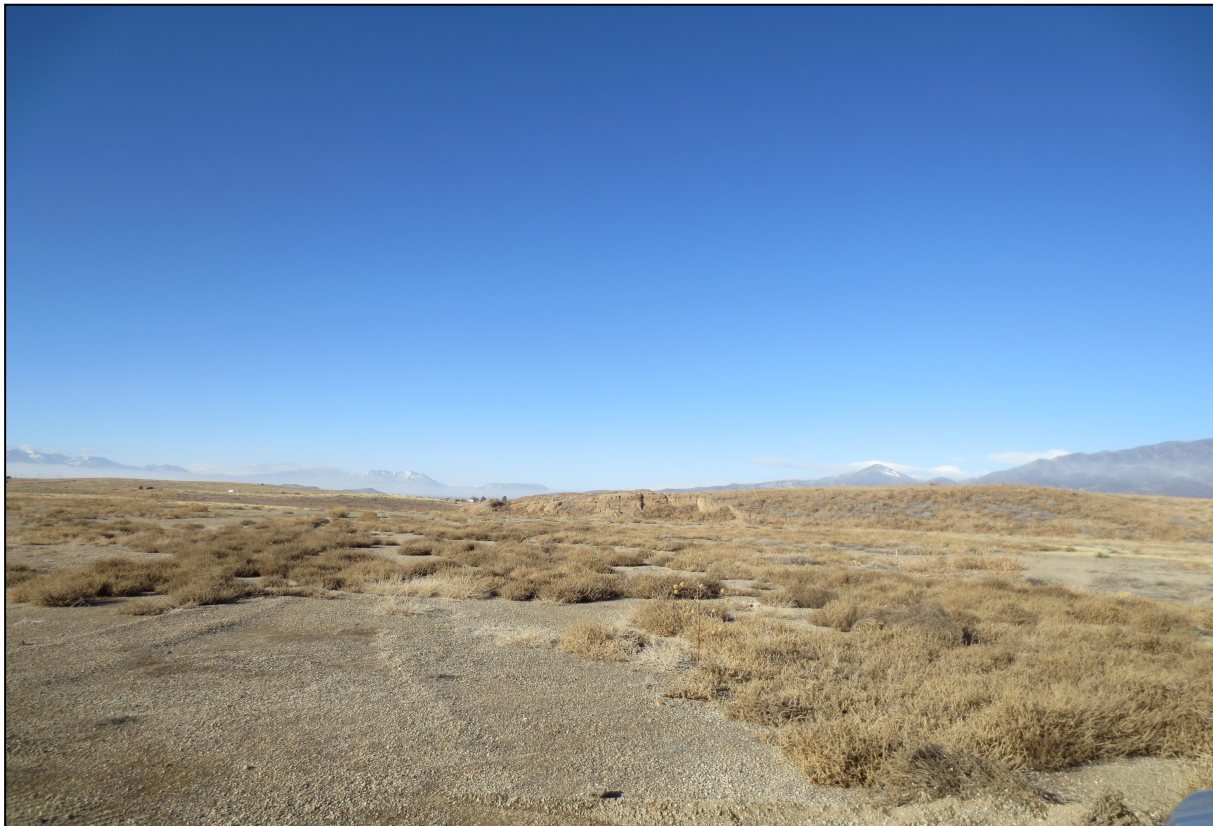
Photo 4: View looking west, pad where the processing plant was, and topsoil stockpile in the background.
