COLORADO DIVISION OF RECLAMATION, MINING AND SAFETY
MINERALS PROGRAM INSPECTION REPORT
PHONE: (303) 866-3567

MINE NAME: Pino Pit	MINE/PROSPECTING ID#: M-2000-118	MINERAL: Sand and gravel	COUNTY: Huerfano
INSPECTION TYPE: Monitoring	INSPECTOR(S): Tyler V. O'Donnell	INSP. DATE: January 27, 2014	INSP. TIME: 10:30
OPERATOR: APC Southern Construction Co., LLC	OPERATOR REPRESENTATIVE: Richard Pounds	TYPE OF OPERATION: 112c - Construction Regular Operation

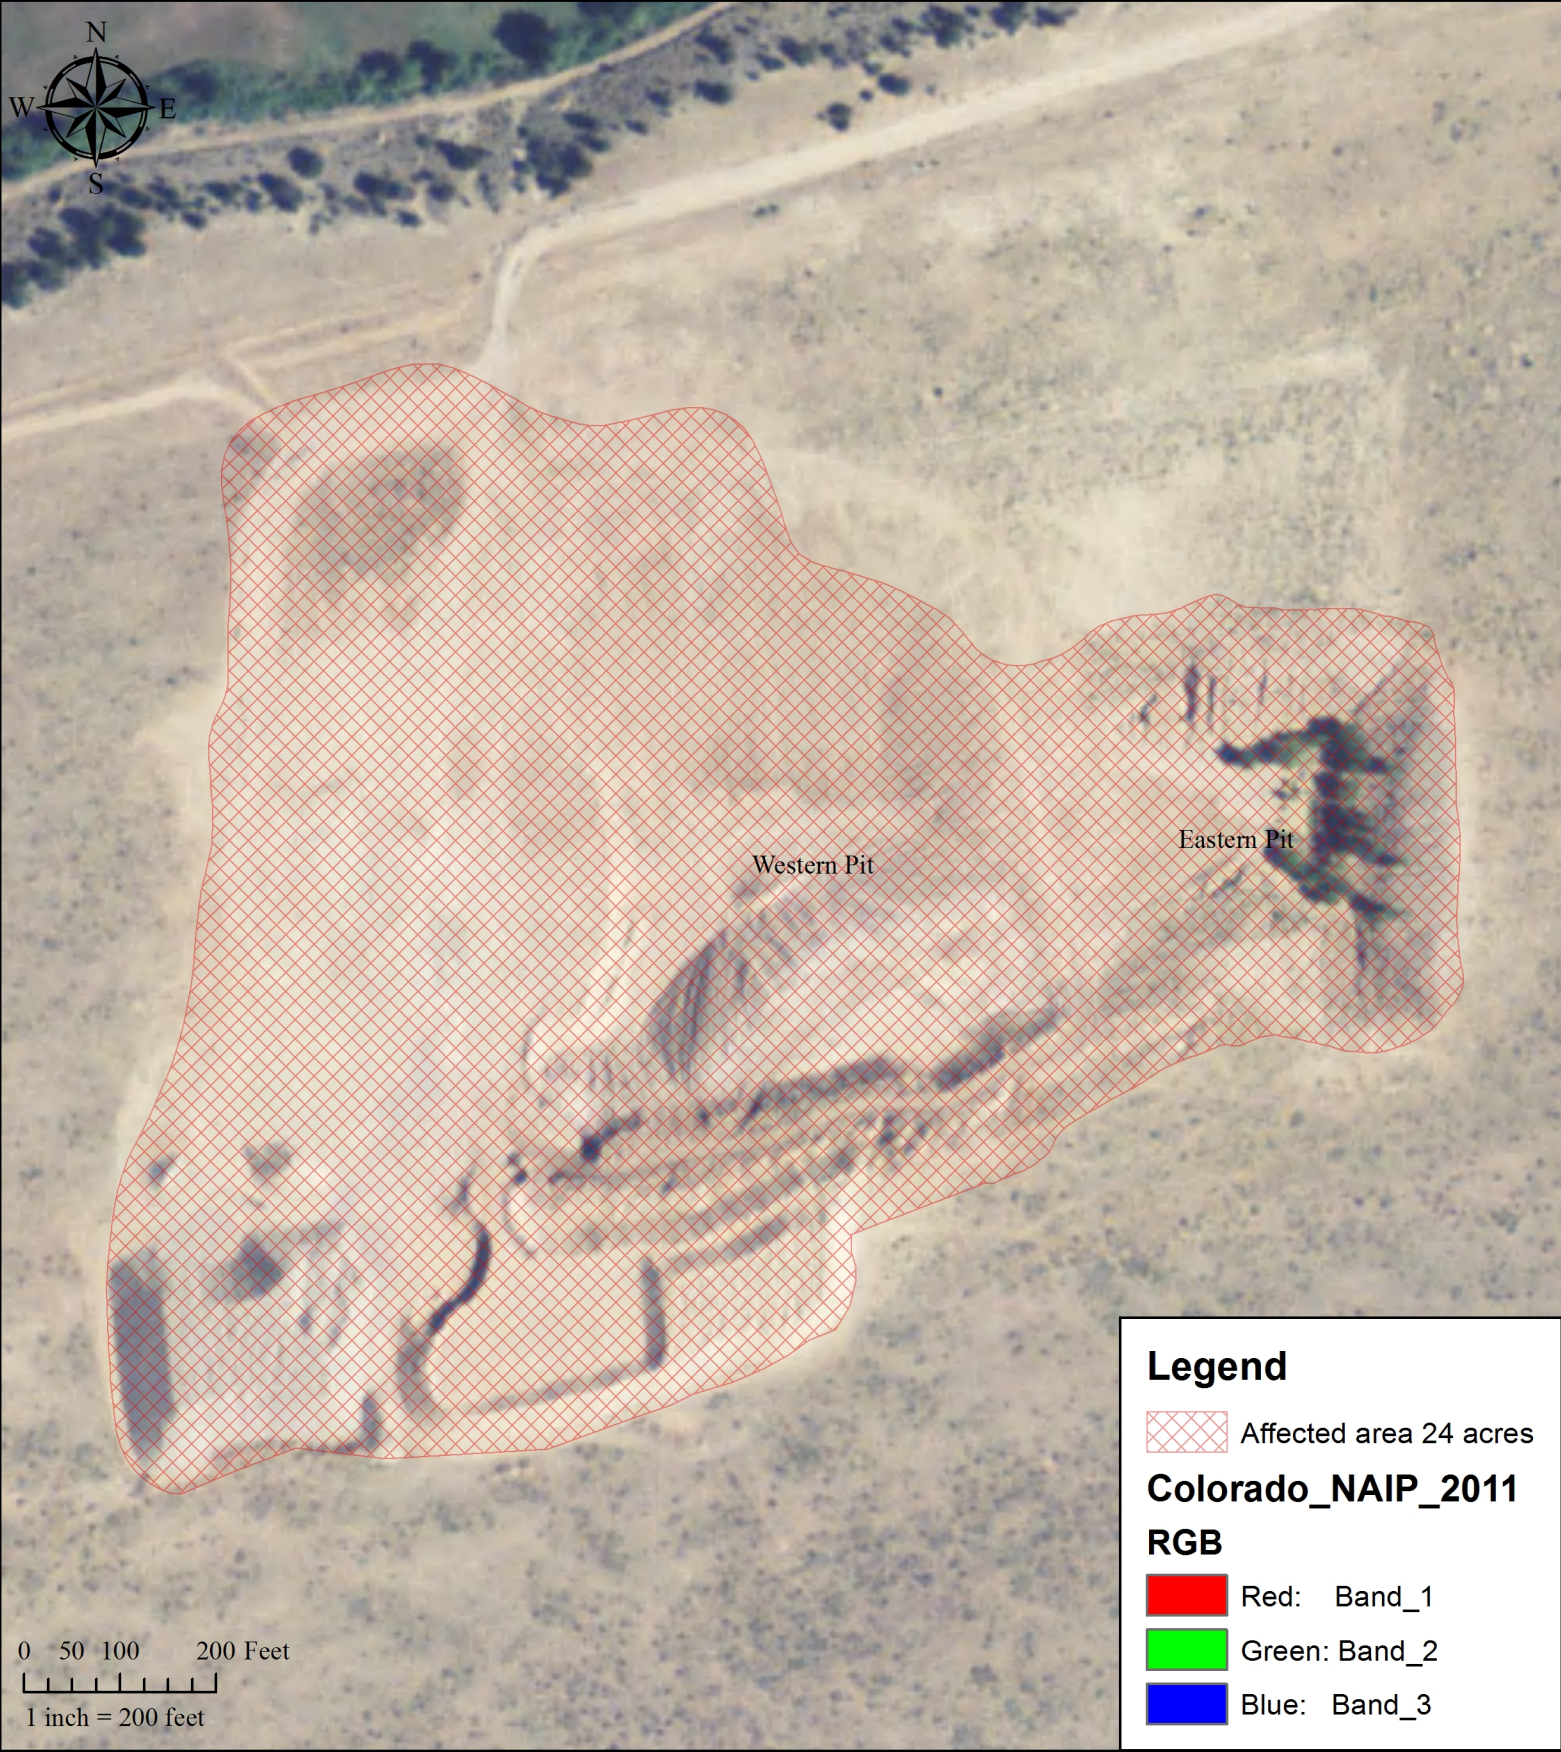
Pino Pit

The site appears to have two separate pits (see Figure #1). The western pit appears to have slopes graded to an approximant slope of 2H:1V. Recent mining activity appears to be taking place in the western pit. The eastern pit appears to have slopes graded to an approximant slope of 2H:1V. The western pit wall of the eastern pit was graded to a slope of approximately 4H:1V or flatter. Both pits appear to be approximately 35 to 40 feet deep. The eastern pit walls have been damaged by erosion (see photo 4). At this time this is not cited as a problem, however the Operator will need to grade, repair and stabilize the pit slopes once final reclamation commences.

The Operator committed to disturbing no more than 35 acres at one time. During the inspection, the disturbed area was measured with a hand held GPS unit and was found to be approximately 24 acres (see figure #1). The Operator Appears to be observing the 50 foot boundary set back and the 25 foot power line offset. All mining activity appeared to be within the approved permit boundaries.

Figure 1: Affected area boundary (marked by the red lines on this 2011 NAIP image) encloses approximately 24 acres.

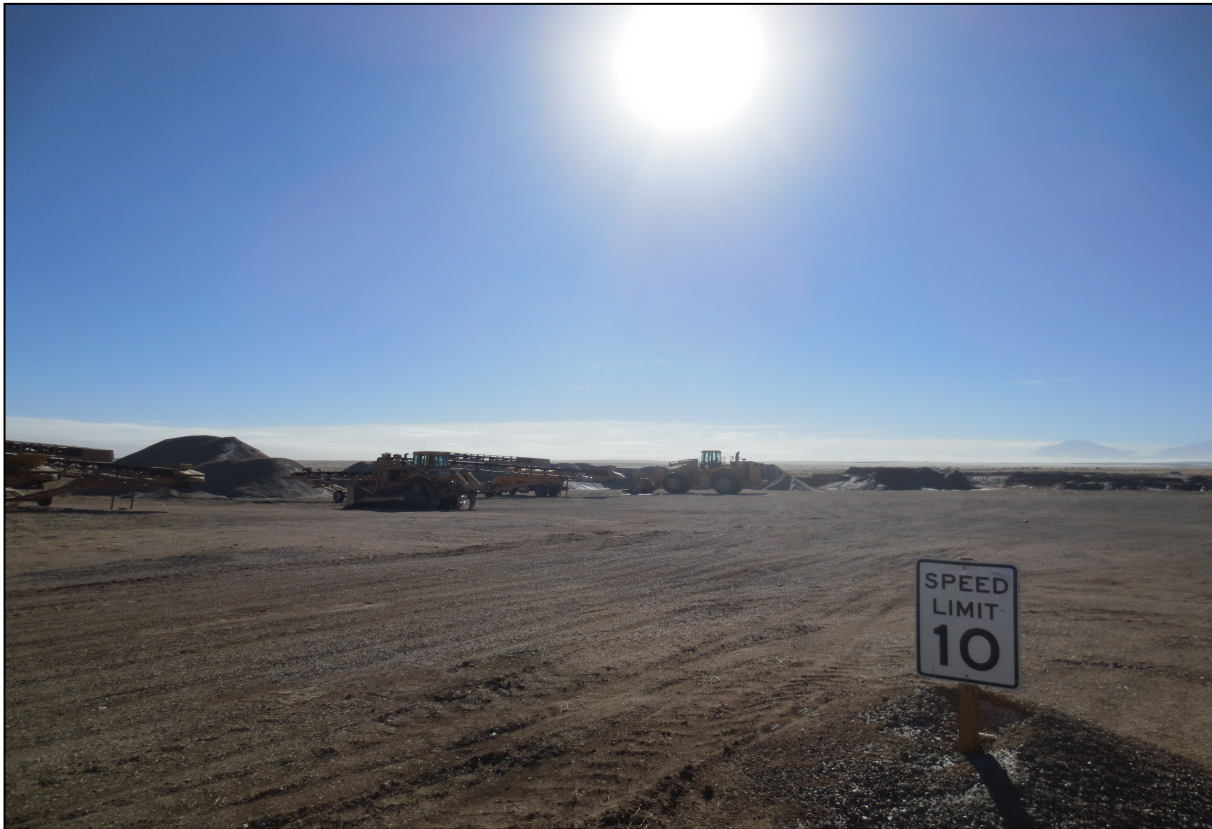
Photo 1: View looking southeast from the access road.

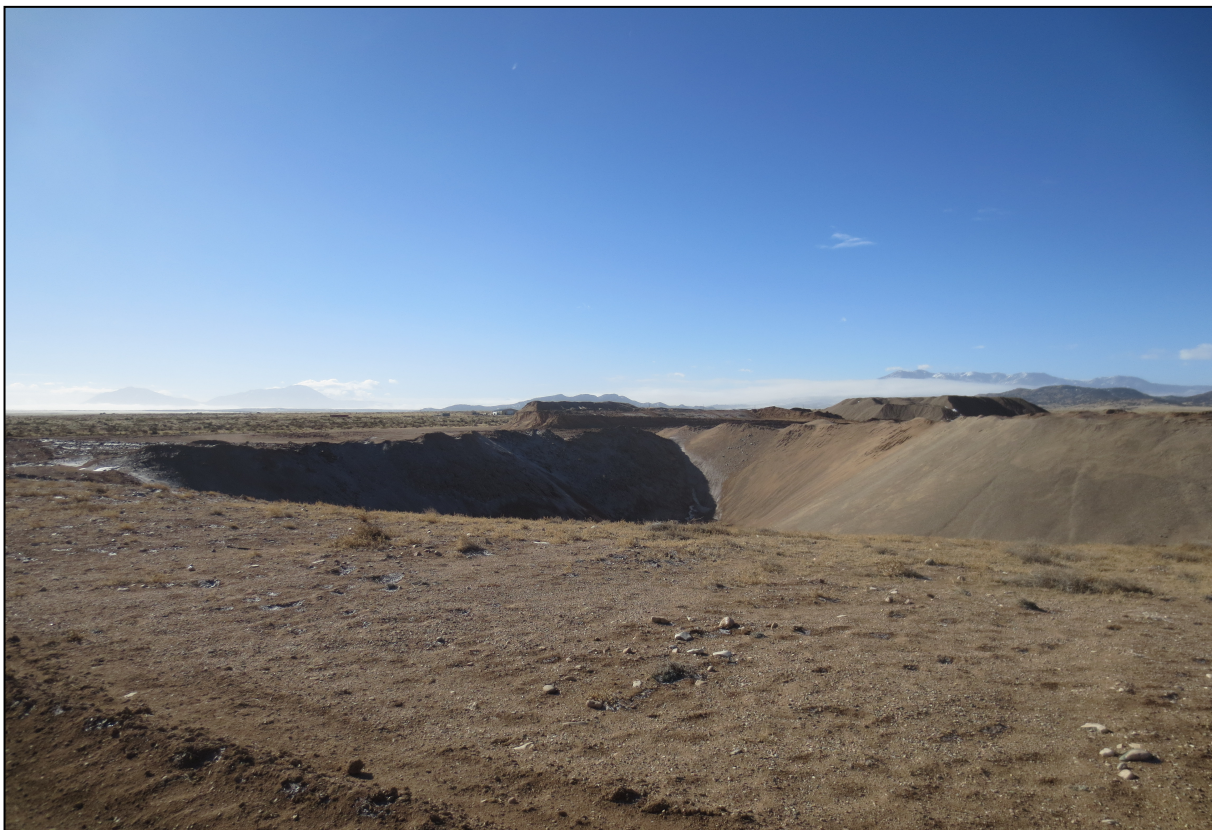
Photo 2: View looking southwest into the western pit.

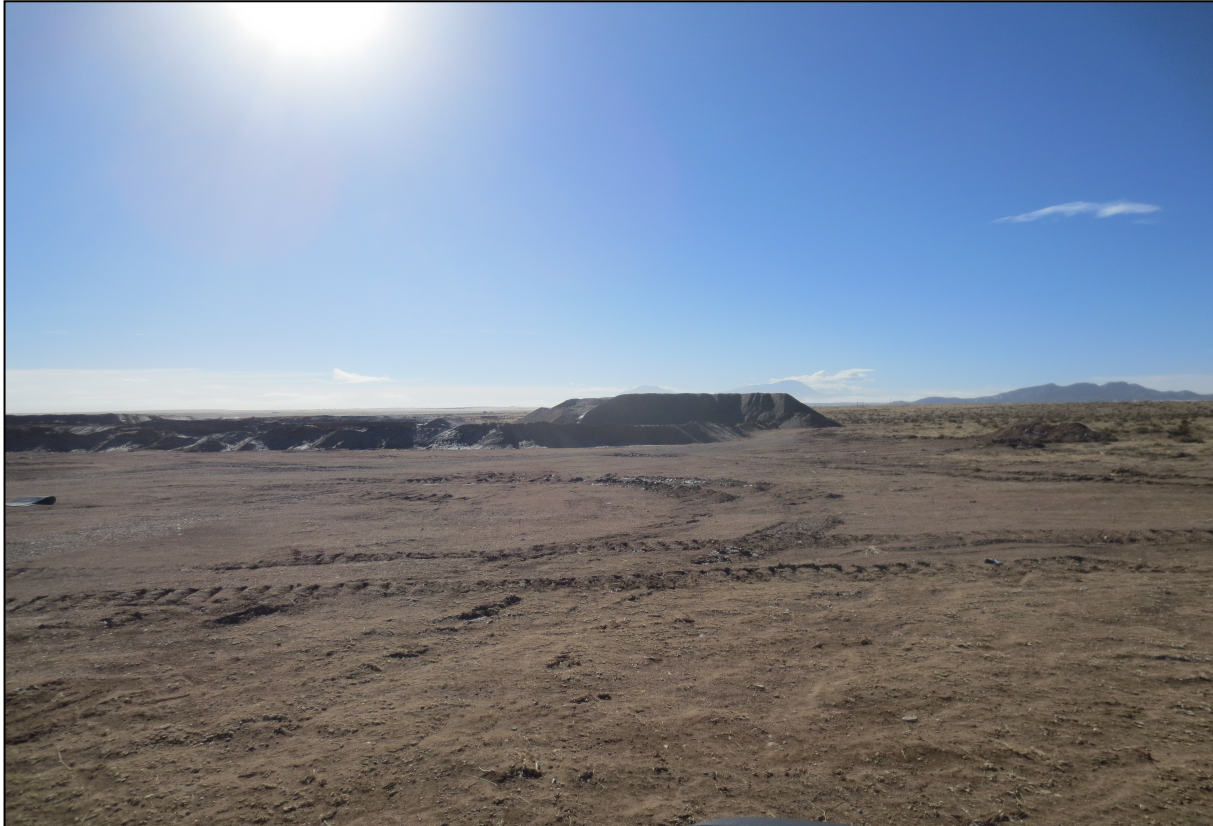
Photo 3: View looking south, western pit in the background.

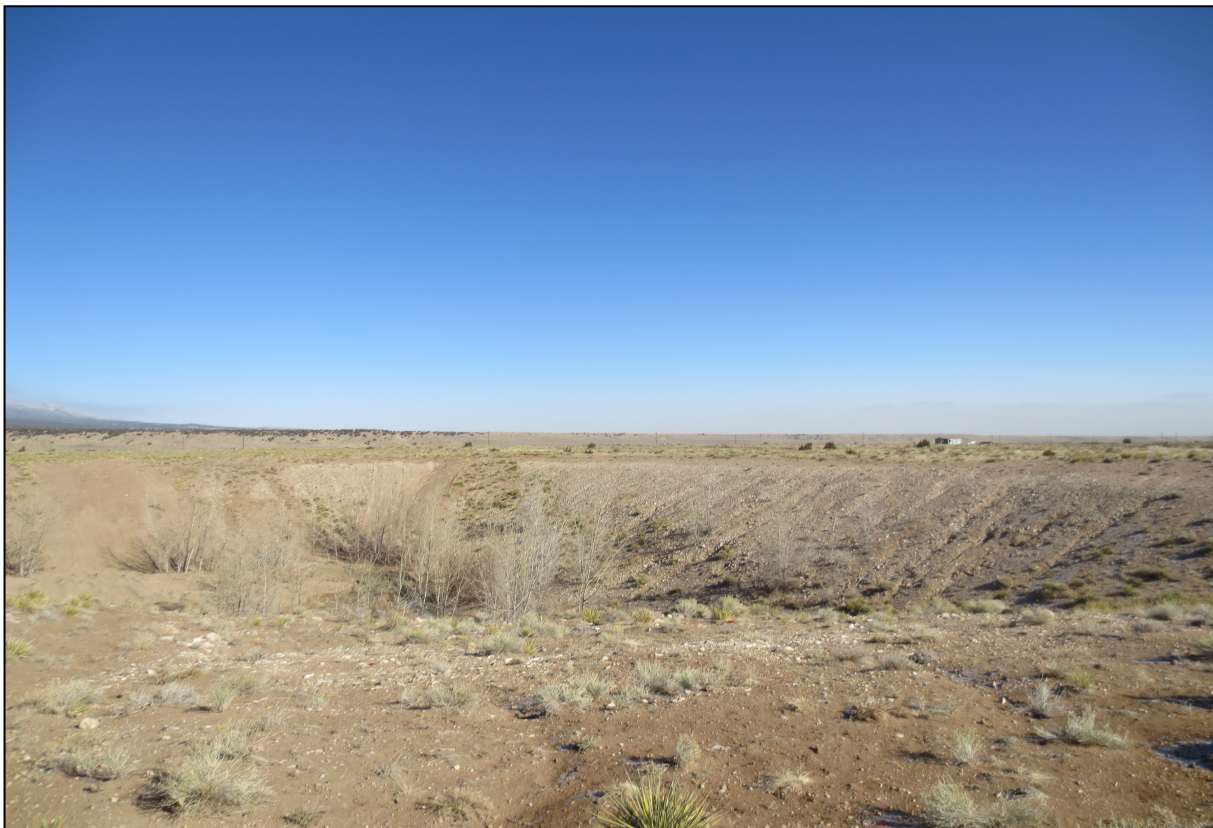
There was no evidence of excessive erosion. Small rills, gullies were observed in the eastern pit.

Photo 4: View looking northeast into the eastern pit.
