COLORADO DIVISION OF RECLAMATION, MINING AND SAFETY
MINERALS PROGRAM INSPECTION REPORT
PHONE: (303) 866-3567

MINE NAME: Silt Pit	MINE/PROSPECTING ID#: M-1981-202-SG	MINERAL: Sand and gravel	COUNTY: Garfield
INSPECTION TYPE: Monitoring	INSPECTOR(S): Stephanie J. Mitchell	INSP. DATE: February 11, 2014	INSP. TIME: 09:00
OPERATOR: Flag Resources Inc	OPERATOR REPRESENTATIVE: Fred Frei	TYPE OF OPERATION: 112c - Construction Regular Operation

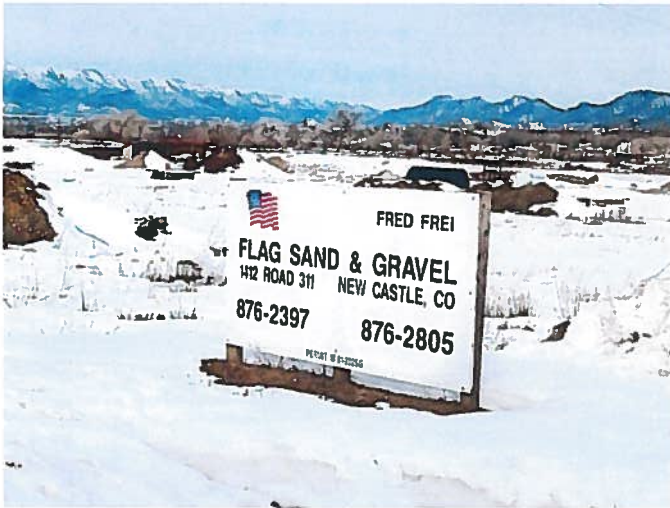
A mine identification sign was in place at the entrance to the mine site. All permit boundaries were all clearly marked delineating the permit area.

Mine Identification Sign

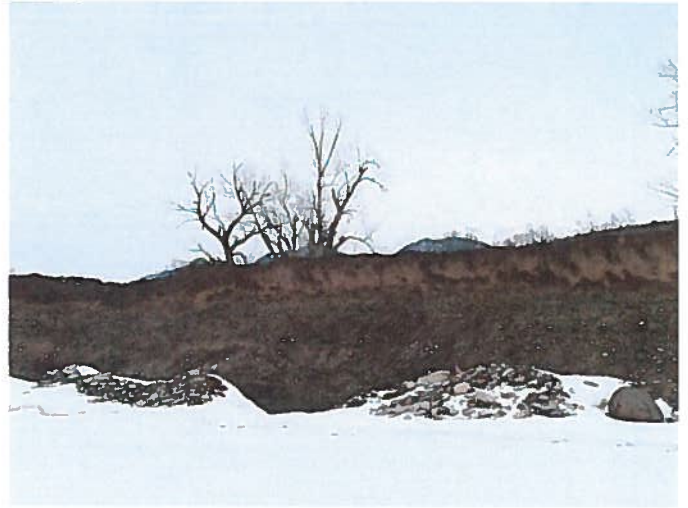
Eastern Edge of pit

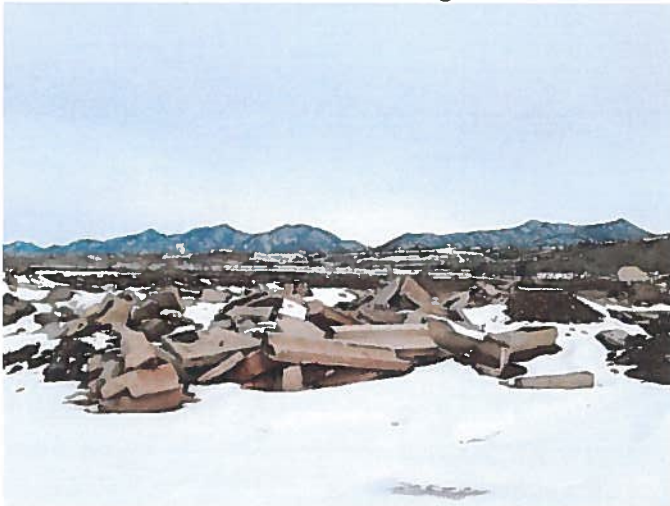
Topsoil and material stockpiles appear to be stable. There were up to 25 different stockpiles, including asphalt and concrete. The asphalt plant has been dismantled.

Stockpiled Asphalt

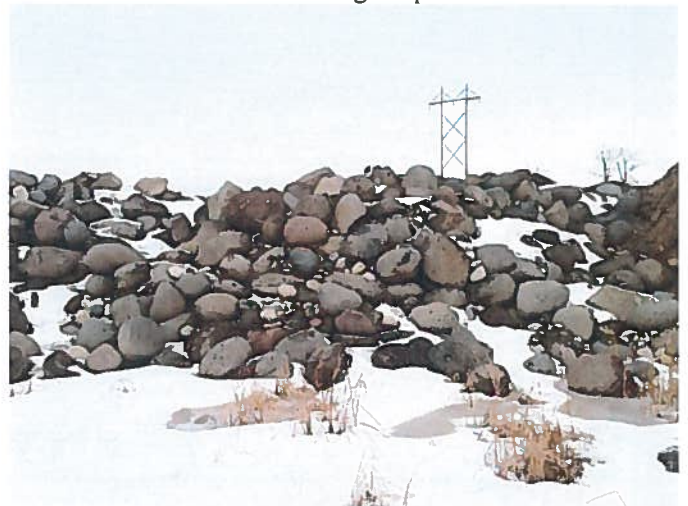
Boulder stockpile

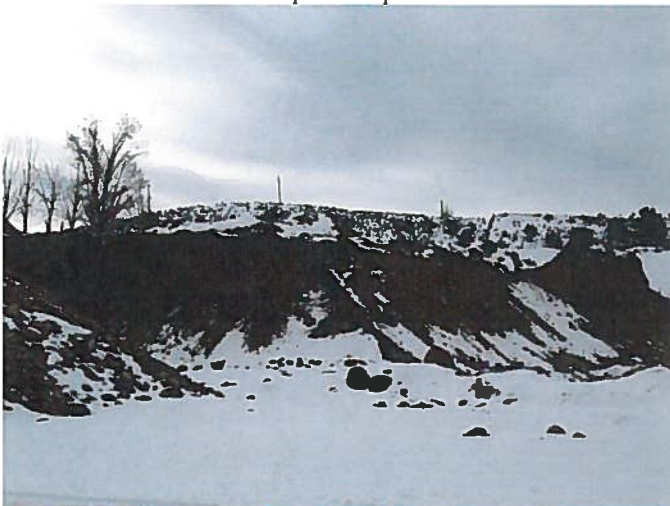
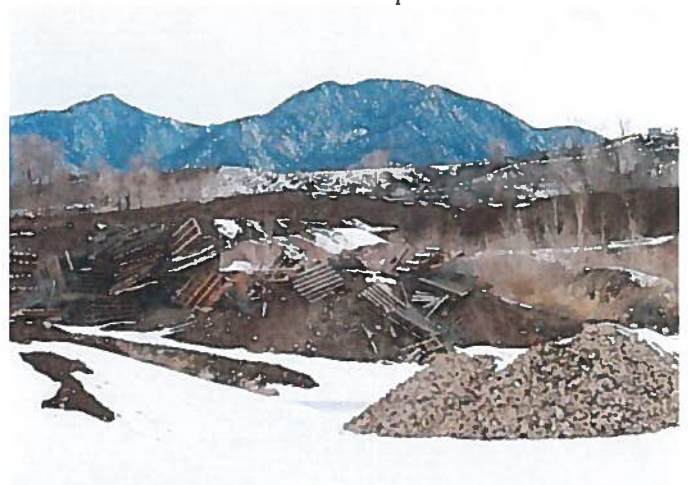
At the southern portion of the pit it appears that the Operator is storing refuse consisting of old equipment, scrap metal, and other metal items on site. The Division recommends the Operator initiate cleanup of the scrap metal and refuse in the Spring of 2014. The Division will do a follow up inspection in the Fall of 2014 to check the status of the scrap metal amounts left on site. In the case that nothing has been removed, the Division will recalculate the financial warranty to reflect the cost of what it would cost to remove the scrap metal and unused machinery from the site and would be a problem for failure to dispose of refuse in a manner that controls unsightliness or deleterious effects of such refuse pursuant to C.R.S. 34-32.5-116(4)(e).

Pallets that need to be removed by Fall of 2014

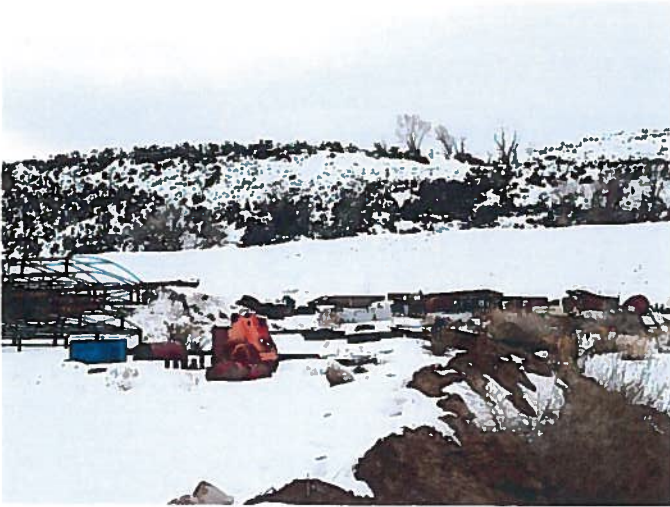
Scrap Metal and equipment need to be removed by Fall 2014

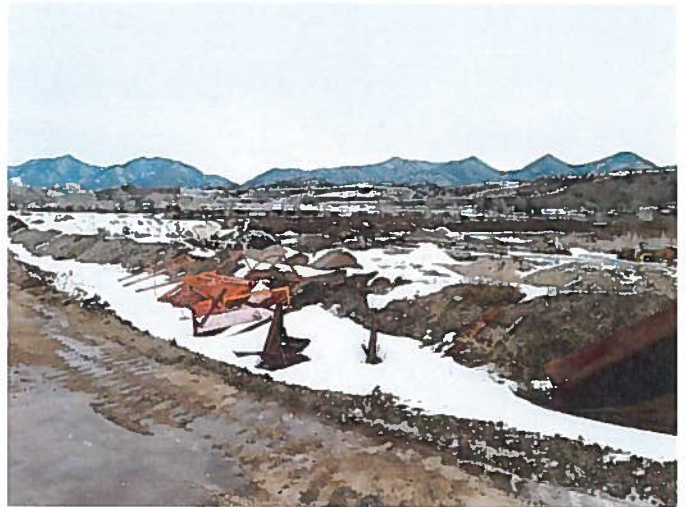
Scrap metal to be removed by Fall 2014

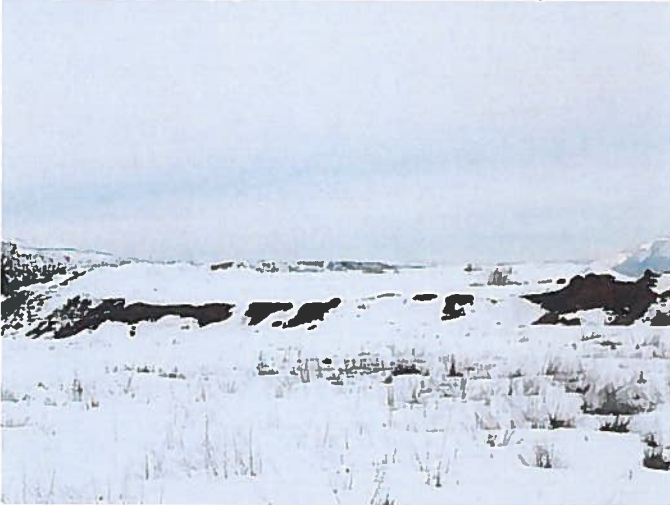
Topsoil Stockpile

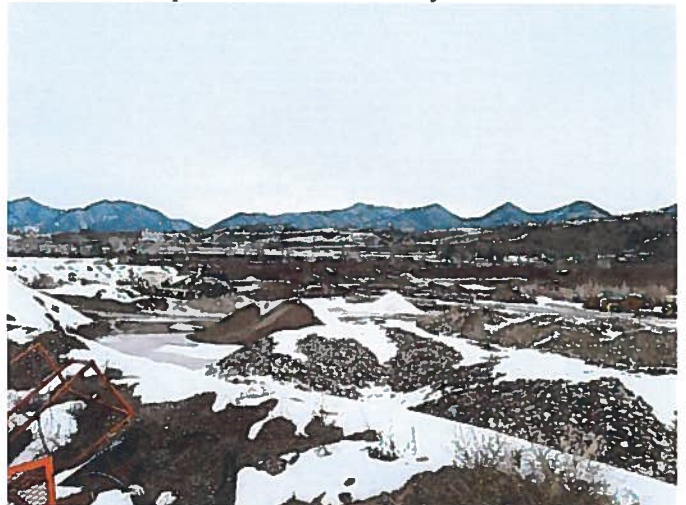
Material Stockpiles

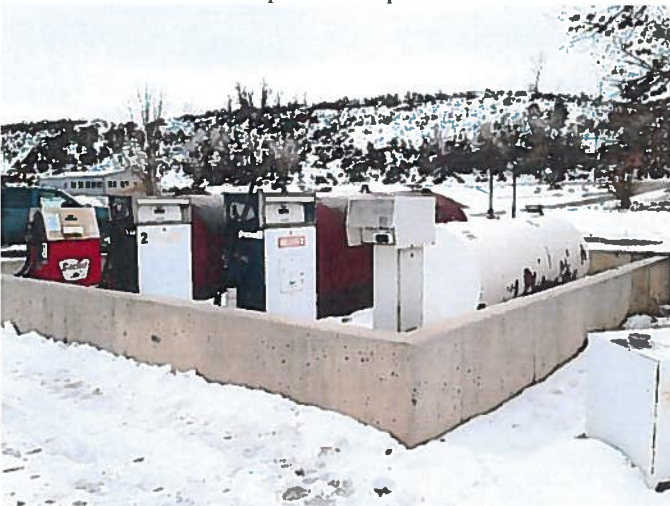
Fuel storage appeared to be adequate with berms around the tanks.

Fuel Storage

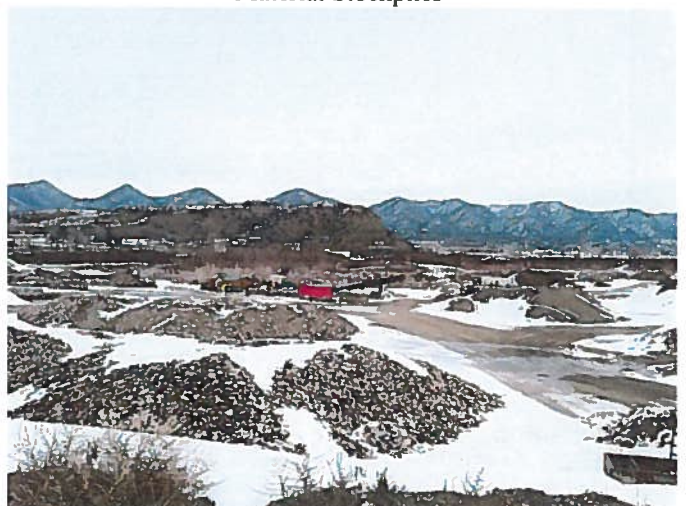
Material stockpiles

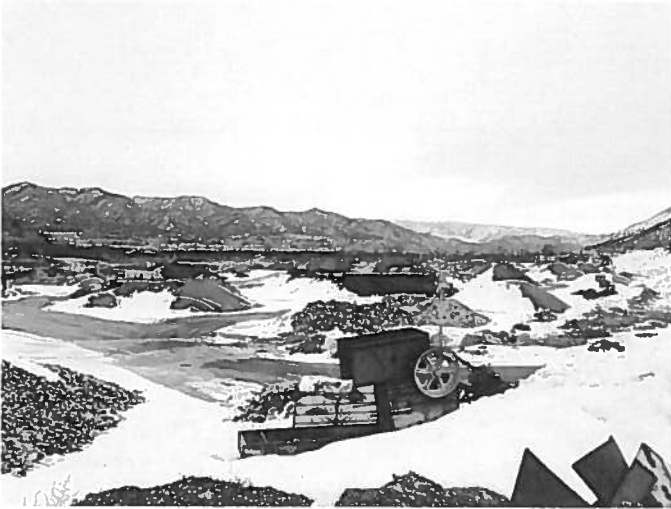
Material Stockpiles in the background, scrap metal in foreground needs to be removed
