PHOTOGRAPHS

COLORADO DIVISION OF RECLAMATION, MINING AND SAFETY
MINERALS PROGRAM INSPECTION REPORT
PHONE: (303) 866-3567

MINE NAME: Animas Glacier Gravel (AGG)	MINE/PROSPECTING ID#: M-2011-028	MINERAL: Gravel and sand	COUNTY: La Plata
INSPECTION TYPE: Monitoring	INSPECTOR(S): Kate A. Pickford	INSP. DATE: February 26, 2014	INSP. TIME: 14:00
OPERATOR: Oldcastle SW Group, Inc. dba Four Corners N	OPERATOR REPRESENTATIVE: Matt Carnahan	TYPE OF OPERATION: 112c - Construction Regular Operation

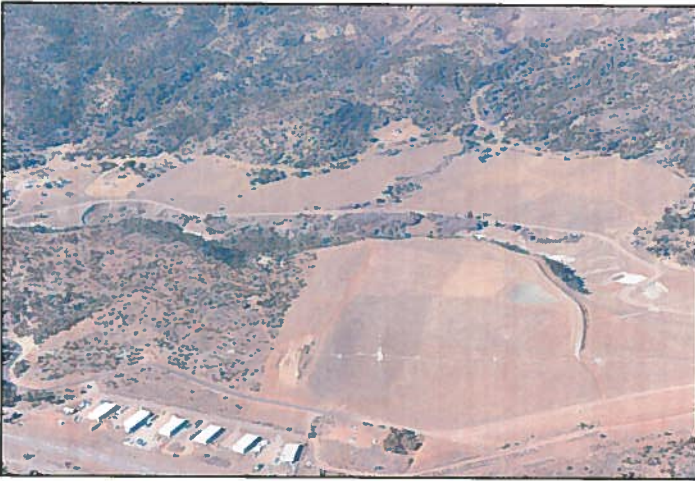
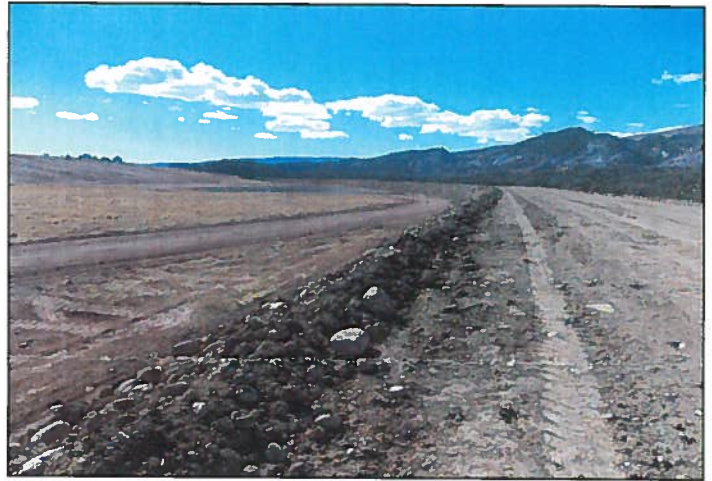
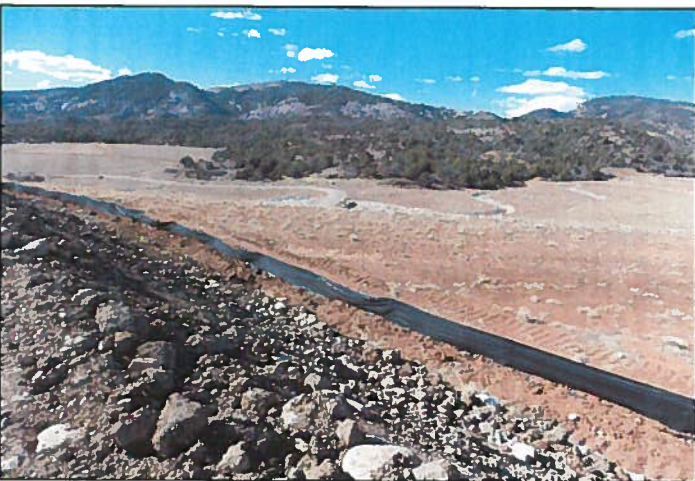
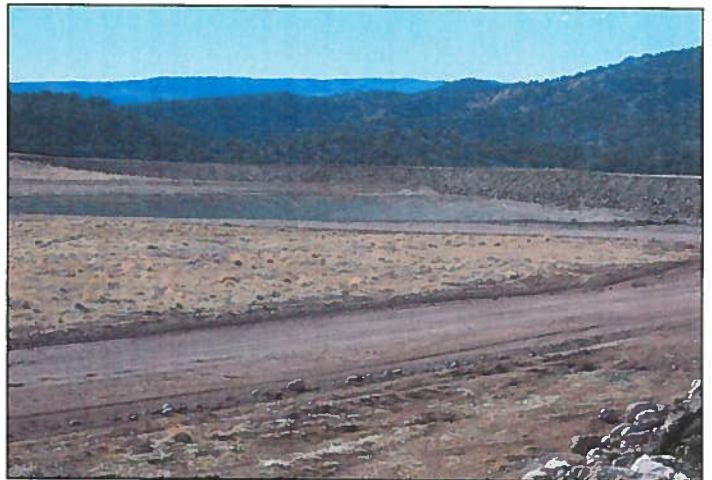
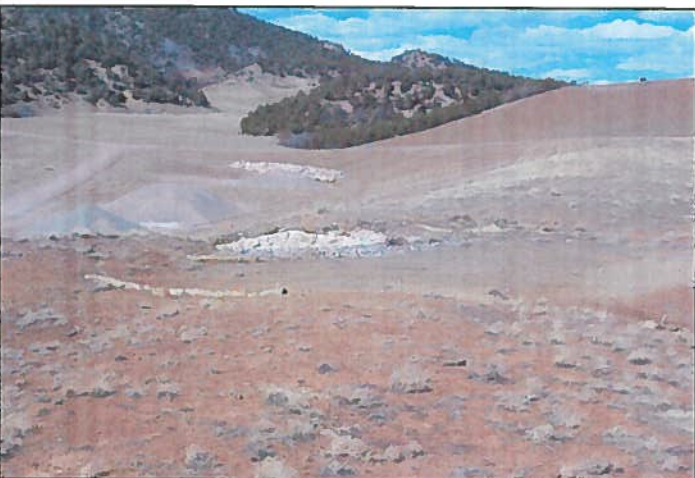
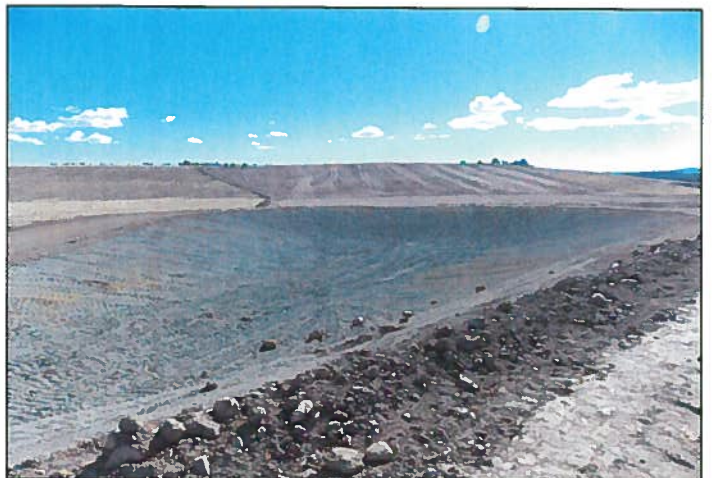
A major focus of this inspection was a berm that was constructed by FCM, designed to retain stormwater on the north phase of the project site. The berm is approximately 35 feet wide at the base, 12 feet wide across the top and up to 9 and one half feet tall at the tallest points. It runs along the west edge of the terrace, situated above the drainage structures related to the spillway for the Animas-La Plata Project (ALP) dam. The top of the berm is flat and is easily accessible by vehicle. Based on the visible material along the flanks of the berm, it appears to be constructed of silty clay with a high content of large cobbles. A silt fence is installed along part of the base on the west side of the berm. Mr. Carnahan also identified some waddles that FCM had installed in the drainage leading down to the ALP structures to restrict the transport of sediments. Located within the boundaries of the berm is a large basin that FCM installed to assist in containment of water within the berm structure.

Tim Cazier, Division staff engineer, had contacted the SEO regarding this structure, questioning its classification with regard to a jurisdictional dam. This question arose due to the containment capacity of 224 acre-feet, and the height of the berm itself. After an assessment of the location, Mr. Gavin indicated that he needed to do some calculations but stated he is not inclined to regulate this structure as a jurisdictional dam because, although the capacity would categorize it as such, the precipitation history in this region results in amounts that are a fraction of the amounts necessary to fill the containment structure. In fact, the technical revision submittal indicates that it would take 36 consecutive 100-year events to fill the structure with water. Mr. Gavin indicated the he would send an e-mail to the Division conveying his opinion related to the structure.

Mr. Carnahan indicated that FCM may make some modifications to the berm structure but wanted the Division to review and approve them prior to committing to the work. The Division requested that FCM submit additional information related to the structure and proposed mining at the site, including:

1. Design specifications regarding how the berm was constructed, including depths of lifts, how they were compacted and how they were keyed in.
2. Current dimension of the berm structure, including maximum height.
3. Proposed changes to the berm structure, including grading of the slope, final slope and final seeding plans.
4. Dimensions of the containment pond located within the bermed area.
5. The proposed mining plan for the south phase of the project, consisting of the area to the south of the bermed portion, specifically addressing how storm water will be contained.
