**COLORADO DIVISION OF RECLAMATION, MINING AND SAFETY**  
**MINERALS PROGRAM INSPECTION REPORT**  
**PHONE: (303) 866-3567**

<b>MINE NAME:</b> Tri-County Gravel	<b>MINE/PROSPECTING ID#:</b> M-1977-305	<b>MINERAL:</b> Sand and Gravel	<b>COUNTY:</b> Delta
<b>INSPECTION TYPE:</b> Monitoring	<b>INSPECTOR(S):</b> Dustin M. Czapla	<b>INSP. DATE:</b> March 6, 2014	<b>INSP. TIME:</b> 10:00
<b>OPERATOR:</b> Oldcastle SW Group Inc.	<b>OPERATOR REPRESENTATIVE:</b> Jason Burkey	<b>TYPE OF OPERATION:</b> 112c - Construction Regular Operation

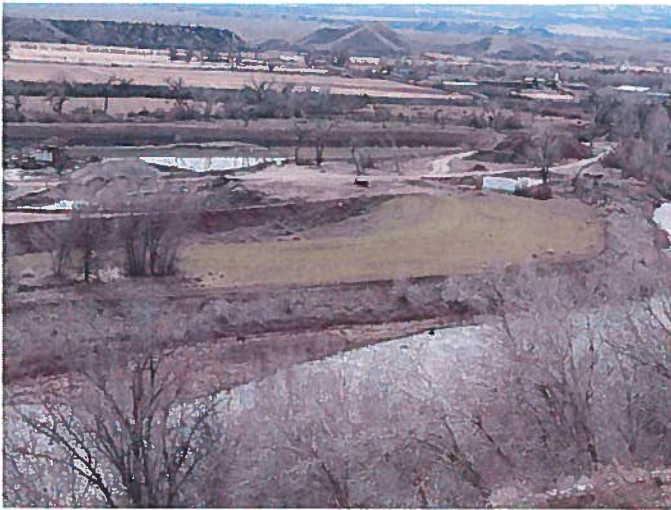
Figure 1: View from Hwy 133, toward the Phase 1 and 2 areas, and the constructed dike.

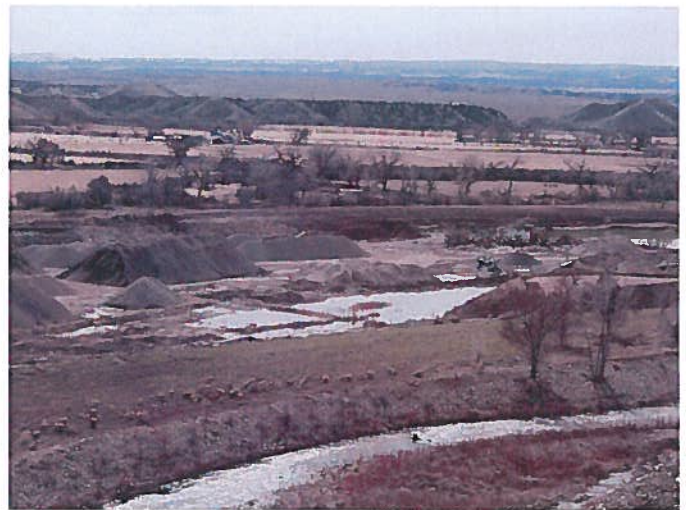
Figure 2: View from Hwy 133, toward the Phase 1 area and the constructed dike.

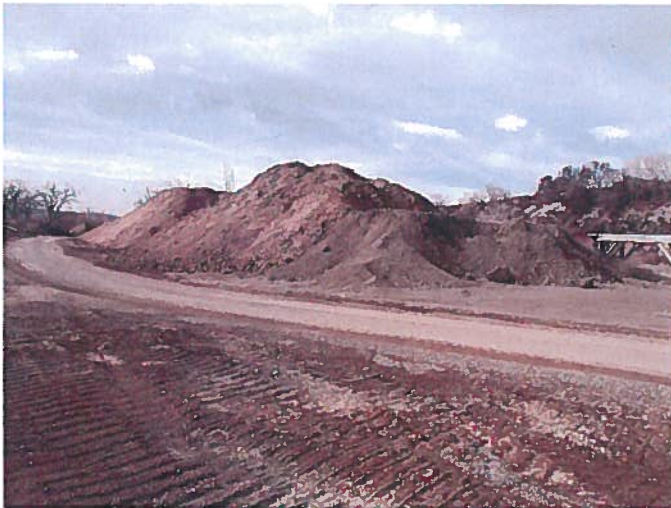
Figure 3: Topsoil pile at the entrance to the pit.

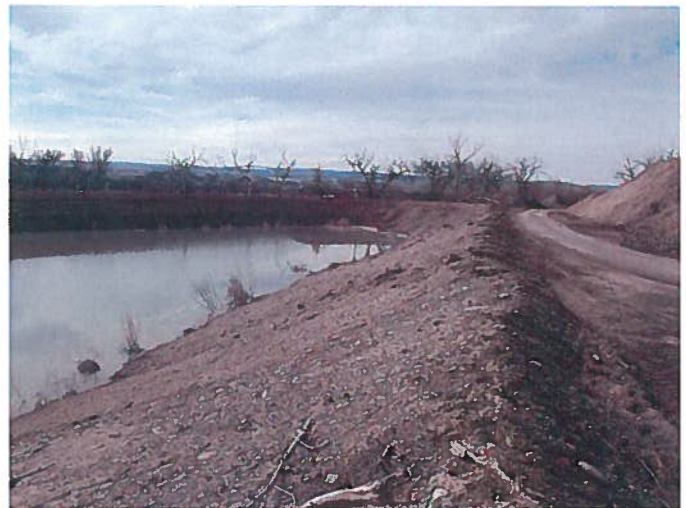
Figure 4: Southwest facing view of the north slope of the Phase 2 area.

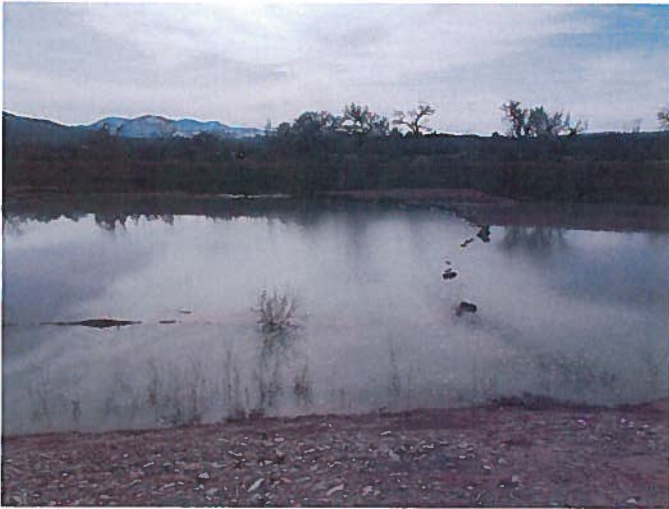
Figure 5: View toward the south slope of the Phase 2 area.

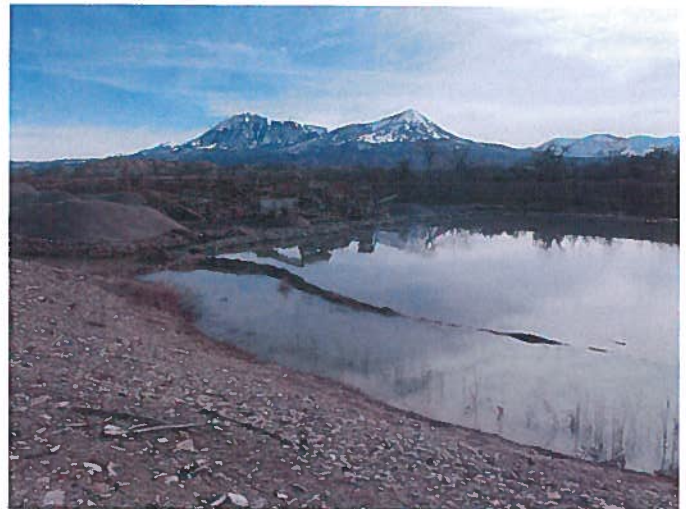
Figure 6: View facing east, toward the Phase 1 area.

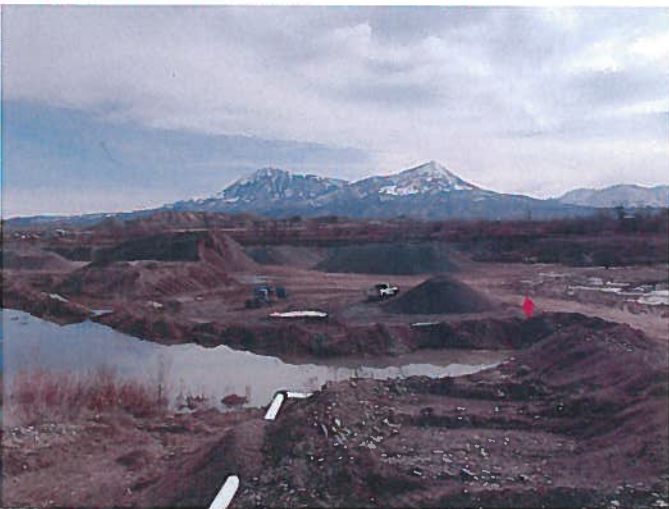
Figure 7: View from the sediment pond outlet toward the Phase 1 area.

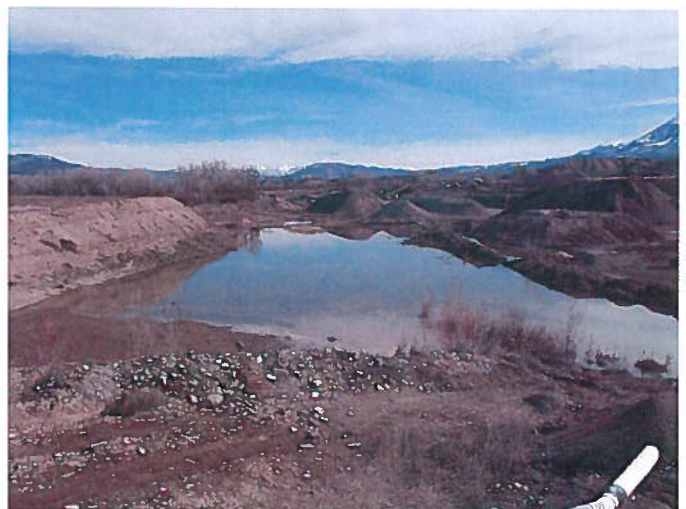
Tamarisk are beginning to infest areas near the water line in the Phase 1 and 2 area and around the sediment pond. The operator is encouraged to remain vigilant in controlling these noxious weeds.

Figure 8: Sediment pond.

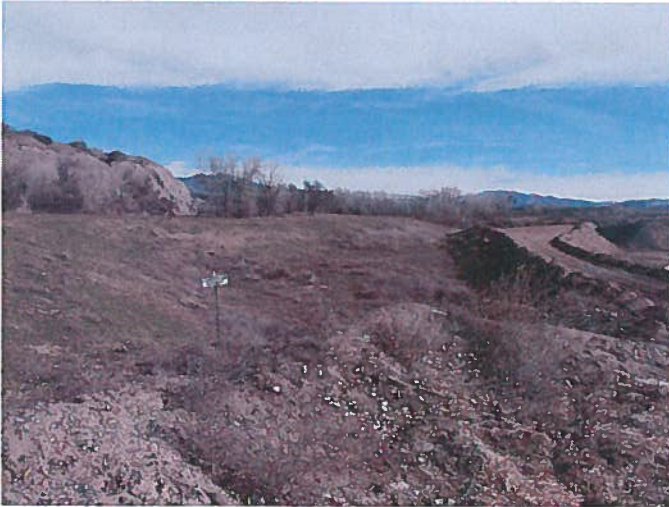
The dike repair in the north side of the permit area appeared stable with vegetation becoming well established.

Figure 9: South slope of the constructed dike.

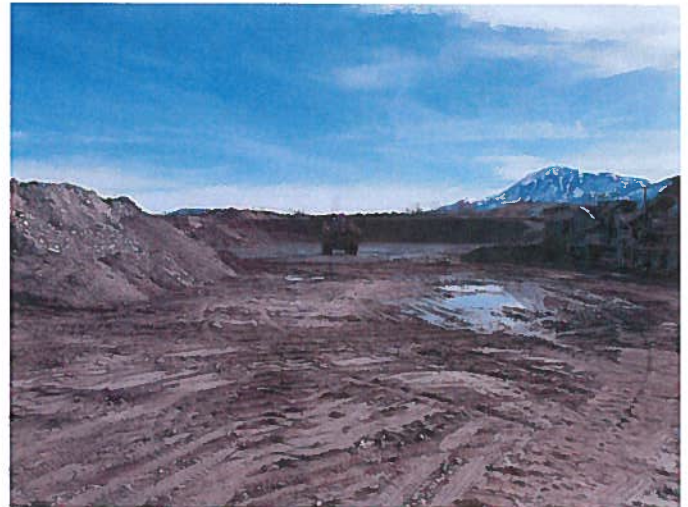
Figure 10: View facing east into the Phase 3 area.

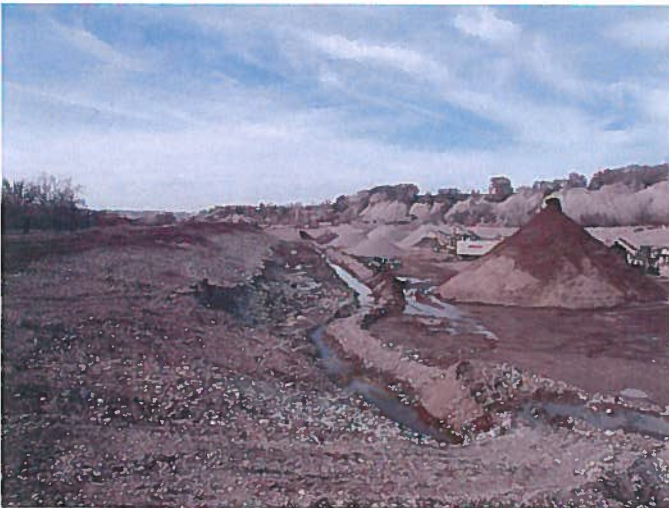
Figure 11: South slope of the Phase 3 area.

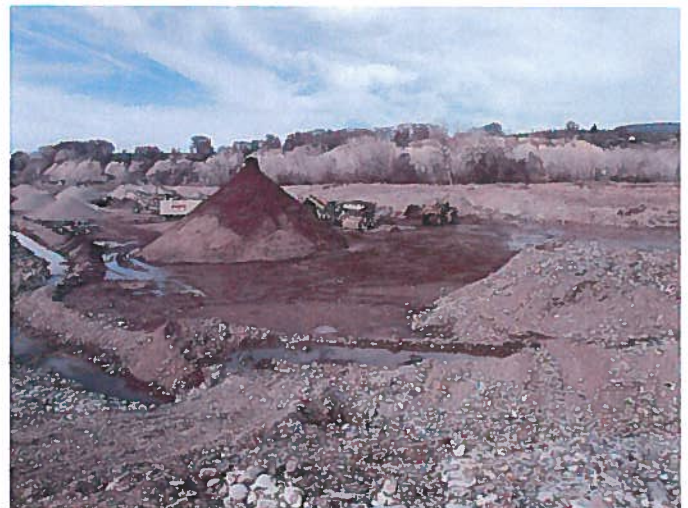
Figure 12: Phase 3 mining area.

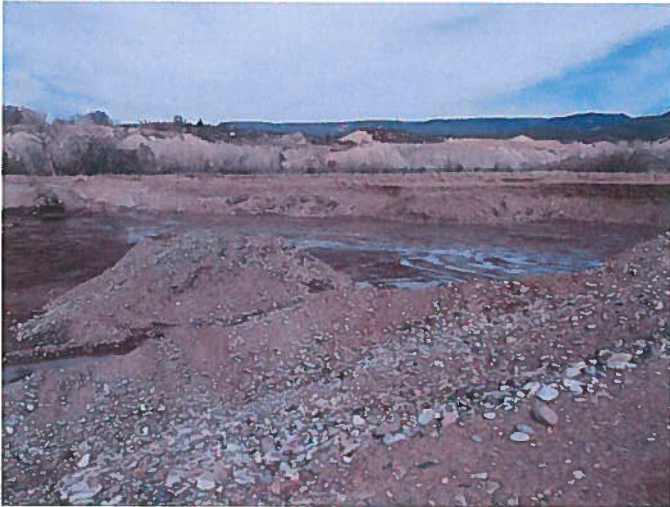
Figure 13: Phase 3 mining area.

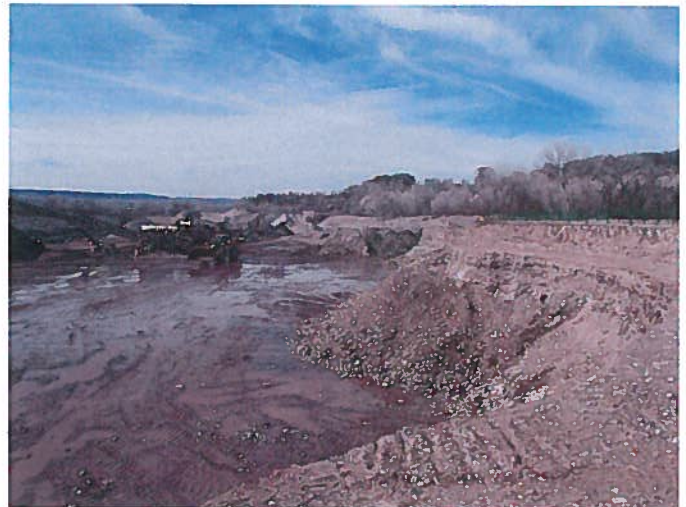
Figure 14: Phase 3 mining area.

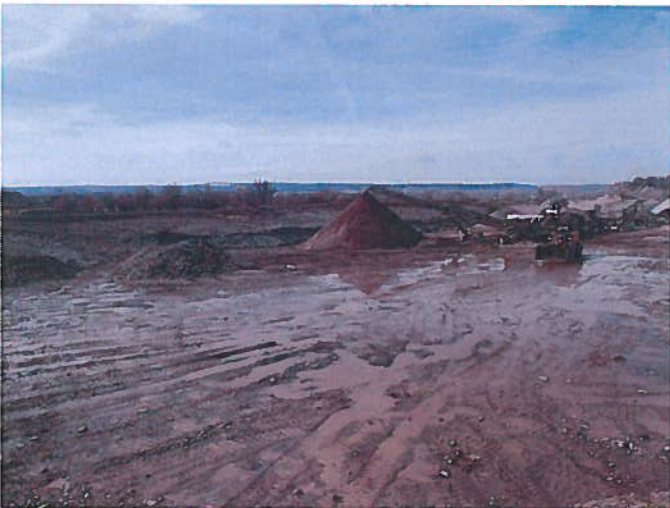
Figure 15: Phase 3 mining area.

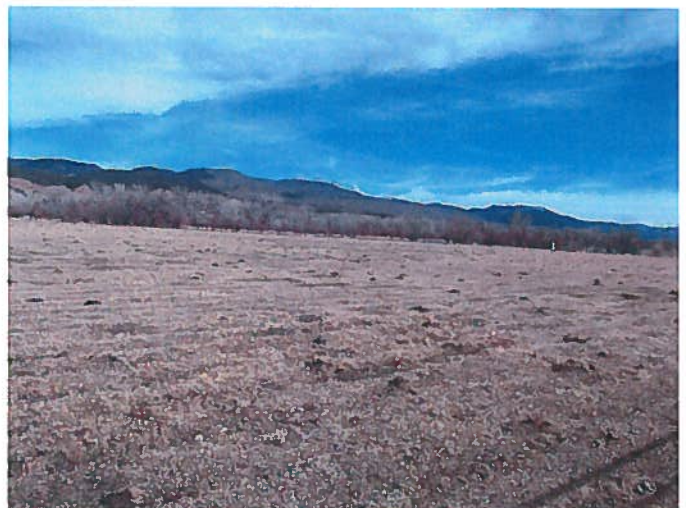
Figure 16: Phase 4 undisturbed area.
