COLORADO DIVISION OF RECLAMATION, MINING AND SAFETY
MINERALS PROGRAM INSPECTION REPORT
PHONE: (303) 866-3567

MINE NAME: Ft. Lupton Sand and Gravel Mine	MINE/PROSPECTING ID#: M-1999-120	MINERAL: Borrow material	COUNTY: Weld
INSPECTION TYPE: Monitoring	INSPECTOR(S): Tom Kaldenbach	INSP. DATE: November 20, 2013	INSP. TIME: 12:00
OPERATOR: L. G. Everist, Incorporated	OPERATOR REPRESENTATIVE: None	TYPE OF OPERATION: 112c - Construction Regular Operation

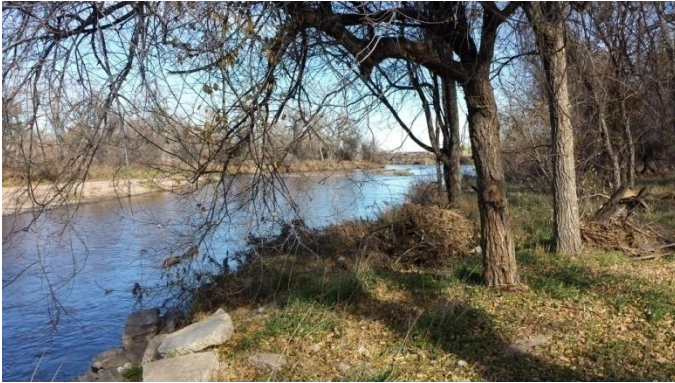
Mr. Bachofer was present during the inspection. The inspection consisted of visually examining Mr. Bachofer's property and discussing aspects of the complaint. The ground on the property was wet. There was evidence of recent high river flows (branches and leaves lodged in trees, etc.) that probably occurred during the mid-September 2013 region-wide flooding. During the inspection, the river was flowing at 422 cfs at the Fort Lupton USGS gauge (06721000), located approximately one-half mile downstream from the Bachofer property. The water surface in the river was more than 6 feet below what appeared would be the bank-full stage at the Bachofer property (crest of east river bank shown in attached photos).

Photo 1 – Downstream view of South Platte River from east river bank on Mr. Bachofer's property. Bankfull elevation is assumed to be crest (top) of this bank.

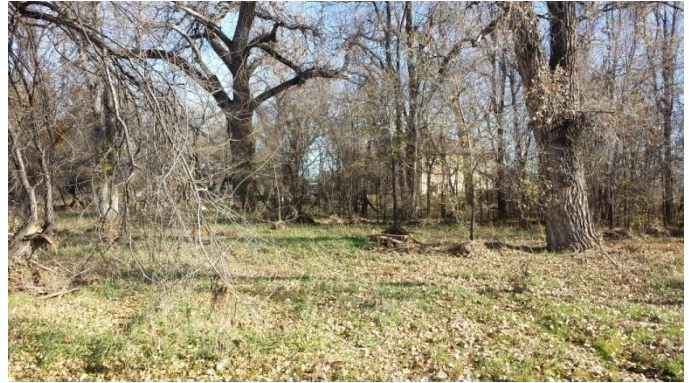
Photo 2 – Treed area between South Platte River and Mr. Bachofer's house (visible in distance past trees).

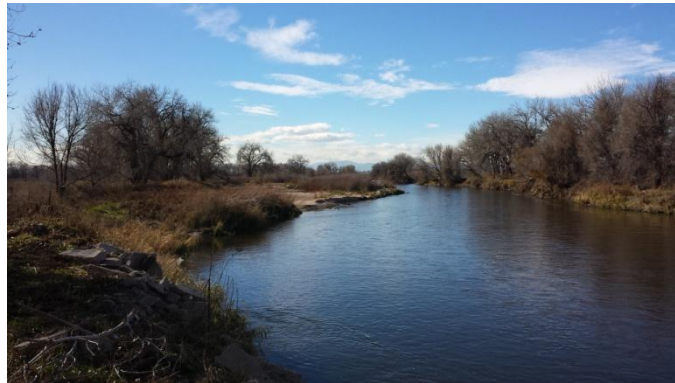
Photo 3 – Upstream view of South Platte River from river bank on Mr. Bachofer's property.
