The Division of Reclamation, Mining and Safety has conducted an inspection of the mining operation noted below. This report documents observations concerning compliance with the terms of the permit and applicable rules and regulations of the Mined Land Reclamation Board.

MINE NAME:	MINE/PROSPECTING ID#:	MINERAL:	COUNTY:
Bent County Pit # 2	M-2001-019	Gravel	Bent
INSPECTION TYPE:	INSPECTOR(S):	INSP. DATE:	INSP. TIME:
Monitoring	Tyler V. O'Donnell	February 27, 2014	10:15
OPERATOR:	OPERATOR REPRESENTATIVE:	TYPE OF OPERATION:	
Bent County	Robert Darnell	112c - Construction Regular Operation

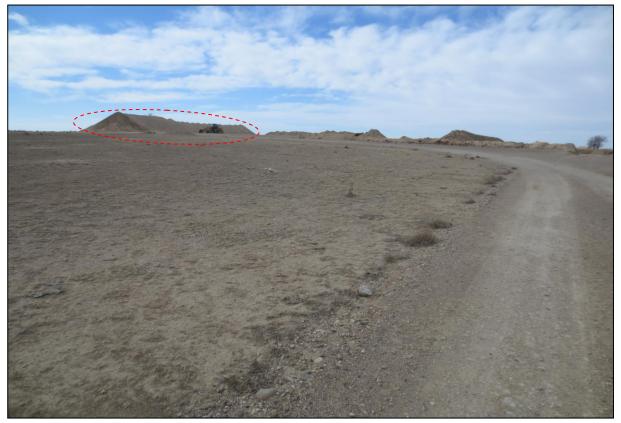
Photo 1: View looking southwest from the access road. Road-base stockpile circled in red.

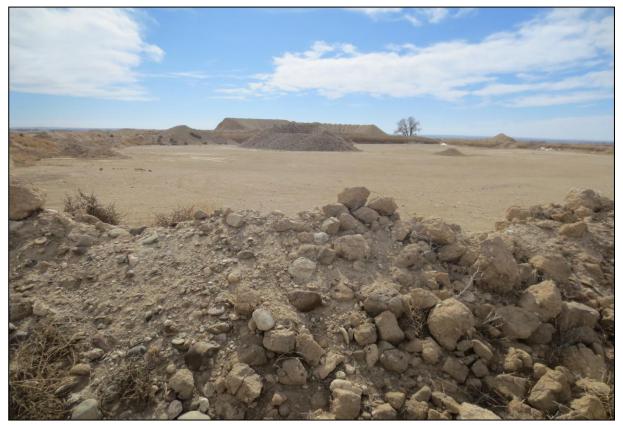
No backfilling or grading work has been conducted. The pit was approximately 5 to 12 feet deep, the highwalls were near vertical.

Photo 2: View looking south from the northern edge of the pit.

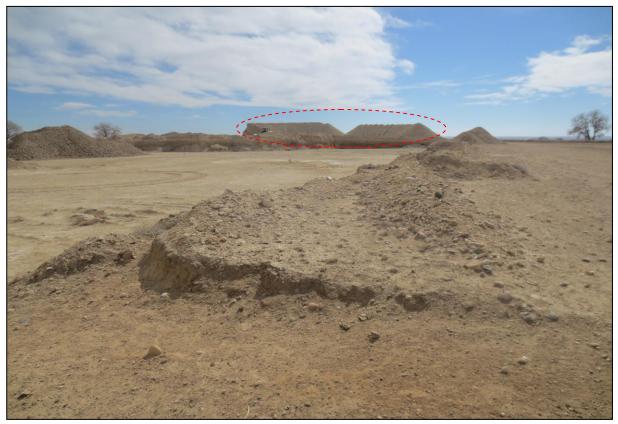
Photo 3: View looking south. Road-base stockpile circled in red.

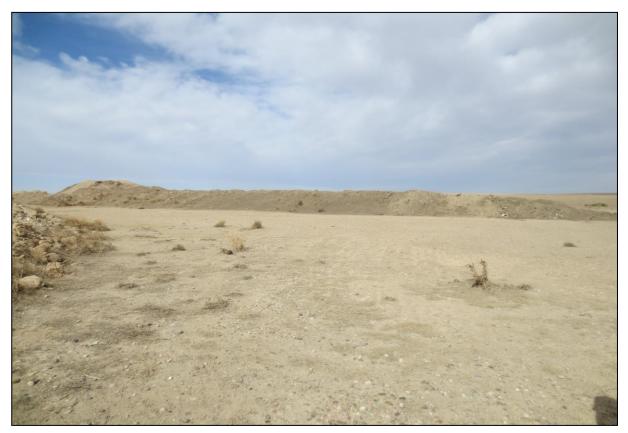
There was a topsoil stockpile located in the northwestern portion of the permitted site. There appeared to be an adequate amount of topsoil to reclaim the site. The Operator should take more measure to protect the topsoil stockpile from erosion. The Operator should consider seeding the topsoil stockpile with grasses or other vegetative cover to reduce erosion.

Photo 4: Topsoil stockpile.
