**COLORADO DIVISION OF RECLAMATION, MINING AND SAFETY**  
**MINERALS PROGRAM INSPECTION REPORT**  
**PHONE: (303) 866-3567**

<b>MINE NAME:</b> Bennett's Gravel Pit	<b>MINE/PROSPECTING ID#:</b> M-1979-166	<b>MINERAL:</b> Sand and gravel	<b>COUNTY:</b> Delta
<b>INSPECTION TYPE:</b> Monitoring	<b>INSPECTOR(S):</b> Dustin M. Czapla	<b>INSP. DATE:</b> March 19, 2014	<b>INSP. TIME:</b> 10:00
<b>OPERATOR:</b> Elam Construction, Inc.	<b>OPERATOR REPRESENTATIVE:</b> Gayle Lyman	<b>TYPE OF OPERATION:</b> 112c - Construction Regular Operation	
<b>REASON FOR INSPECTION:</b> Normal I&E Program	<b>BOND CALCULATION TYPE:</b> None	<b>BOND AMOUNT:</b> \$147,436.09	
<b>DATE OF COMPLAINT:</b> NA	<b>POST INSP. CONTACTS:</b> None	<b>JOINT INSP. AGENCY:</b> None	
<b>WEATHER:</b> Clear	<b>INSPECTOR'S SIGNATURE:</b>

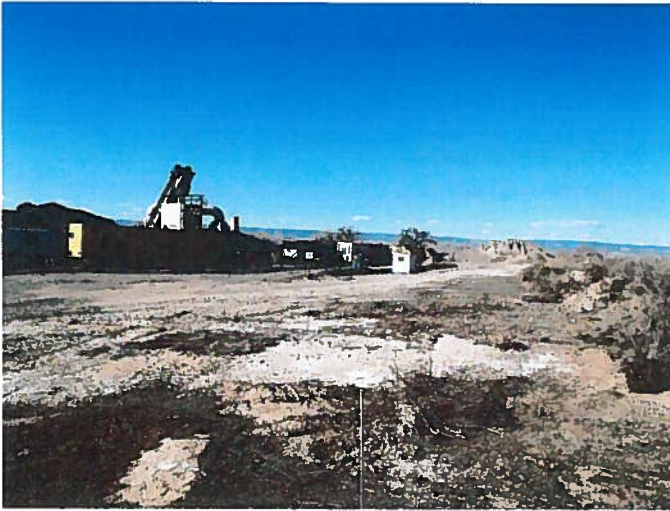
The site was inactive during this inspection. An asphalt plant and materials stockpiles were located in the north part of the permit area. The plant was not operating during this inspection.

Figure 1: Operation and stockpile area.

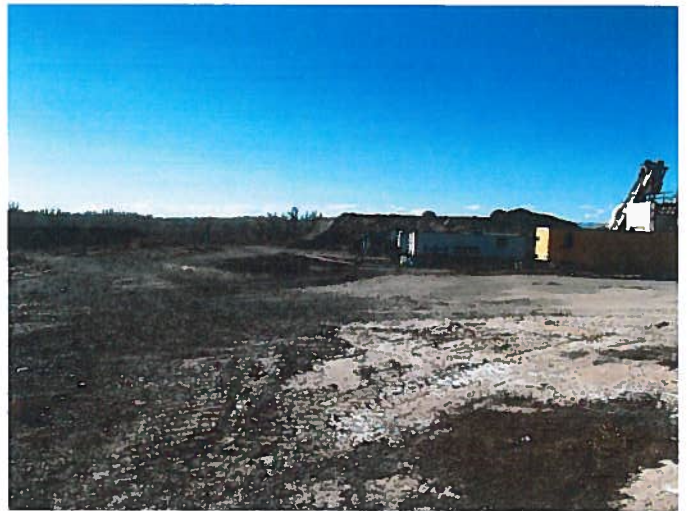
Figure 2: Operation and stockpile area.

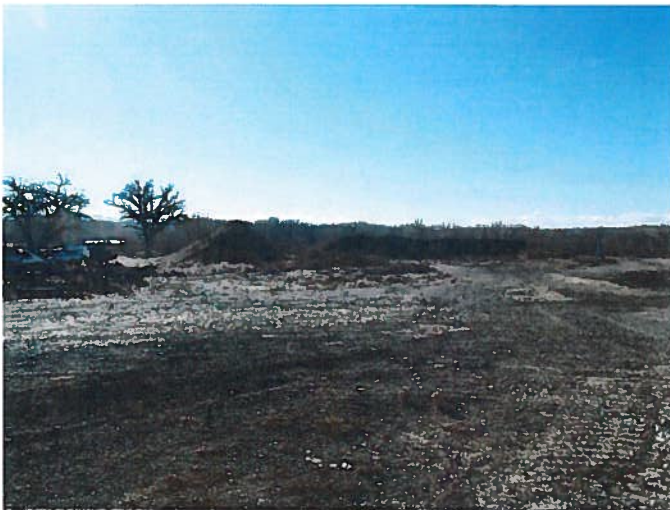
Figure 3: Operation and stockpile area.

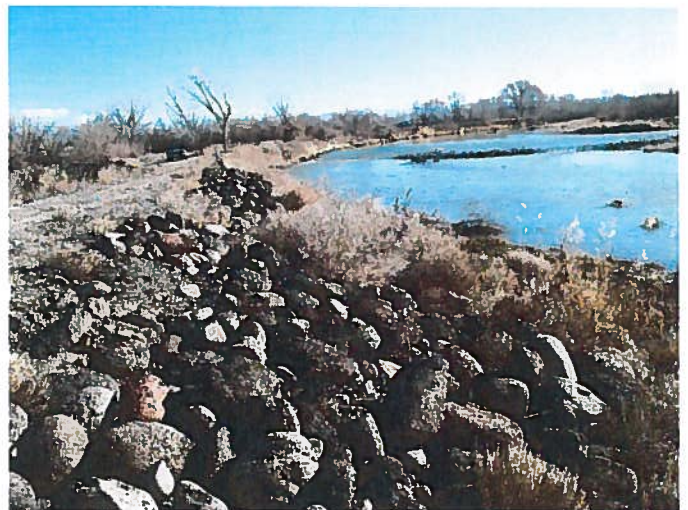
The river bank on the east side of the mined pond has been stabilized with basalt boulders.

Figure 4: River bank stabilization adjacent to pond.

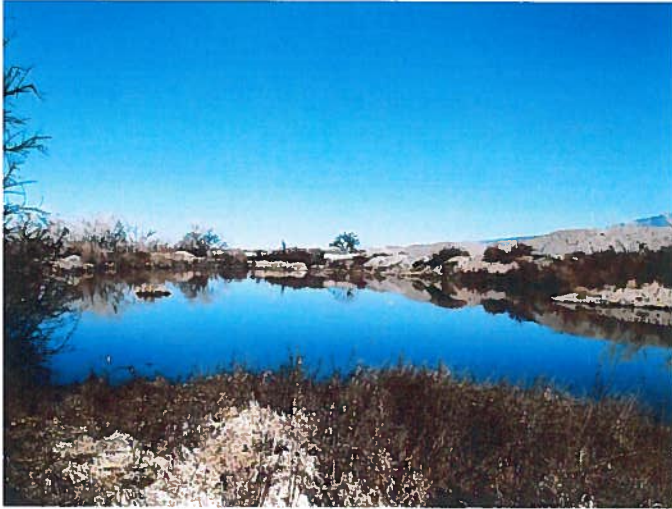
The pit slopes appeared to be left at approximately 1H:1V. Slope reduction will be necessary during reclamation.

Figure 5: Mined area.

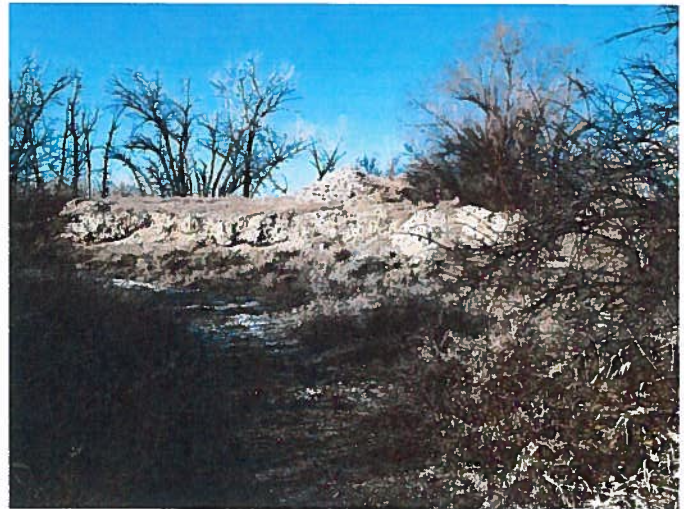
Figure 6: Soil pile on west side of pond.
