COLORADO DIVISION OF RECLAMATION, MINING AND SAFETY
MINERALS PROGRAM INSPECTION REPORT
PHONE: (303) 866-3567

MINE NAME: Upland Gravel Pit No. 4	MINE/PROSPECTING ID#: M-2006-005	MINERAL: Sand and gravel	COUNTY: Delta
INSPECTION TYPE: Monitoring	INSPECTOR(S): Dustin M. Czapla	INSP. DATE: March 19, 2014	INSP. TIME: 10:15
OPERATOR: Upland Gravel, Inc.	OPERATOR REPRESENTATIVE: Jason Rinderle	TYPE OF OPERATION: 110c - Construction Limited Impact

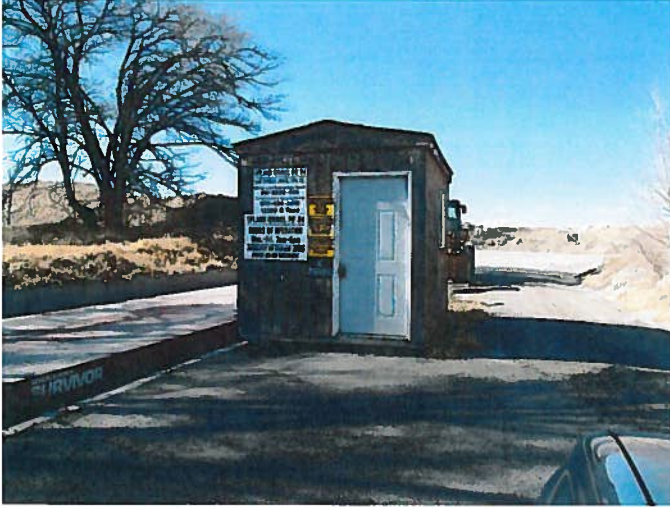
Figure 1: Scale house at site entrance.

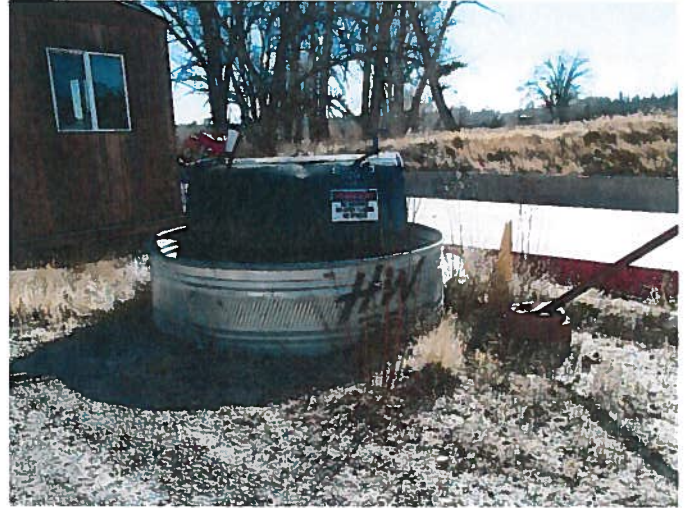
Fuel storage was kept in adequate secondary containment.

Figure 2: Fuel storage behind scale house.

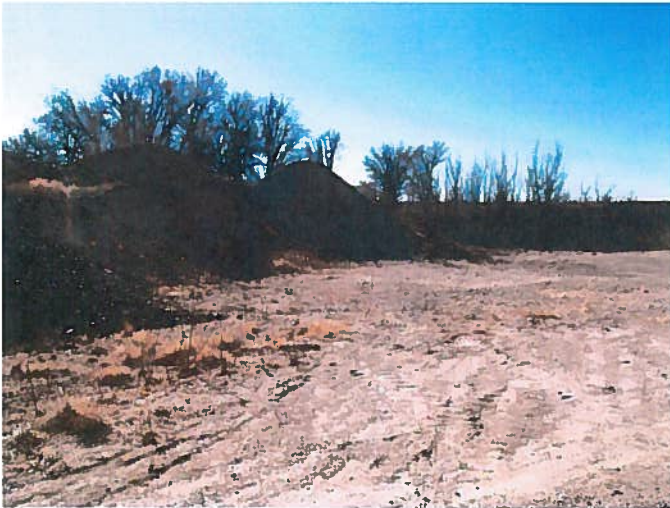
Figure 3: View from pit entrance, facing south.

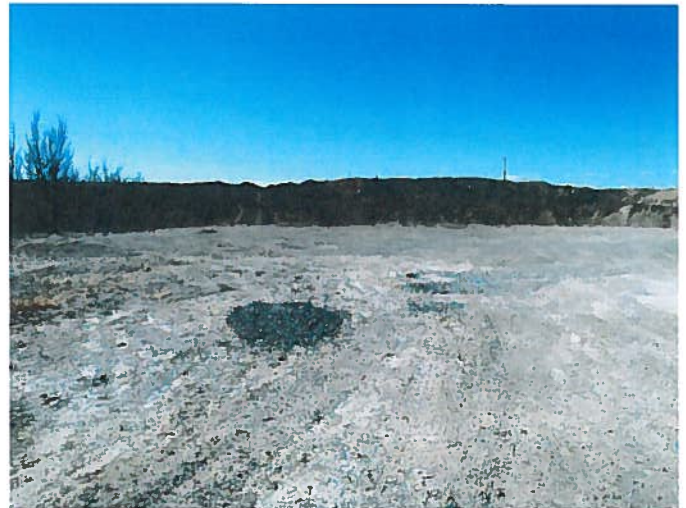
Figure 4: View from pit entrance, facing south.

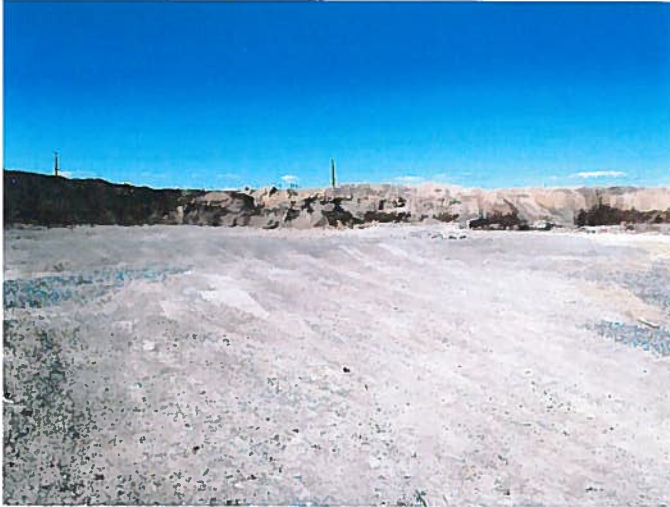
Figure 5: View from pit entrance, facing southwest.

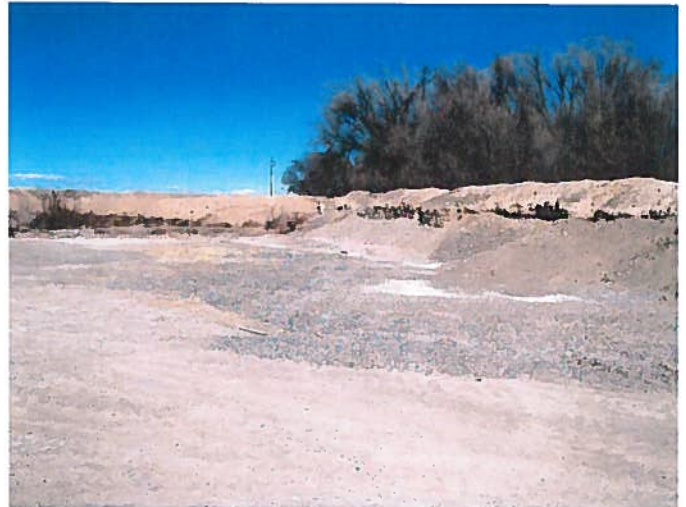
Figure 6: View from pit entrance, facing west.

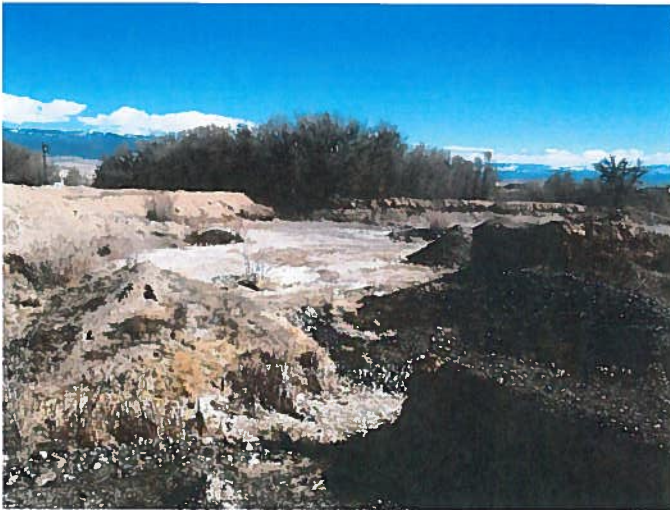
Figure 7: View of low area in pit floor, which was dry during this inspection.

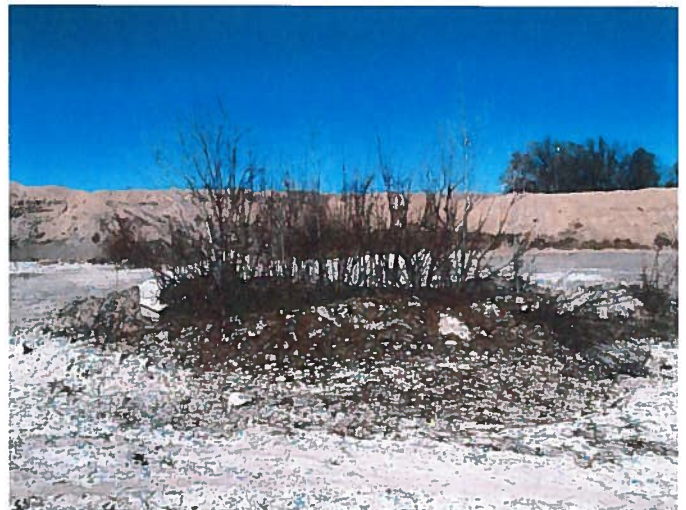
Mining was not occurring during this inspection. Conditions appear similar to the Division's previous inspection. Water was not observed in the low part of the pit. Pit highwalls average approximately 1H:1V, and fifteen feet high. Tamarisk is beginning to establish in the pit low areas. The operator is encouraged to be vigilant in combating these invasive noxious weeds.

Figure 8: Tamarisk beginning to establish in low areas of pit floor that hold water during irrigation season.

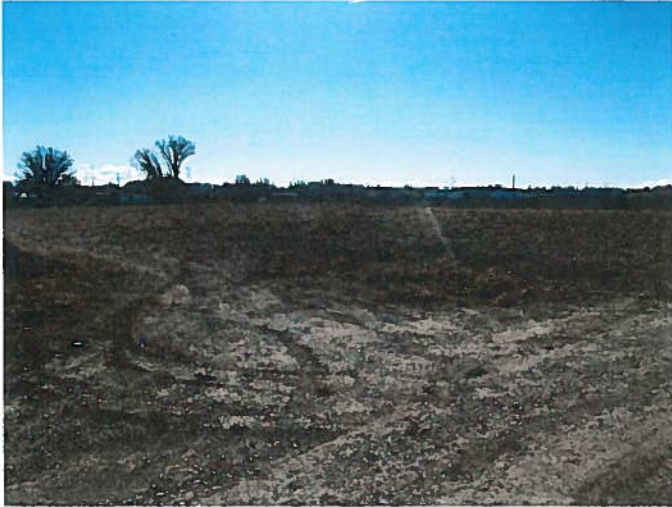
Figure 9: Unmined area on south side of pit.

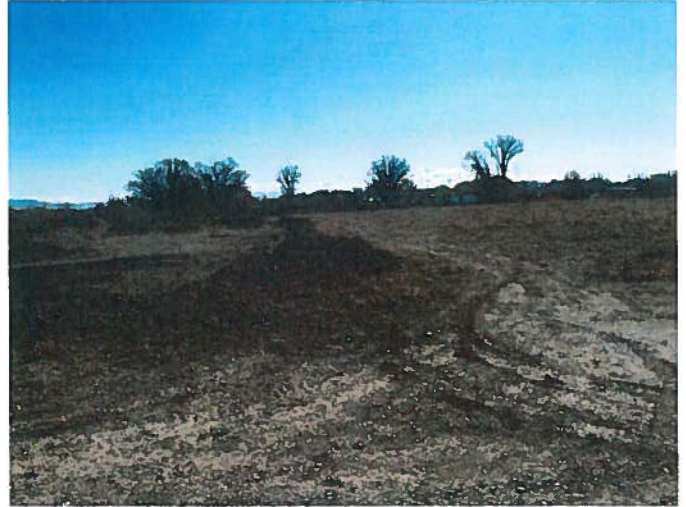
Figure 10: Unmined area on south side of pit.
